OPERATION DAKOTA

D.M.MCELVOGUE

(September 2018)

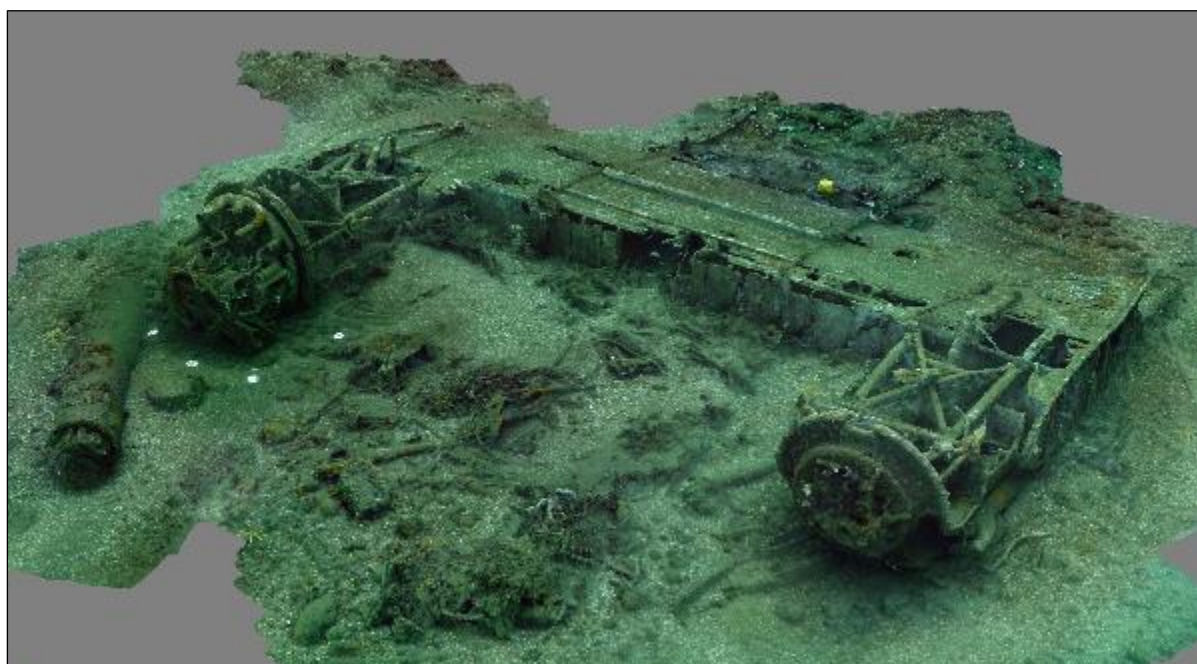
Figure 1 General view of site taken form 3D photogrammetry.

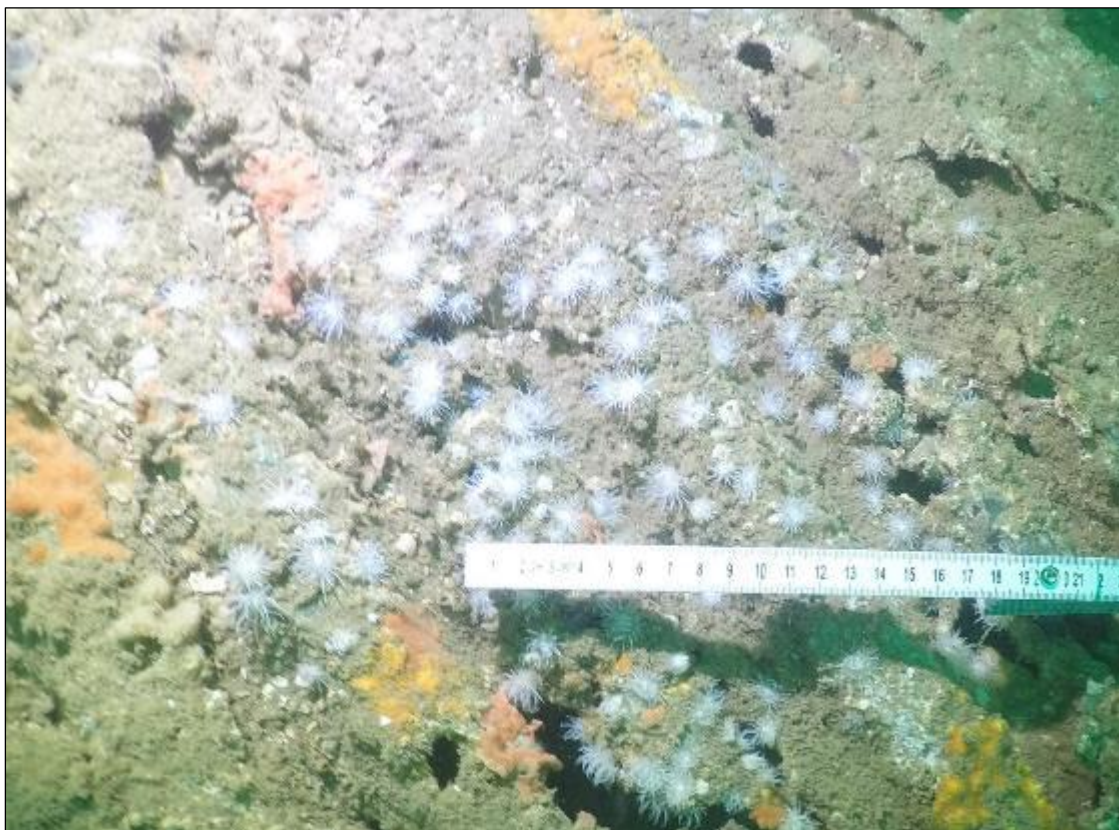
Figure 14 *Anemones growing on the corrugated inner skin of the C-47.*

The smooth outer skin of the wing section does not remain. Instead the corrugated sheet metal of the inner skin remains. (seen in figure 14). The corrugations run perpendicular to the leading edge of the wing of the aircraft and runs the entire width of the wing section. Just inboard of the port engine fairing are two holes. They are 0.772 m from the leading edge and 0.942 m between their centres. These had rubber seals/grommets in situ when first found. These were recovered by WA in 1997. The diameter of the grommets is 200 mm (WA 1997a).

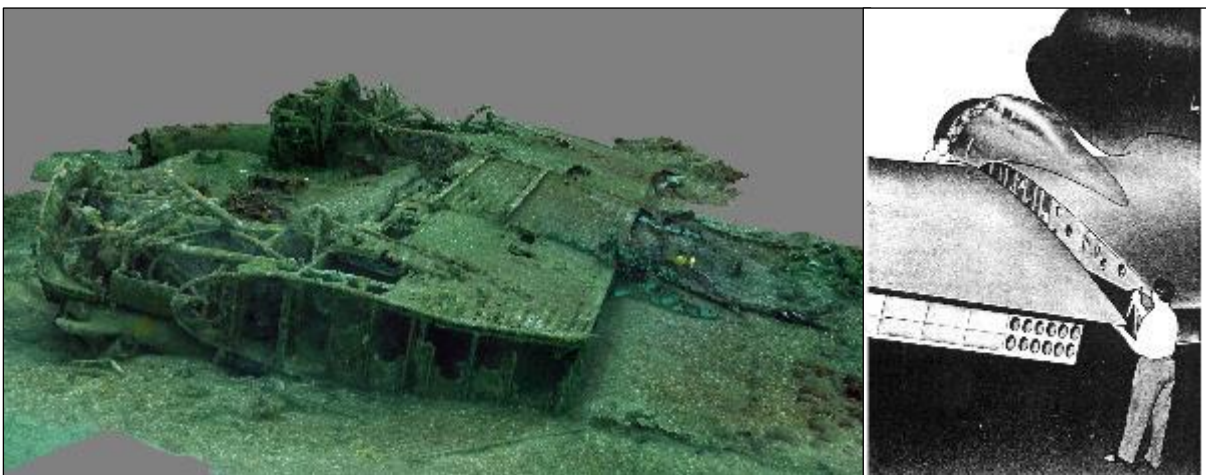
The outer edge of each wing comprises a longitudinal member over 4.252 m long and 0.653 m high at its highest point. This corresponds to the joint at which the outer wing was attached by bolts (Figure 15). The portside joint is perforated by a series of circular holes which follow the series from the leading edge aft as; single, single, single, single, double, single, single, double, single, single, single, single. The starboard wing is more corroded but has similar features. Other longitudinal members are visible in the top surface of the wing section, as is at least one transverse member.

Figure 15 Comparing the C-47 on site with the maintenance manual.

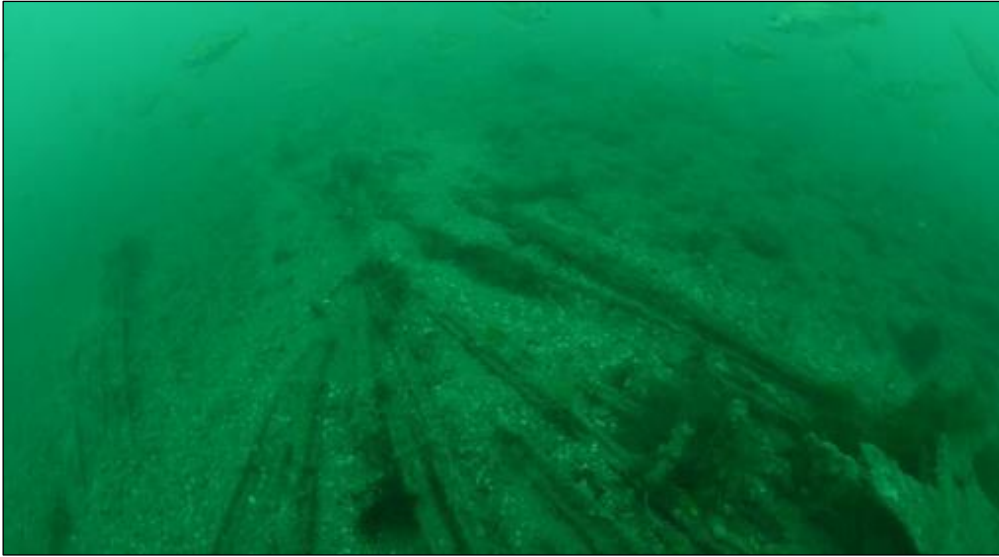
The outer wings are not visible as a coherent structure. There is evidence within the seabed sediments either side of the bulkheads for the lower part of the wings. This consist of light aluminium struts and partial pieces of corroded sheets (Figure 16).

Figure 16 Parts of the outer wing struts uncovered in 2015.

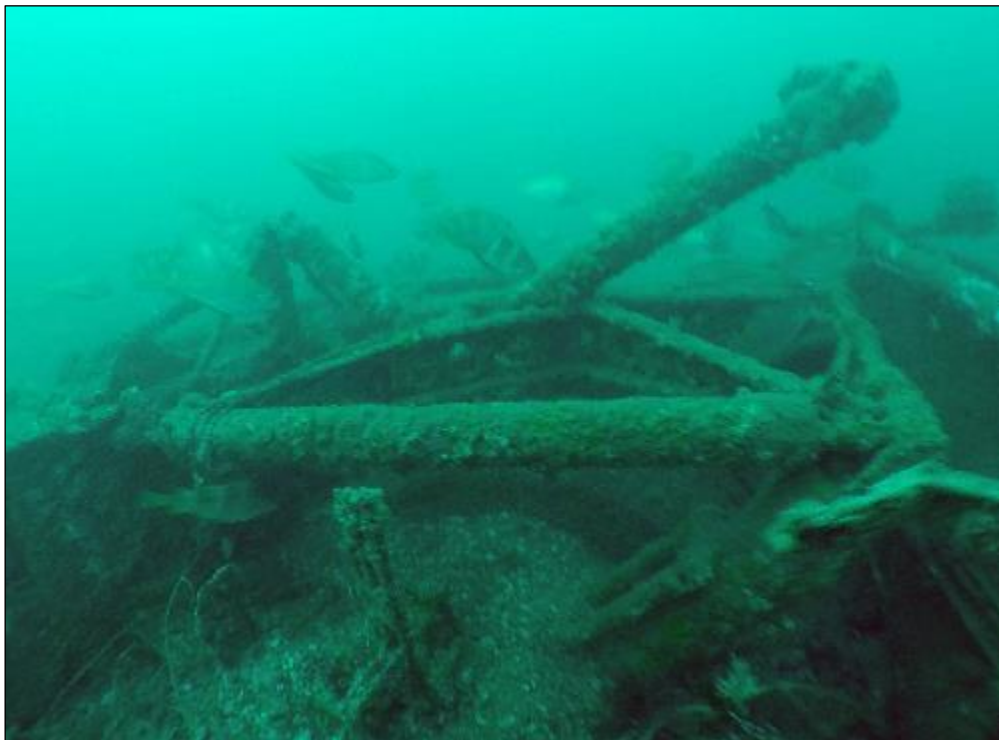
Figure 17 The long hydraulic jack within the engine mount, and behind it a shorter hydraulic jack. The X shaped metal cross brace is also visible.

Aft of each flange, and within the struts, are several diagnostic features. These include the aircraft's landing gear which comprises of a wheel, surrounded by elements of its undercarriage. Only the top of the tyre is visible. Its maximum visible dimensions are 0.804 m length and 0.402 m wide. The undercarriage consists of a long hydraulic jack projecting upwards towards the back of the engine mount, and behind it a shorter hydraulic jack projecting up towards the trailing edge. An X shaped metal cross brace is also visible (Figure 17).

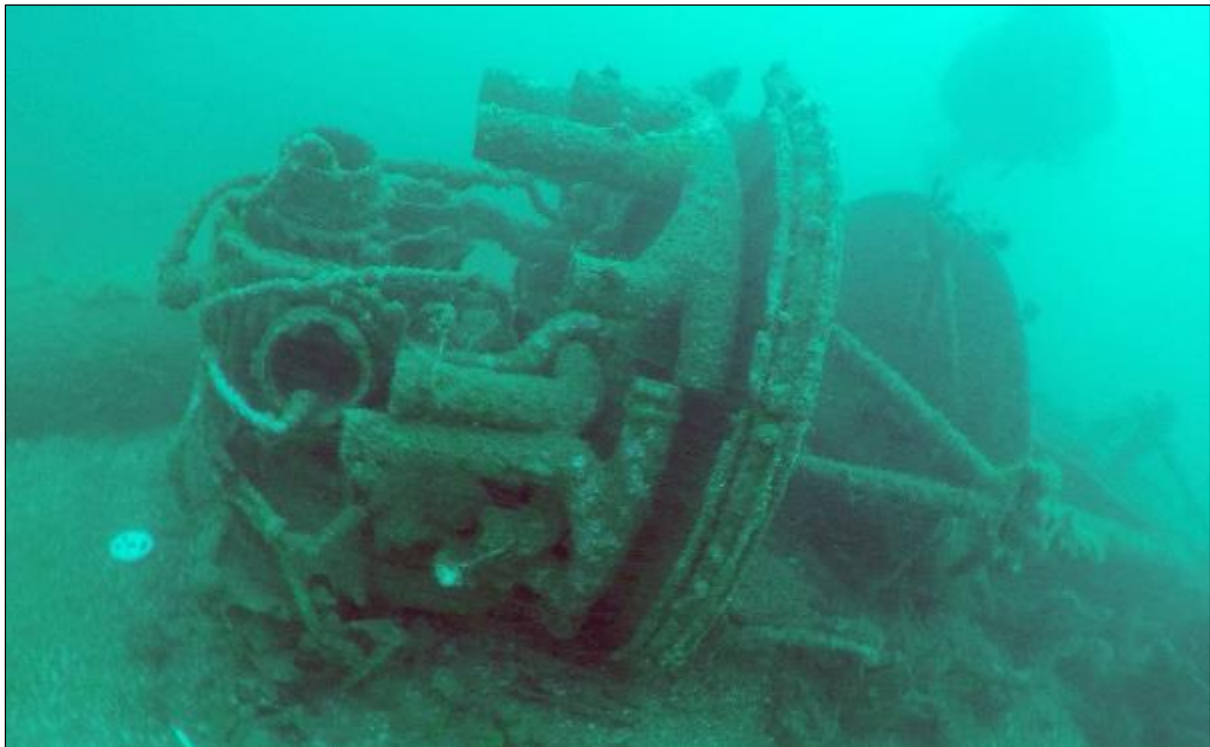
The starboard engine is still in situ on its mount (Figure 17). Its propeller is detached and lies 25 metres forward of the port engine. The port engine is no longer on site (see conclusion), though it was noted to lie in front of the port engine mounting in 1997 and 2007. When first found the engine stood upright in front of its mounting. The port engine's three-bladed propeller was still attached, and it was this that it stood upon. Both engines were radial engines and consist of two banks of seven cylinders each, making a total of fourteen cylinders.

Figure 18 *Starboard Engine still lying in situ.*

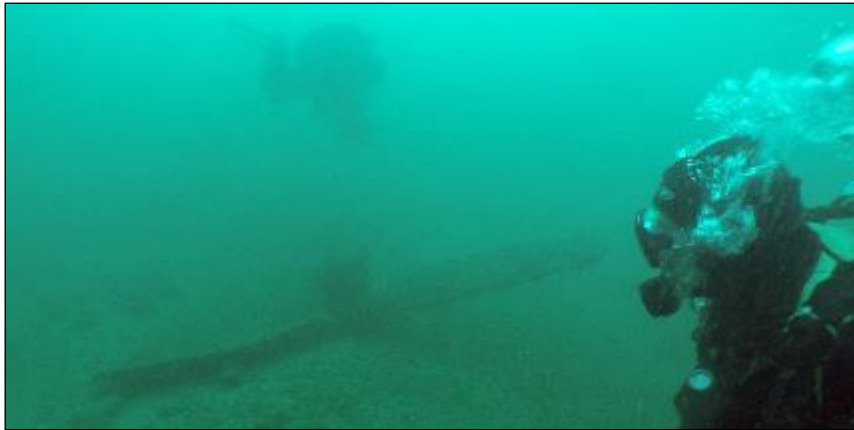
The blades of the propellers are 1.66 m long. The port engine propeller is no longer on site having disappeared along with the port engine. WA reported that it did not appear to be feathered and had no visible sign of damage. The starboard engine propeller lies forward of the port engine. It is partially buried but still intact with all 3 blades serving. It lies boss-down (Figure 18). The boss and two of the propeller blades are partially buried whilst the third blade projects upwards at an approximate angle of 30 degrees. Lying on the seabed by the propeller

is a small piece of aluminium sheet and some angle bar and represent parts of the wreckage. A steel wire 15 mm in diameter runs from the main part of wreckage past the propeller and continues out in a loop. The end of this wire was not located.

Figure 19 *Starboard propeller lying on the seabed.*

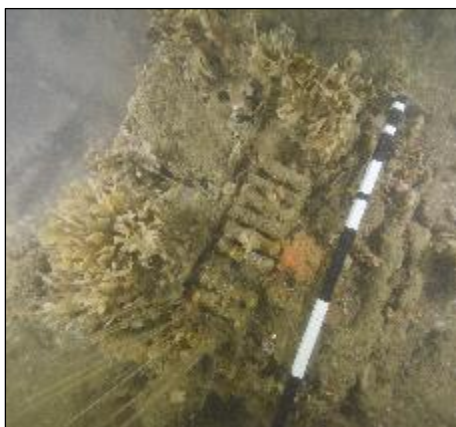
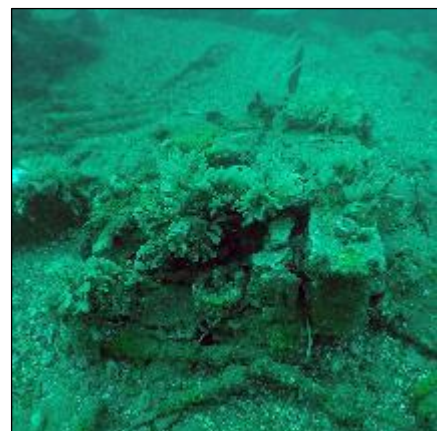
Lying inside of the starboard engine is a rectangular object measuring 0.50 m by 0.25 m. Inside the rectangular object are two hollow open-ended cylinders and a reel. On its upper surface can be seen a series of brass/copper cylinders (Figure 19) These look like a belt of machine gun ammunition. They are upon closer inspection hollow cylinders with wire wrapped around one end. The object is most probably the remains of the planes radio equipment. Nearby this possible 'radio' is another box-shaped object 0.605 m by 0.302 m. Its uppermost face has a shallow oval recess made from a concreted material which is reinforced inside by interwoven wire. It is possible it a speaker.

Figure 20Figure 19 *Possible radio equipment lying in situ (left is the top right is the side)*

The location of this equipment corresponds to the radio operator's position within the aircraft (see C-47 cutaway, item 28 in Cacutt 1988: 198-9).

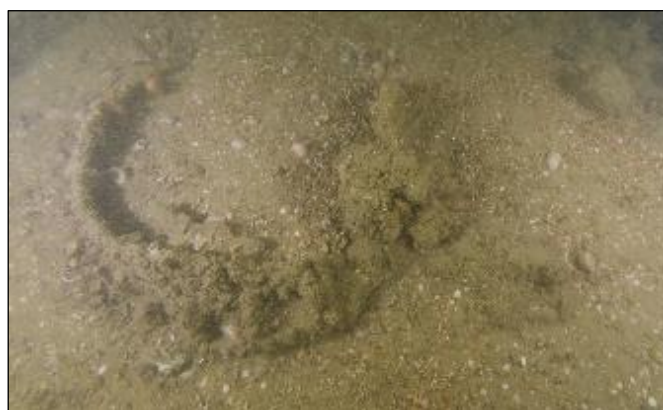
A hollow circular metal object 480 mm in diameter and 300mm high is located forward of the port engine flange. It is open at the bottom and has a flange protruding from its outer rim (Figure 20). The upper face is convex with a small central hole whilst the outer edge is crenelated. The function of this object is open to interpretation, but it might form part of the cylinder lying beside the starboard engine (see below).

Figure 21 Cowling on seabed forward of the main wing section.

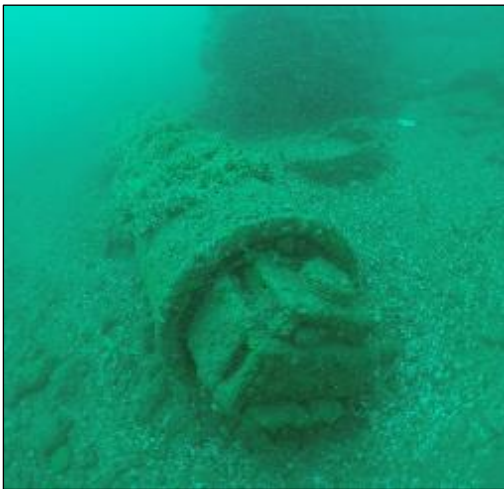
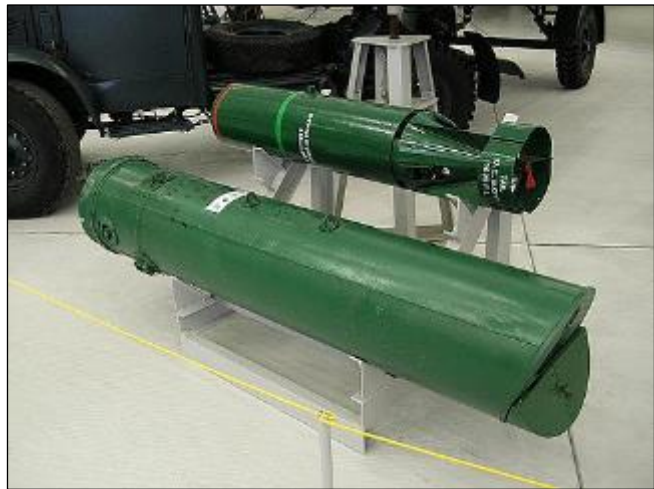
Figure 22 *Possible Mark V Anti-Shipping mine in situ and on display at IWM Duxford.*

The function of this object is unknown. It has been suggested that it might be an external parachute delivery pack or a mark 5 air deployable sea mine.

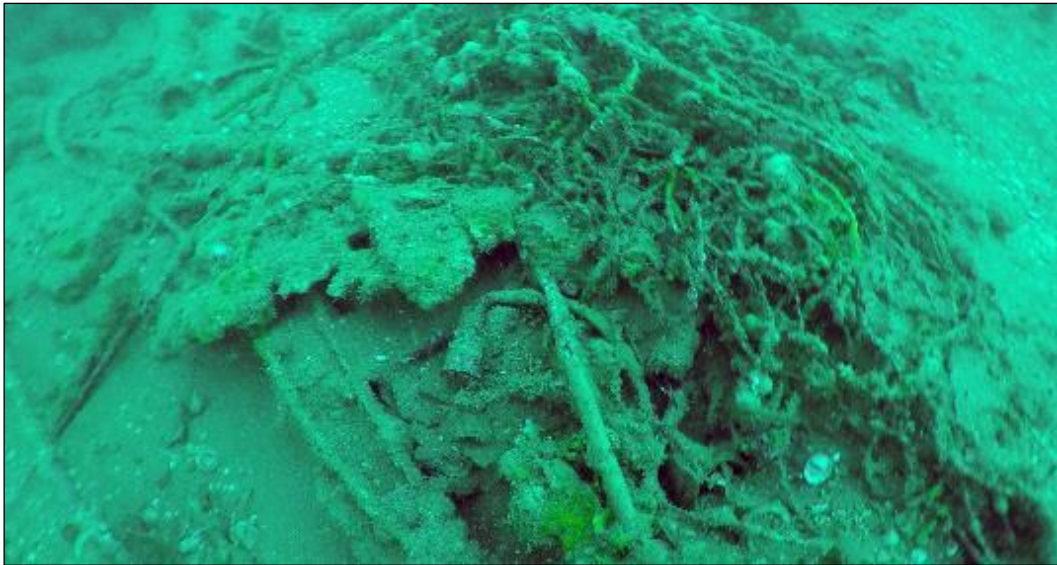
Immediately in front of the wing to 3.50 m distance out the debris is a mass of 3 mm diameter wire. This mass consists as individual wires, twisted pairs, and twisted pairs in shielding with terminations. These terminations consist of “Amphenol plugs”, the recognised standard cable termination within the aviation industry.

Figure 23 Mass of wire with Amphenol plug evident in the middle.

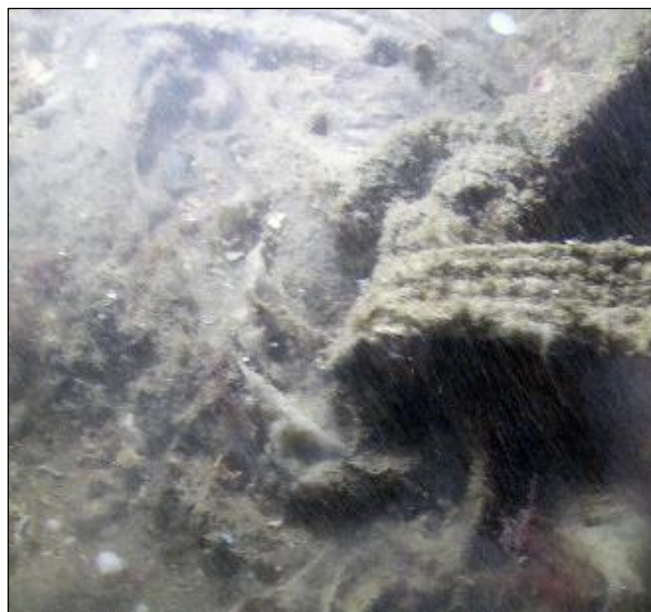
Figure 24 Cloth including webbing-like material with a herring bone pattern weave.

All around the site there is evidence for cloth including webbing-like material with a herring bone pattern weave. This noted in 1997 and 2018. In 1997 a sample of cloth was taken from material protruding from the seabed by the starboard wing section (WA 1997a). The material consists of very fine pale threads and is thought to possibly be parachute silk. More of this material was noted to lie in and around the wreckage, including a large mound 7.5 m to the back of the plane and a conspicuous pill intermingled with the mass of wire.

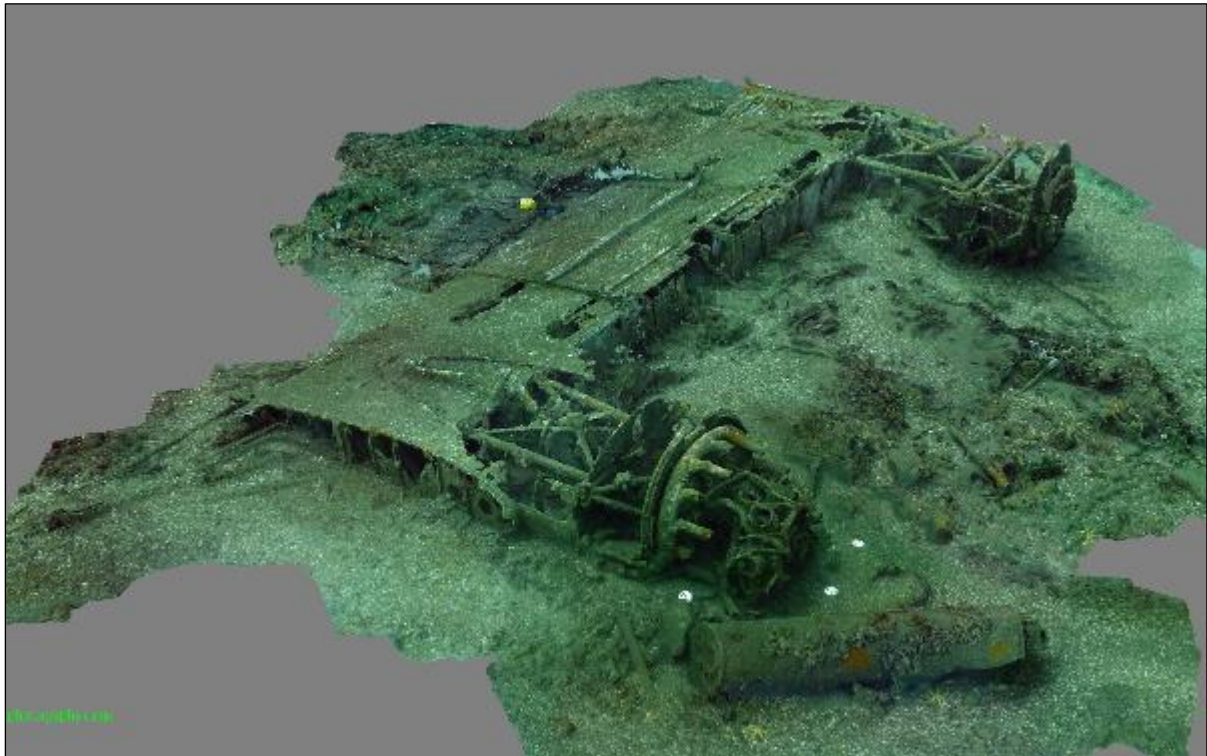
Figure 25 *Side view of C-47 taken from the 3D photogrammetry. Note the possible Mark V mine in the foreground, starboard engine hanging off its mount and large debris field between the two engine mounts.*

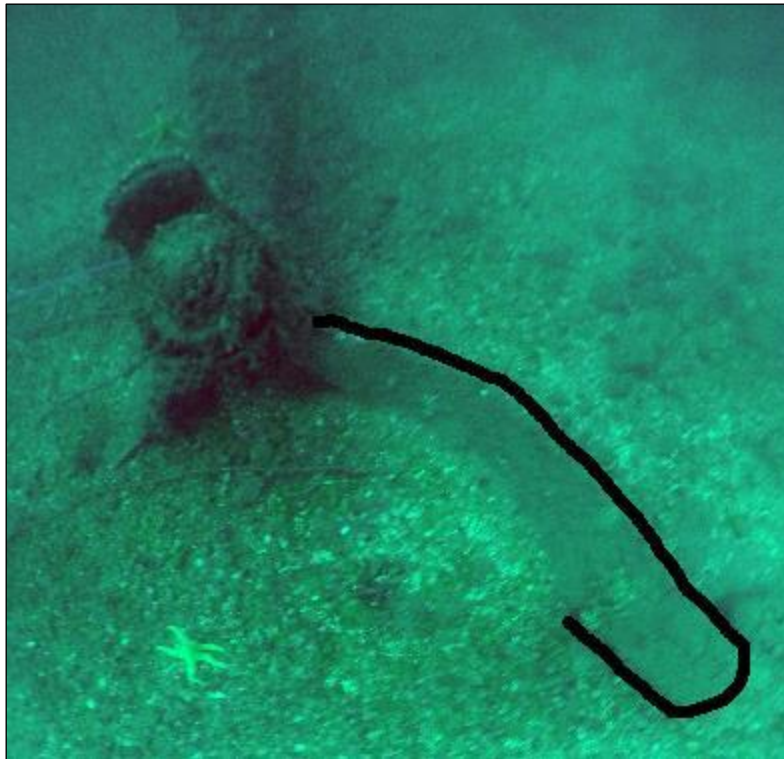
they were intact and straight. The only published image of the propeller is not detailed enough to discern whether it was bent. If this interpretation is correct this further supports the identity of this C-47 with the plane returning damaged from D-Day.

Figure 30 Bent blade on starboard propeller.
