SOLENT ARCHAEOLOGICAL DIVERS SUB AQUA CLUB

SOLENT WRECK PROJECT REPORT 2012

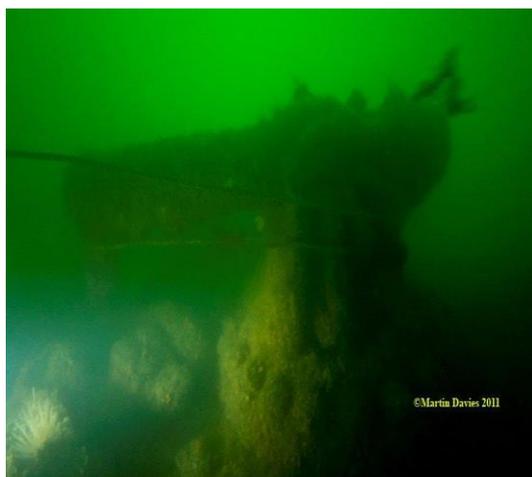
Figure 3. Stern gun on SS Serrana.

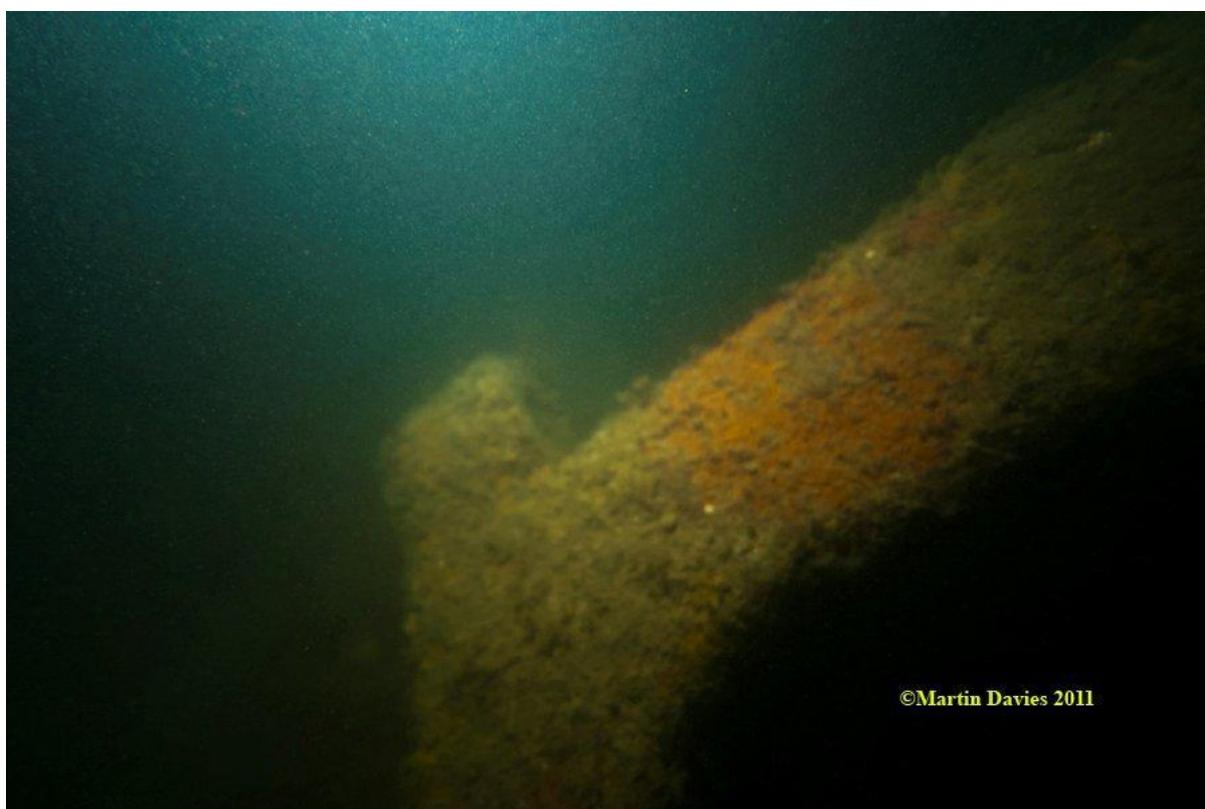
He was also successful in getting images from the rudder fixings (gudgeon) on the stern (figs 4 and 5). Evidence from video taken by Dave Robbins shows that the four-bladed steel propeller (fig.6 is still attached to the shaft, and that the propeller tunnel is still in evidence for some metres as an intact tunnel, not a series of reinforcing hoops as had had been thought.

Figure 4. Rudder post SS Serrana 2011.

Figure 5. Stern gudgeon on rudder post SS Serrana

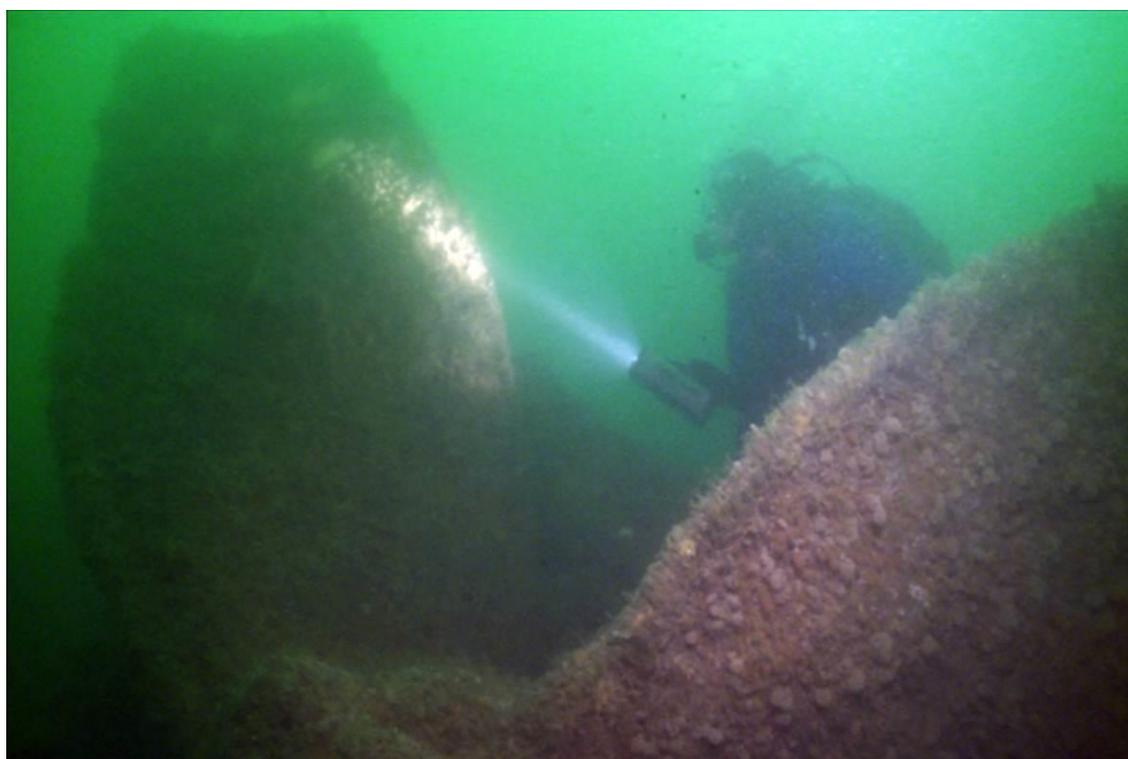
From various measurements it was possible to state that one propeller blade measured 2200mm and the width of the boss behind the propeller had an external diameter of 370mm. The length of the fittings from the stern end to the forward edge of the propeller was 1200mm. A mast lying on the seabed on the port side just forward of the howitzer (the upright gun) was measured at 4000mm long with a diameter of 250mm. China plates were observed in close proximity with the mast (Alison Mayor pers.comm. 2011).

Figure 6. Propeller on Serrana ©Michael Pitts 2011

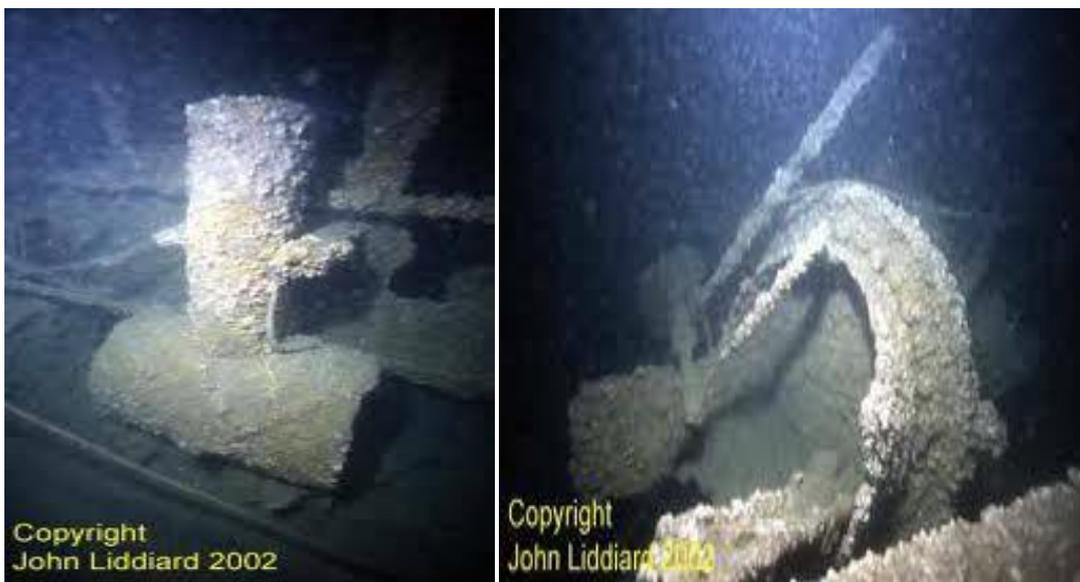
Figure 10. Depth charge launcher and upturned gun pedestal on HMS Warwick Deeping. Photographs by kind permission of John Liddiard

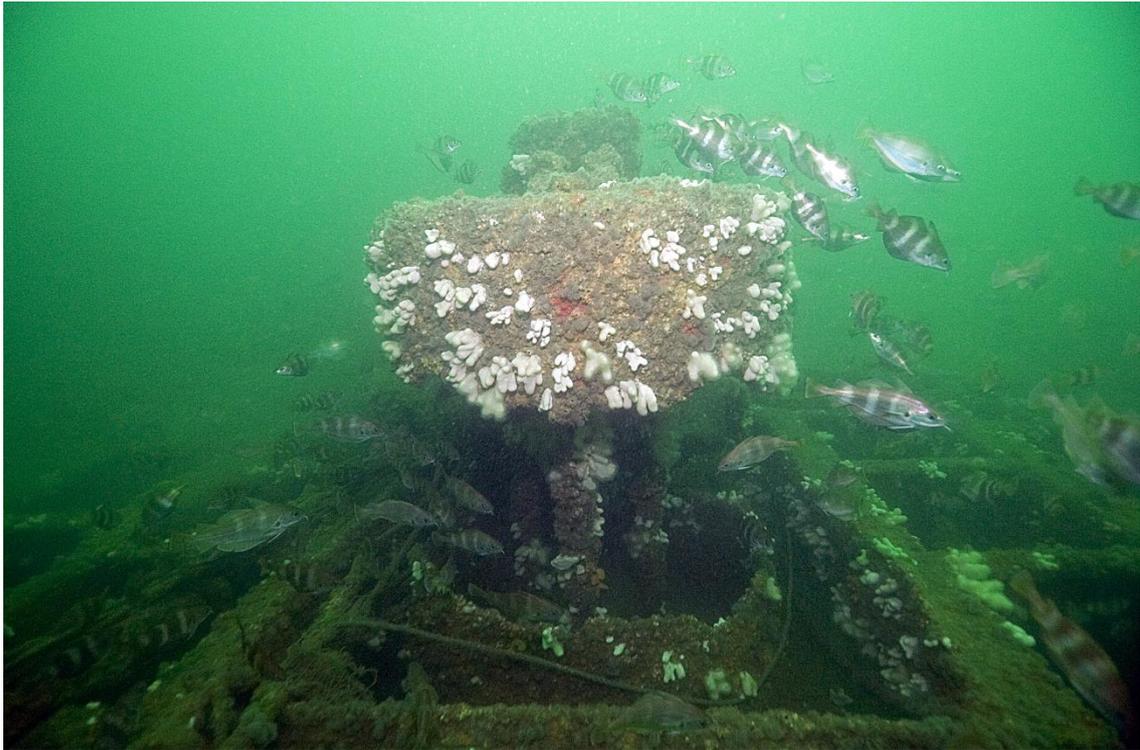
The boiler is partially buried, with less than half its circumference exposed. The boiler measured 4.4m in length, with the steam drier drum 1m in from the aft end of the boiler (figs.14 and 15). The maximum width of the steam drum was approximately 70cm.

Figure 14. Side view of steam drier on boiler © Barry Jarvis 2012

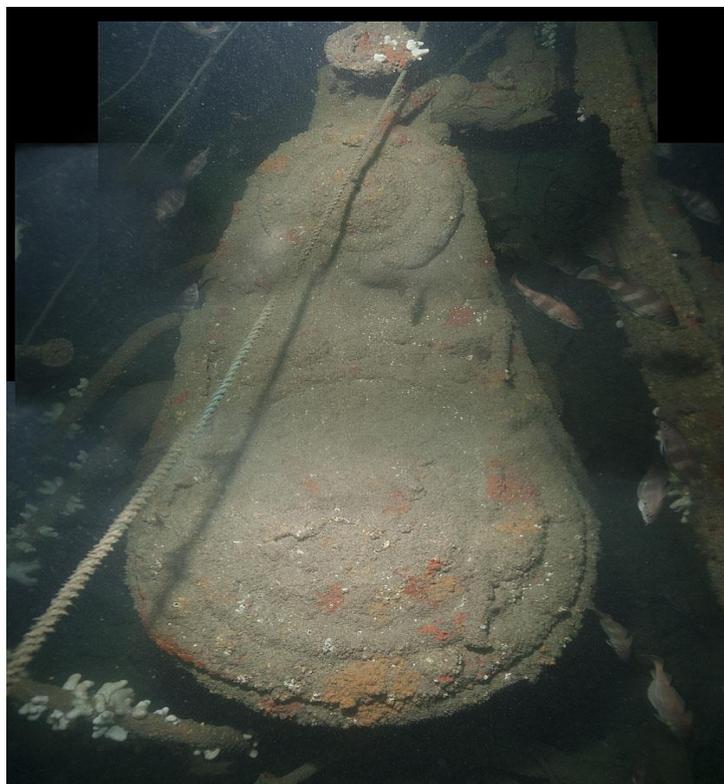
The engine was a twin cylinder compound engine. The overall length of the engine block was 225cm, the high pressure cylinder measured 44cm across the top and the low pressure cylinder was 81cm in diameter.

Figure 15. Twin expansion compound engine on SS Spyros © Barry Jarvis 2012.

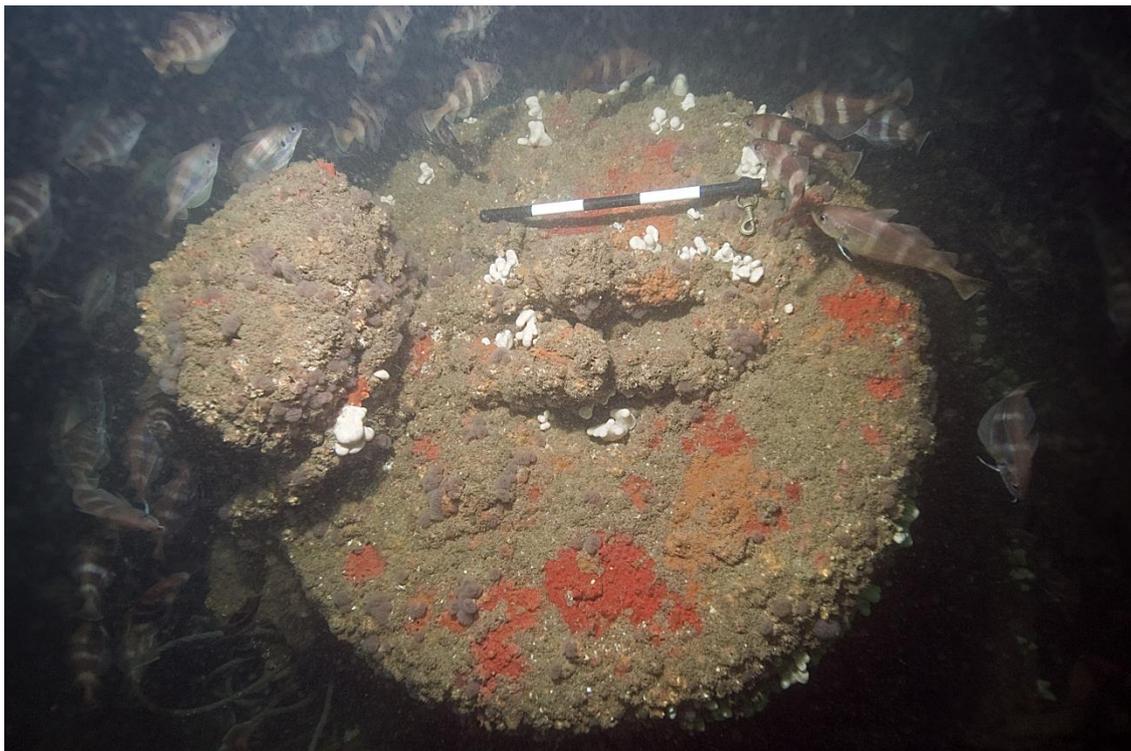
Figure 16. Detail of high pressure cylinder © Barry Jarvis 2012.

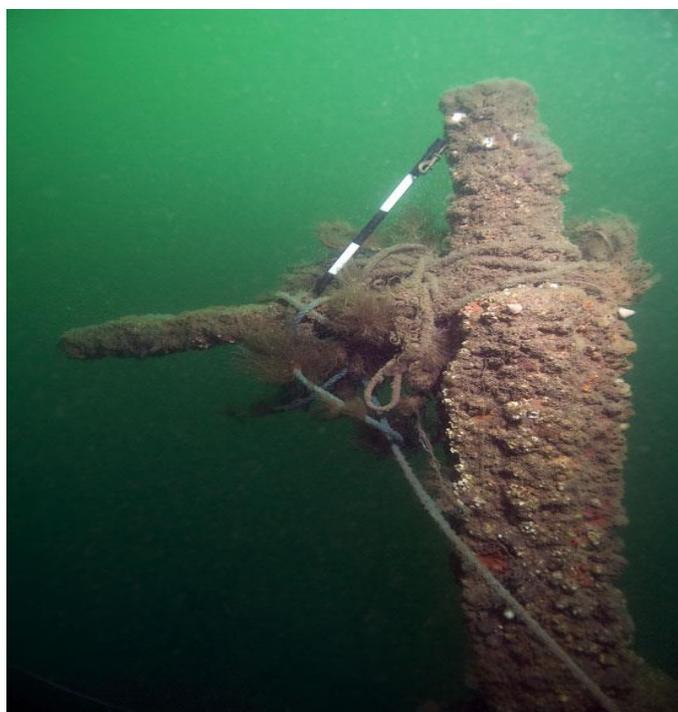
The bladed propeller and the steering arm on the stern are still visible (fig.17). The propeller is broken.

Figure 17. Remains of rudder and rudder post© Barry Jarvis 2012.

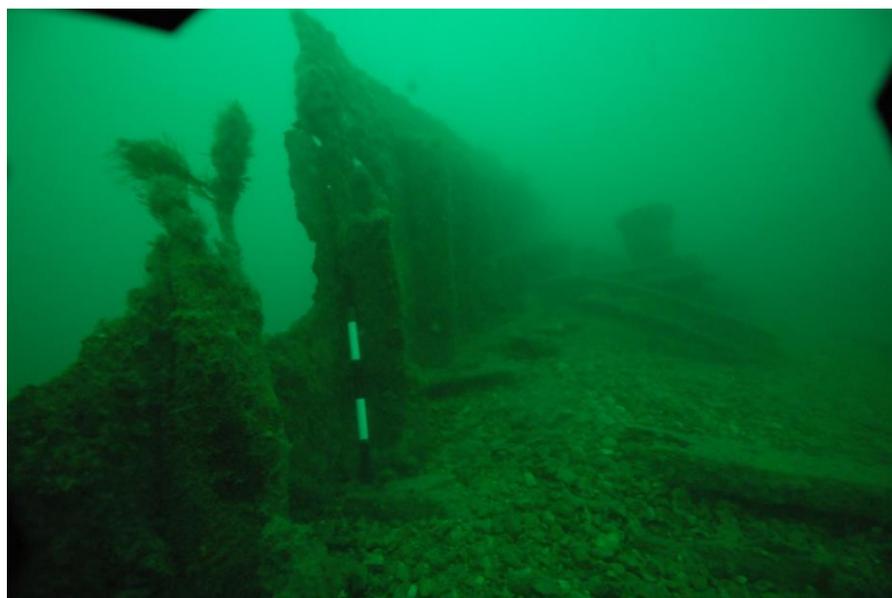
Figure 23. Hull remains 2011 observed again 2012 by SADSAC ©HWTMA

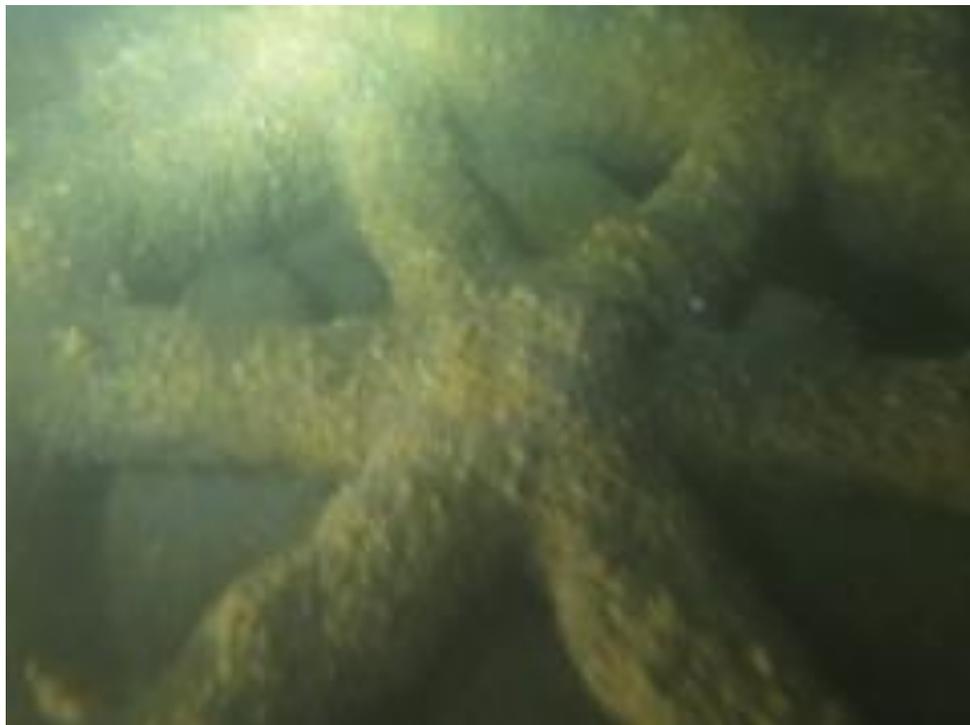
Figure 28. Wheel, possibly used to regulate a valve on steam driven machinery ©Dave Robbins 2012
