Ship, Rock, Selsey

A REPORT ON THE WRECKS OF TWO WOODEN SAILING BARGES
AND THEIR CARGO OF STONE.

Alison Mayor | Southsea Sub-Aqua Club | May 19

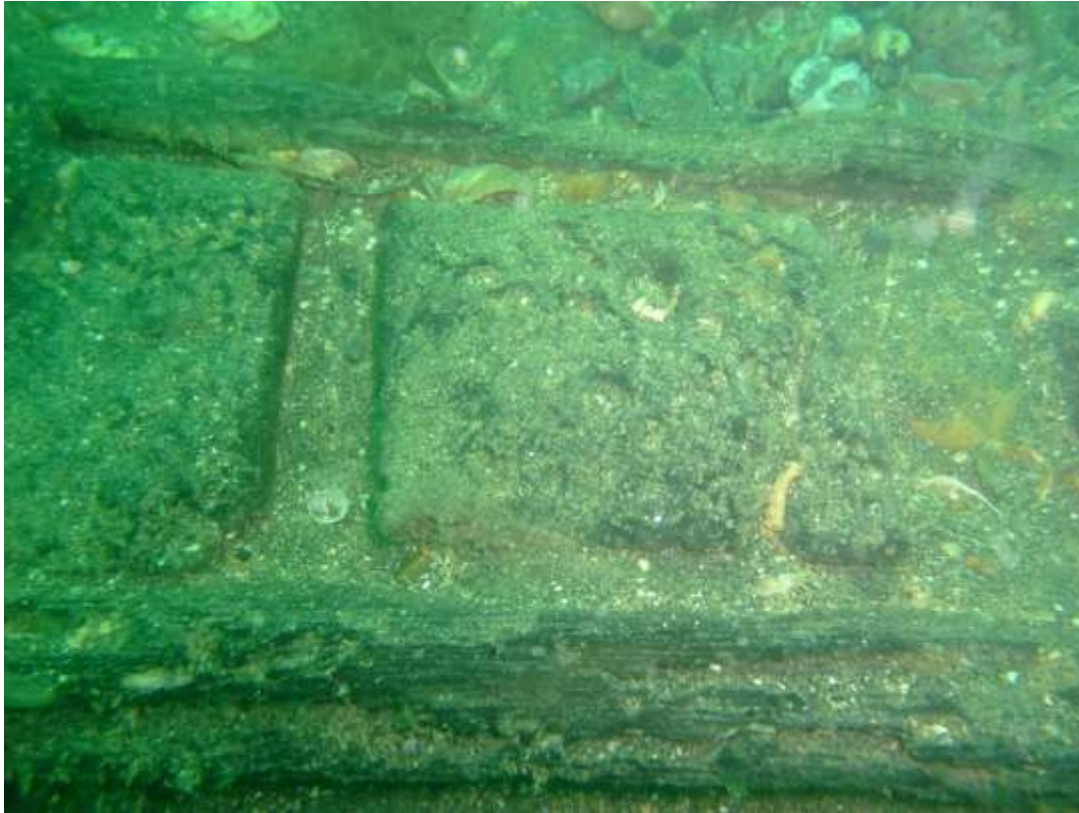
The wooden structure of the vessel is also mostly buried though some exposed timbers were visible on both the port and starboard side from the winch area on the port side (bow) to the end of the stone blocks. On the starboard side there were timbers partially exposed on from the first block (from the bow) to mid-way point along the stone blocks. The frames that were visible indicate a carvel type construction with the frames very close together resulting a heavy but strong hull. Frames and planking were joined by treenails with no evidence of copper nails or sheathing.

Figure 8 Timber frames from the port side (© John Bohea)

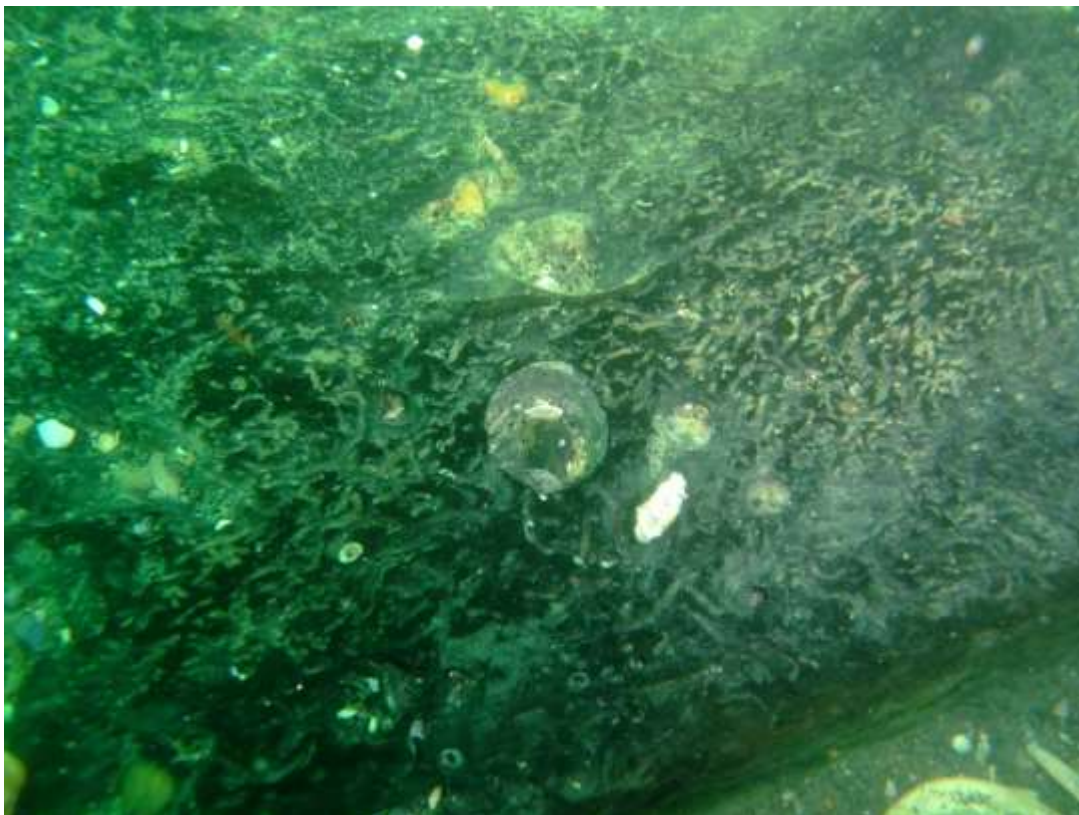
Figure 9 Treenail visible on port side. (© John Bohea)

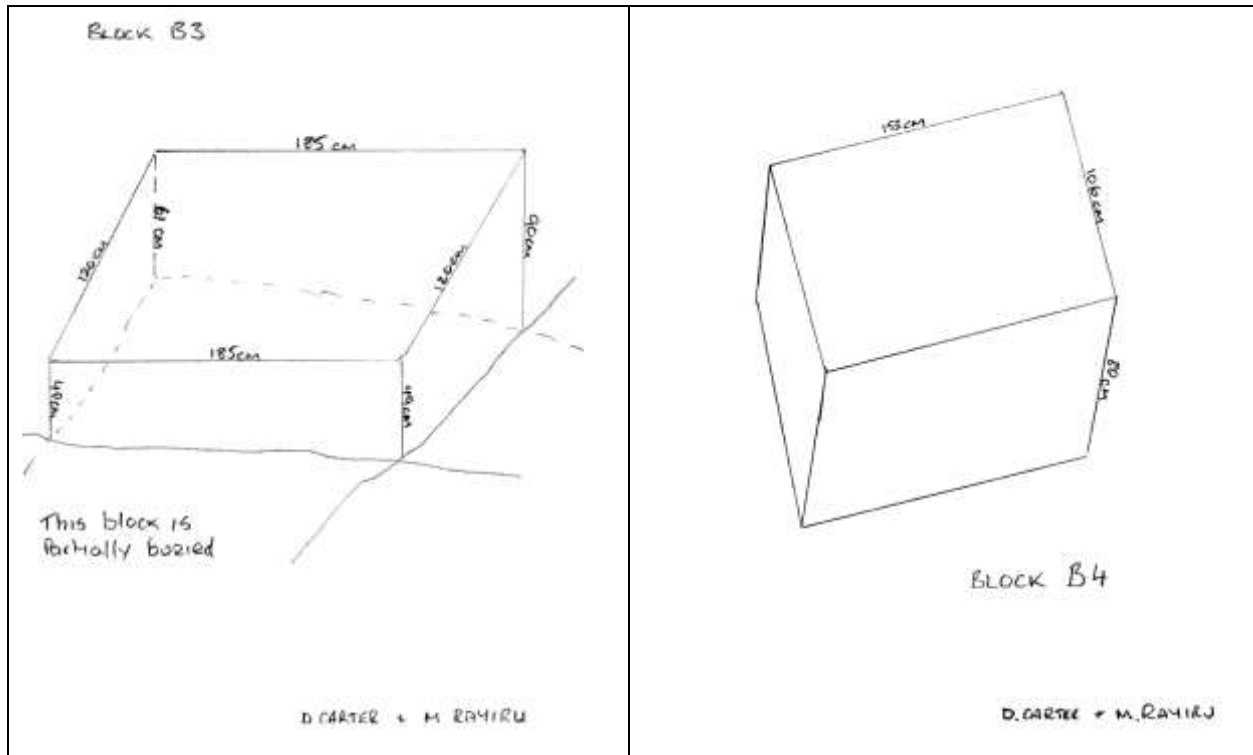
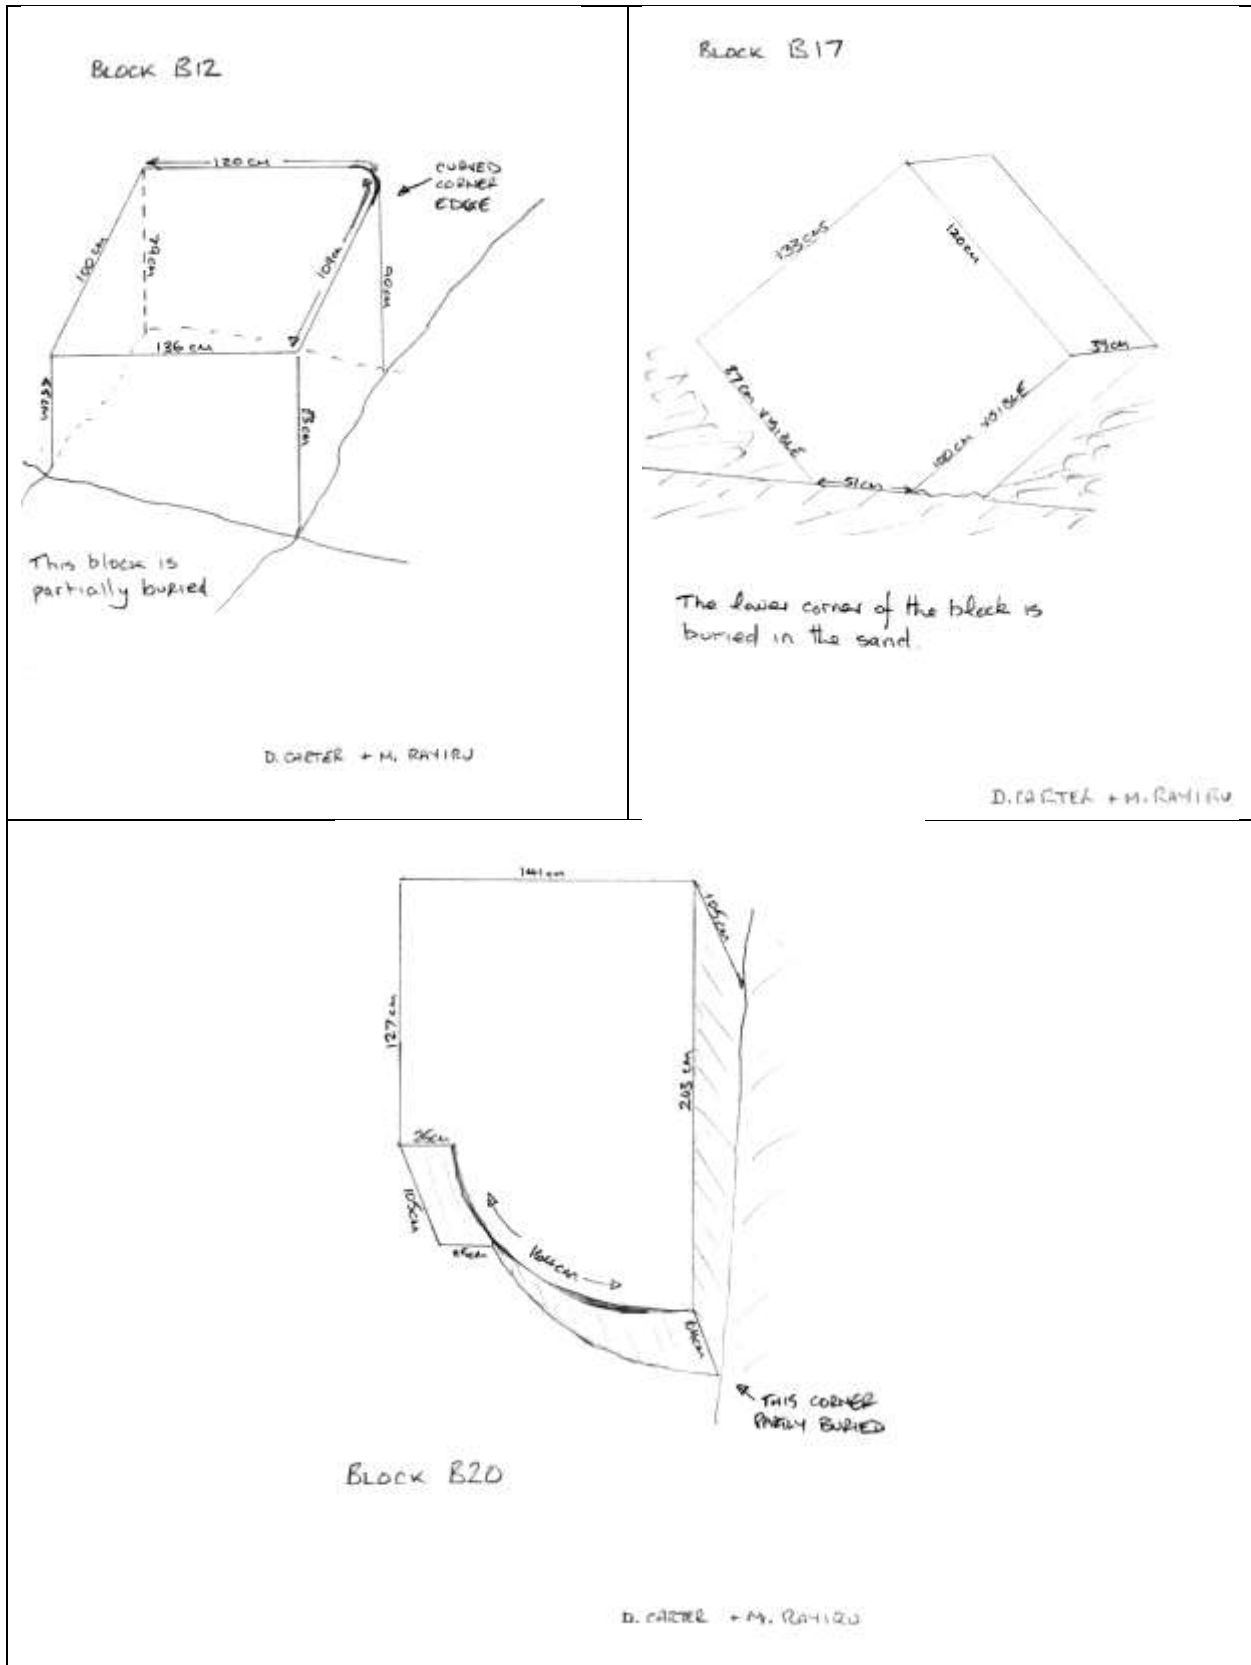
Figure 10 Measurements and sketches courtesy of Doug Carter and Mark Rayiru. (© Doug Carter)

Block 20, above is an unusual shape and at least two other blocks were the same size and shape. A fourth is assumed to be buried. These stones are understood to be 'corbel stones', built into the walls to support the roof beams.⁸

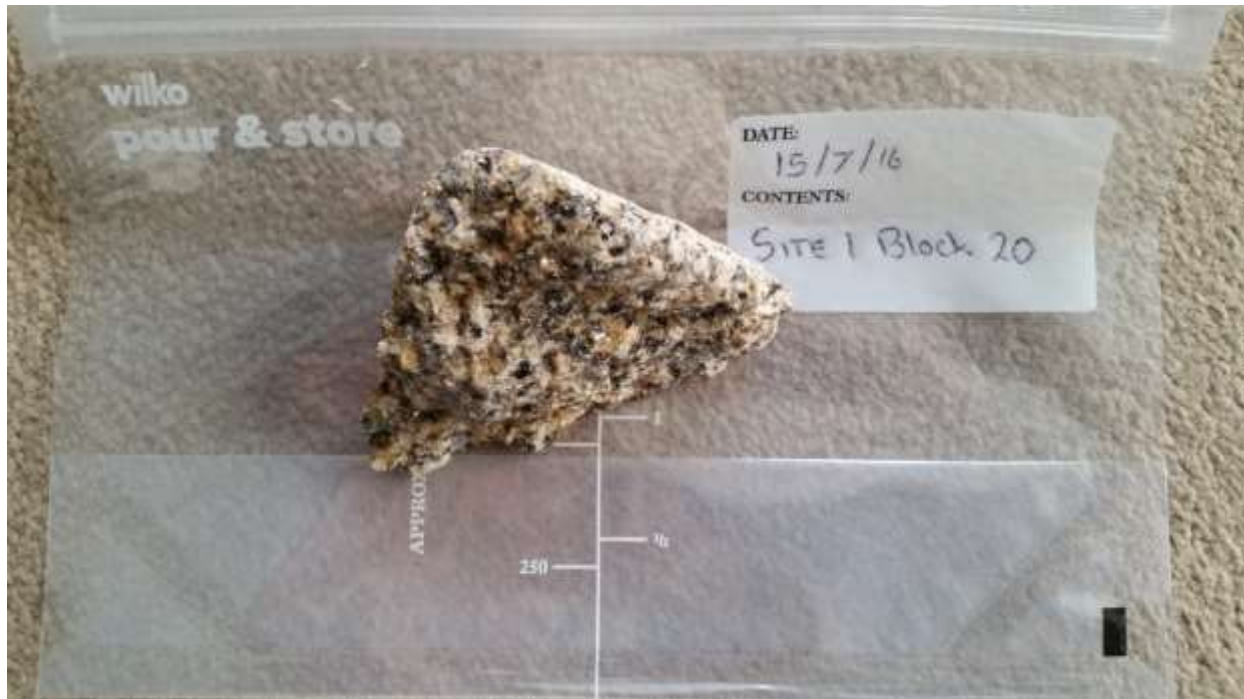
Figure 11 Sample from Block 20. (© Pete Dolphin)

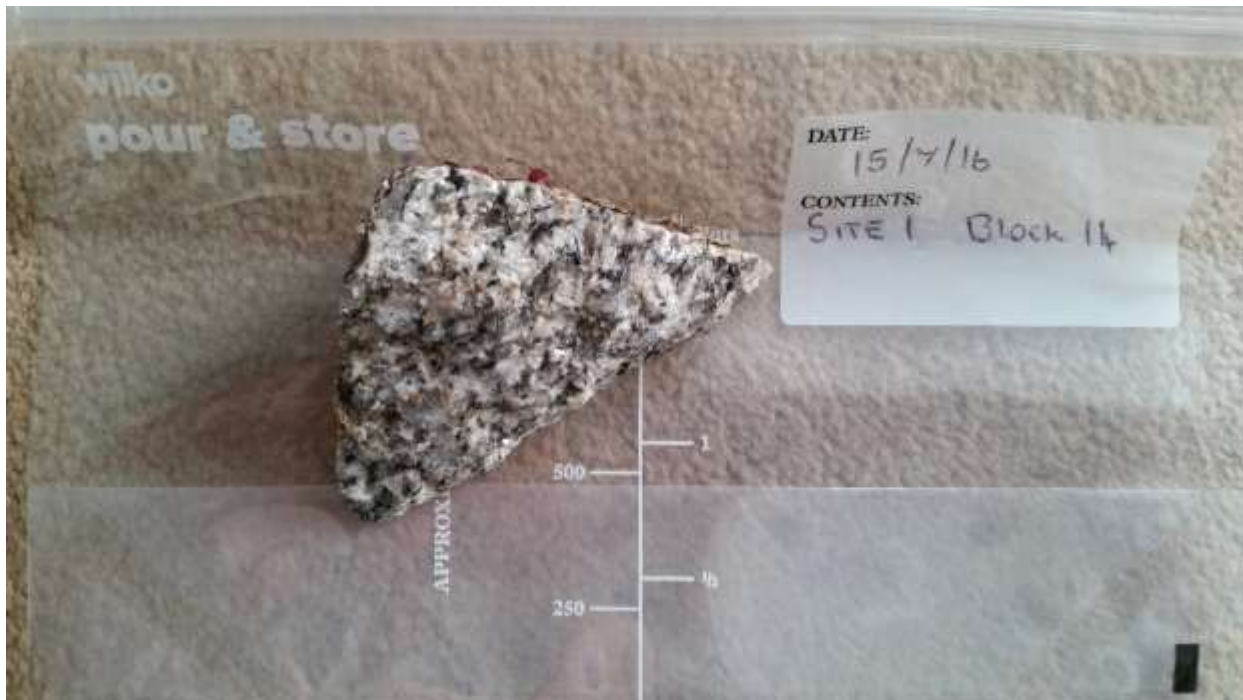
Figure 13 Sample from Block 14 (© Pete Dolphin)

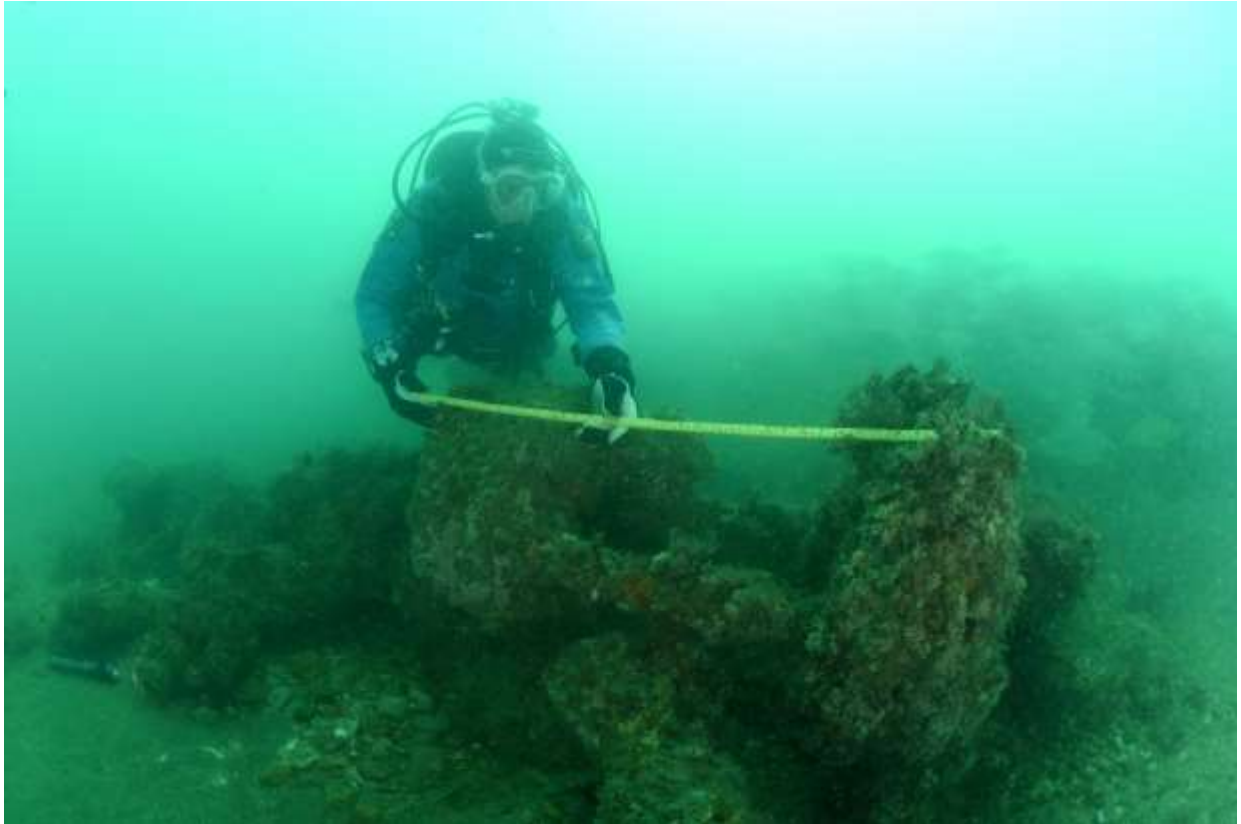
The iron winch is located on the port side just forward of the hold and granite blocks. In comparison to the images taken in 2005 the winch has deteriorated significantly with the collapse of several of the reel bars.

Figure 15 Elements of the winch has collapsed. (© Martin Davies)

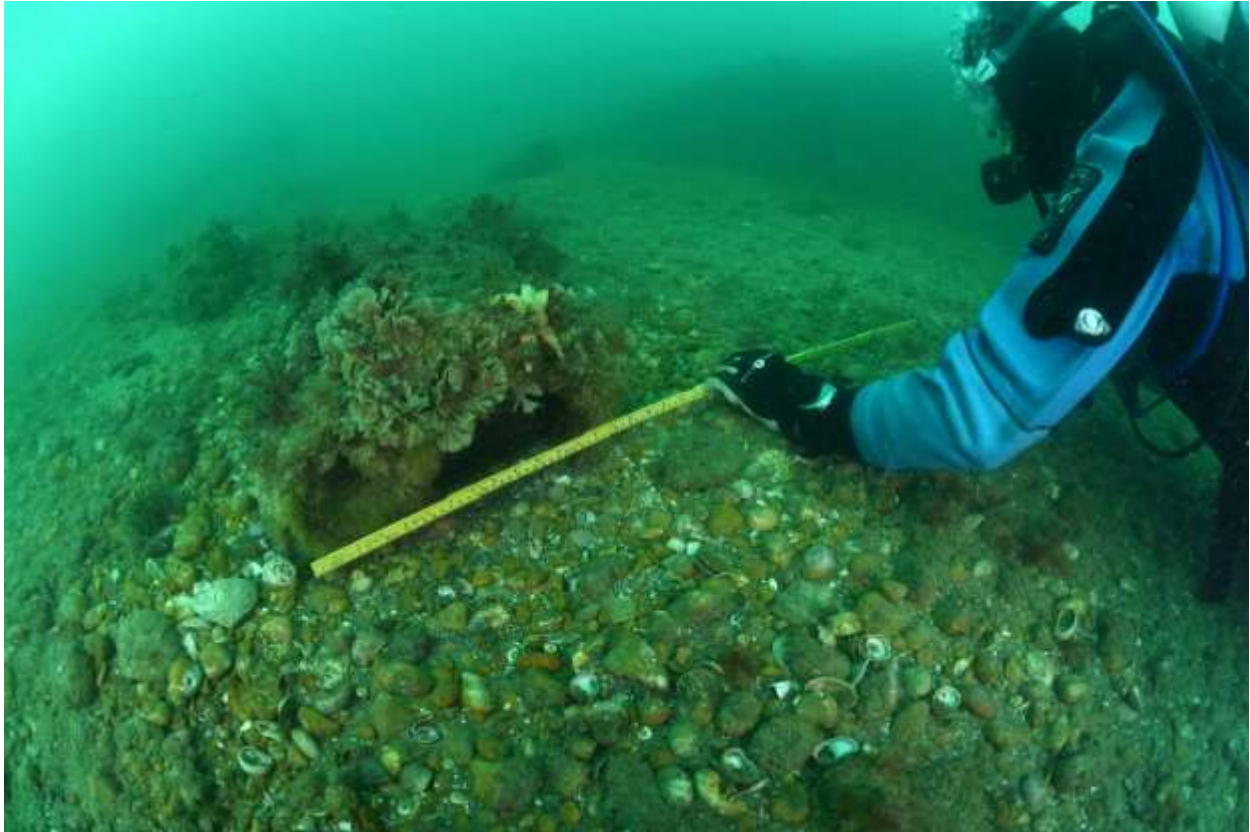
The small cooking stove at the stern would have provided the crew with both heat and cooking facilities. The stove resembles those traditionally used in Thames barges a modern version of which is still available.

Figure 17 the small iron stove. Note the anchor in the background. (© Martin Davies)

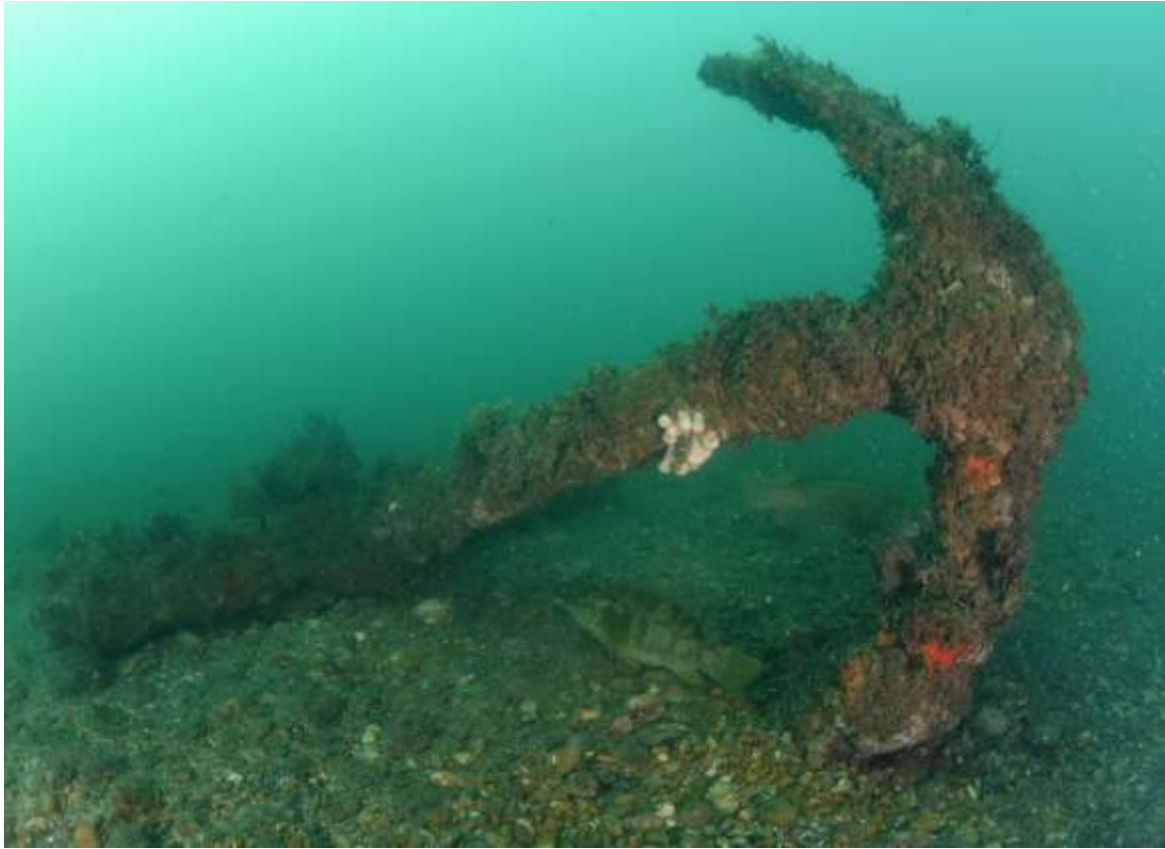
The anchor is an Admiralty Pattern type and made of iron. It can be found towards the stern on the port side approx. 3m from the last block. The stock is 1.8m across as is the shaft. The stock and lower fluke are exposed.

The location has puzzled us as it does not align with the Wessex Archaeology description of the site. In the publicity leaflet which features a sonar image of the site and photograph (see Annex B). It was observed that this anchor, if the same as that recorded in the Wessex Archaeology report has become more exposed than in was when surveyed 10 years earlier.

Figure 18 the anchor. (© Martin Davies)

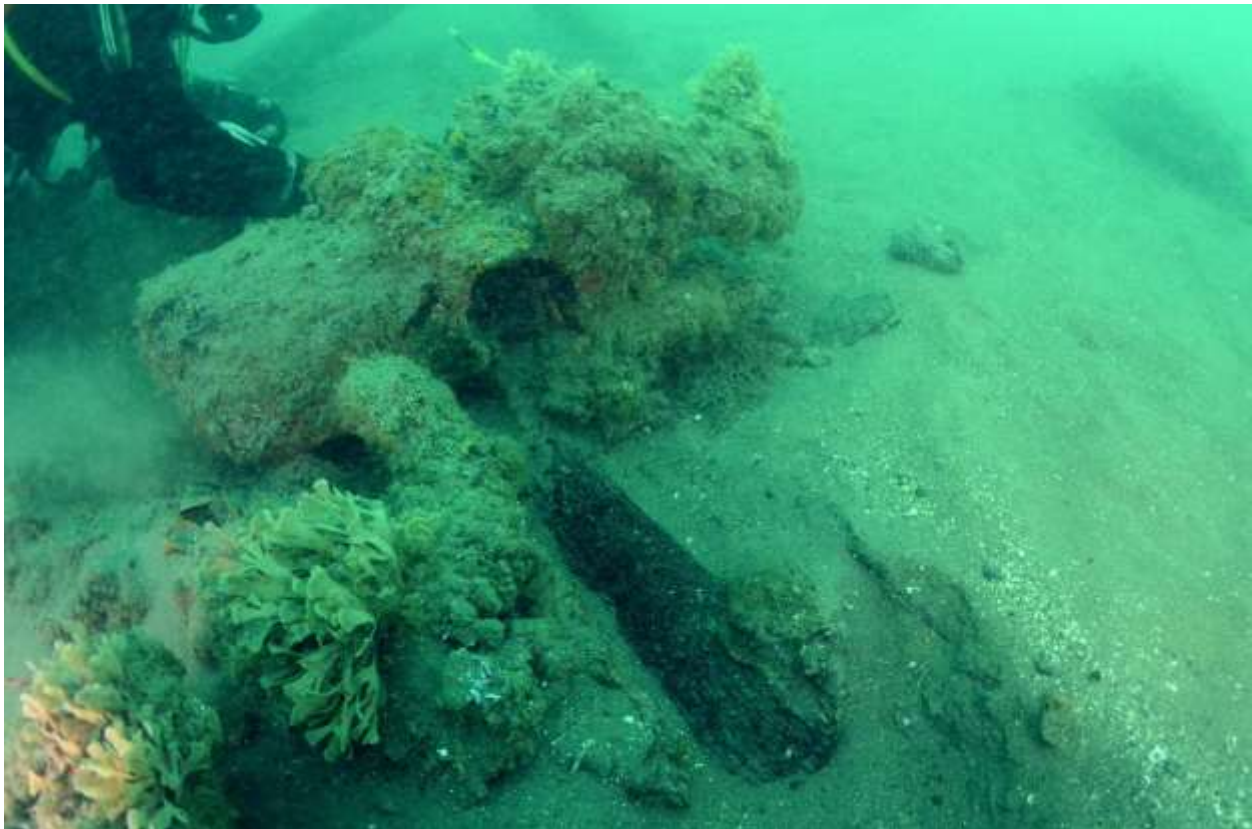
Although a limited amount of timber can be seen near the anchor we have been unable to detect sections of hull without a degree of excavation. There was evidence of treenails but frames were not visible which meant that it was not possible to confirm the construction method of the vessel.

Figure 24 Timber exposed with concreted material (© Martin Davies)

Ideally we would like to take advice on the selection of timbers suitable for samples (as kindly provided by Dr Sara Rich) however to date this has not been possible. Also any excavation would require a MMO

license (and associated fee) though may be considered in the future in order to ascertain the nature of the vessel's construction and obtain timber samples to assist with dating.

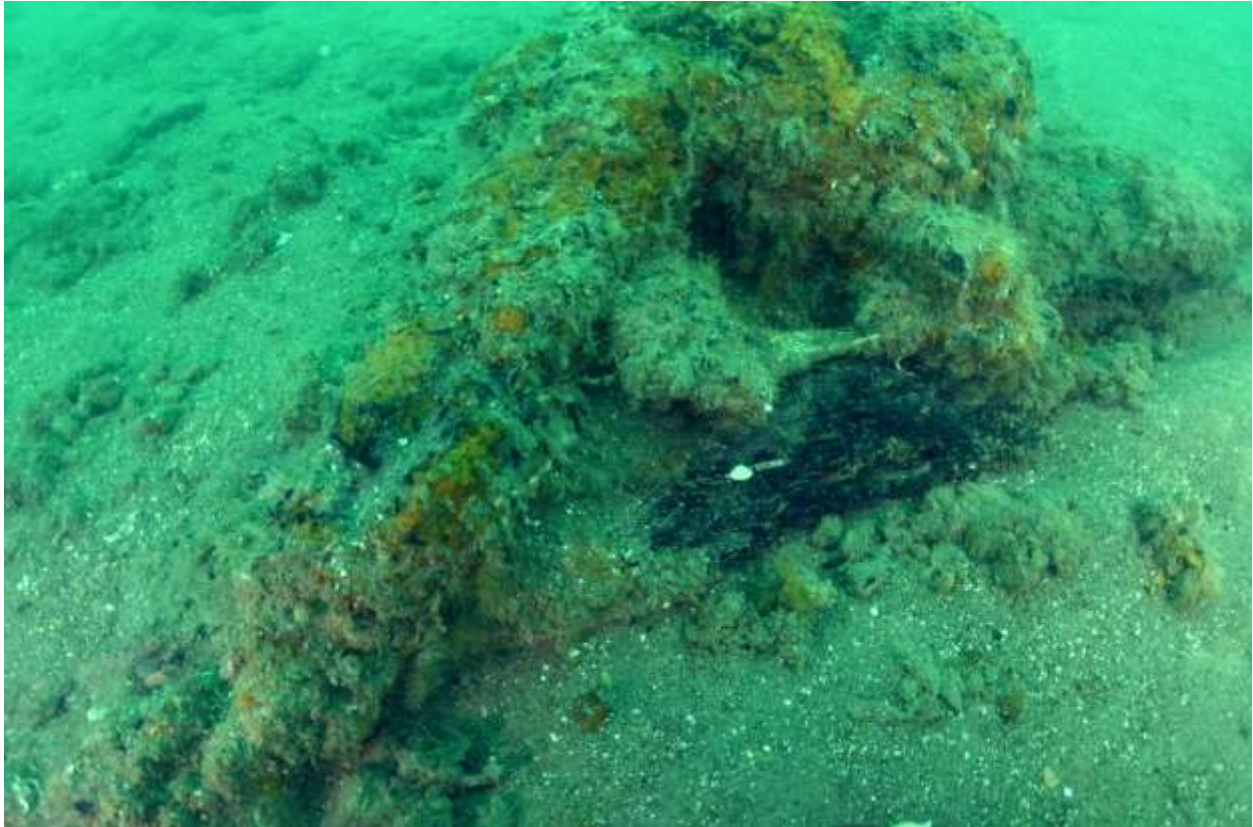
Figure 25 Timber exposed with concreted material. (© Martin Davies)

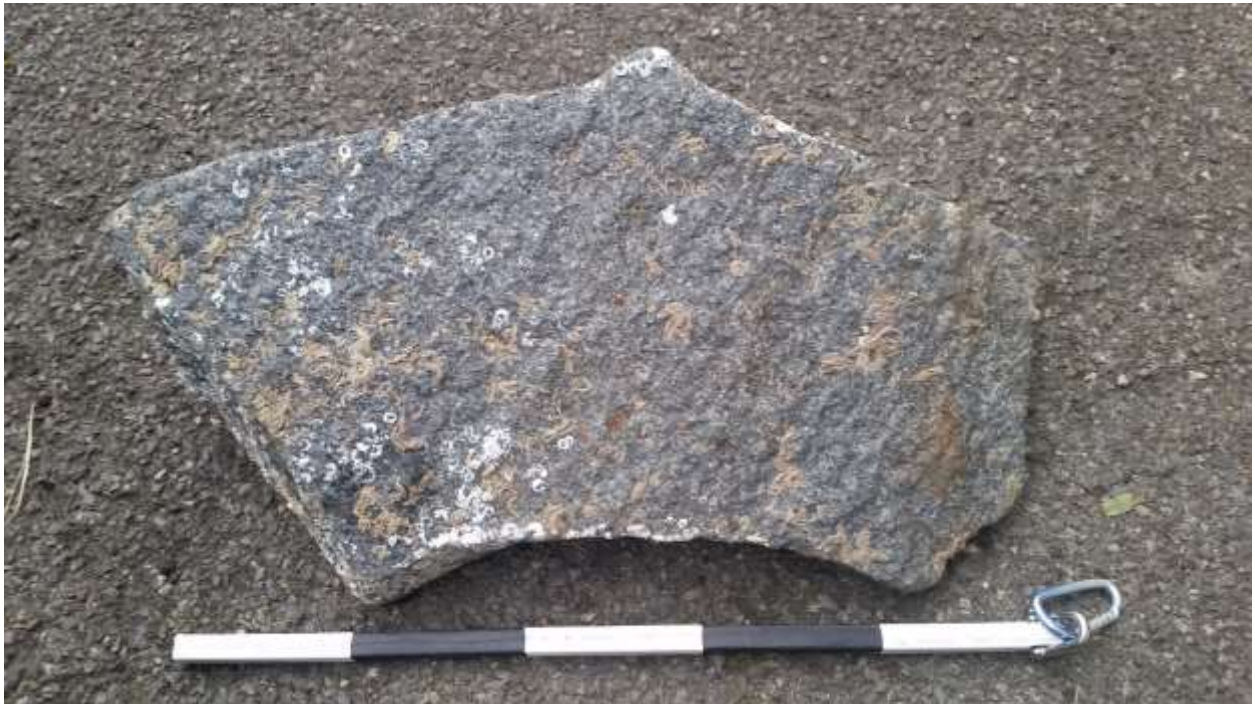
Figure 27 Sample of rock from Site 2. Note rough and straight edges. (© Martin Davies)

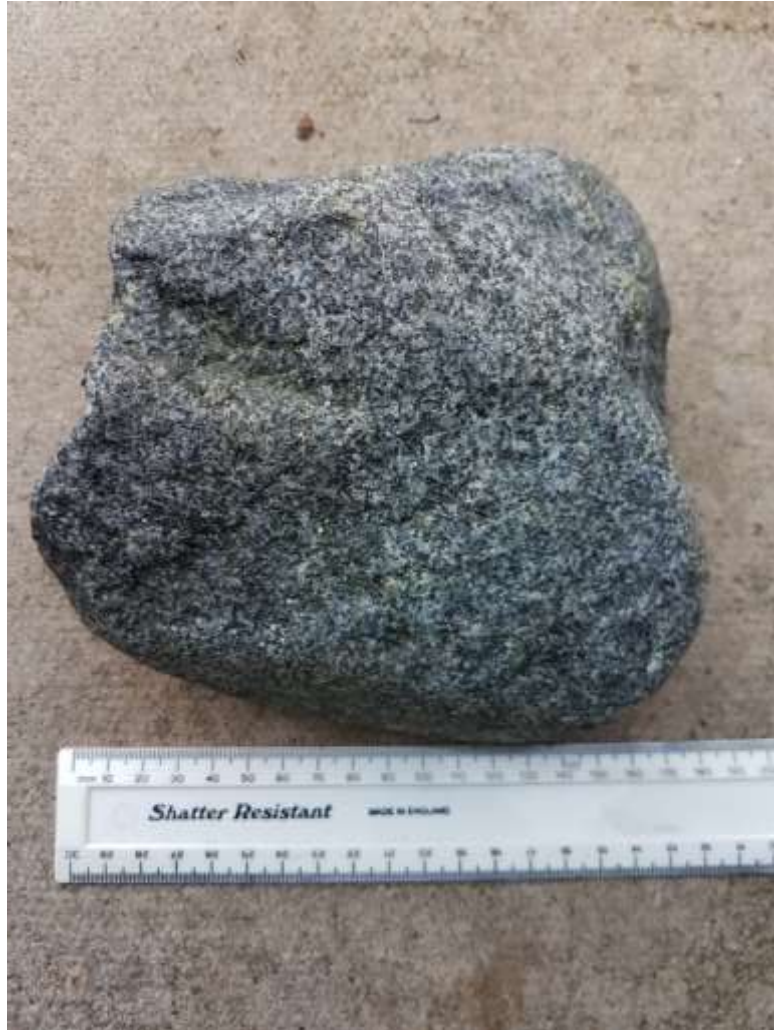
Figure 28 A sample rock from the ballast mound. Note smoothed surfaces. (© Martin Davies)

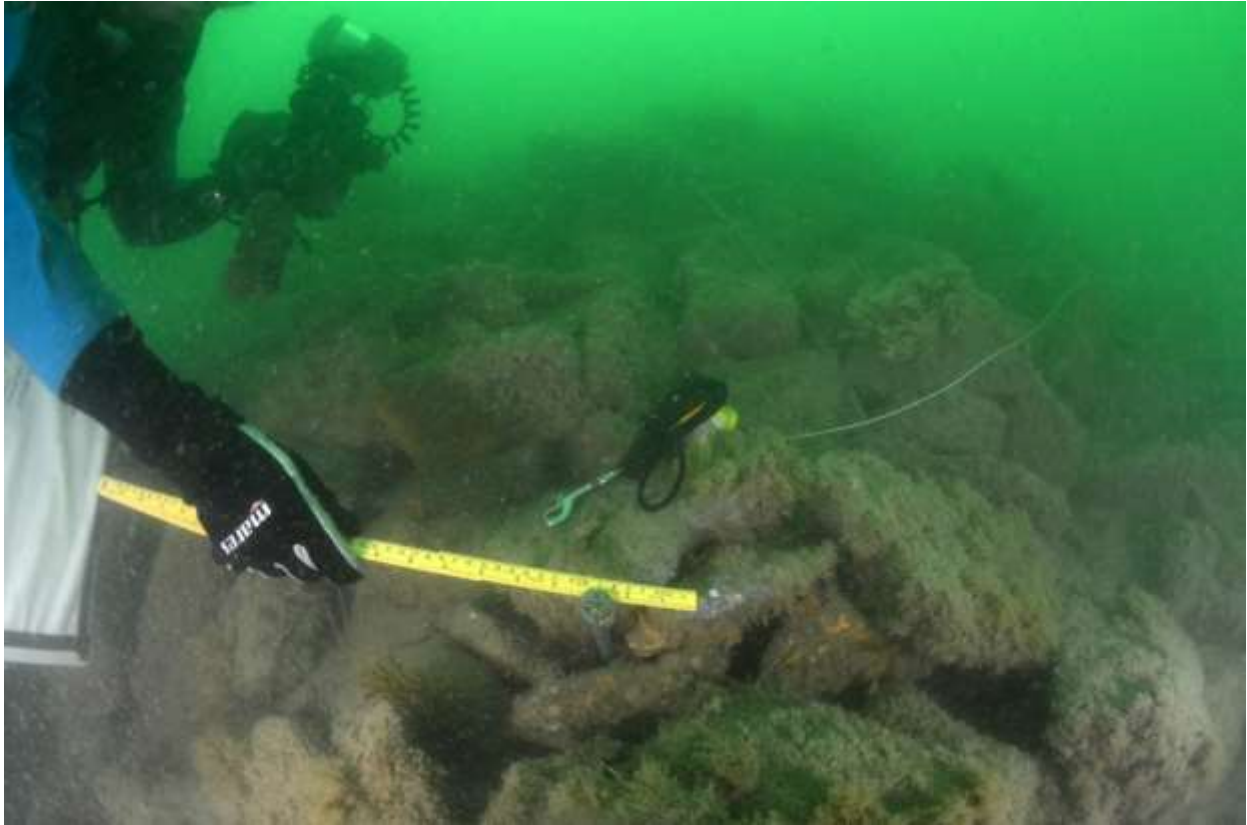
A small copper nail was observed protruding from the ballast mound. A second piece of copper nail (without the head) was also found in the sand in the same area.

Figure 30 the copper nail is embedded in the ballast mound. (© Martin Davies)

The copper nail has a round head and round shaft. Due to it being firmly embedded in-between rocks in the ballast mound it is not possible to determine its length without removing it. However the broken nail, again with a round shaft but without the head was 22cm.

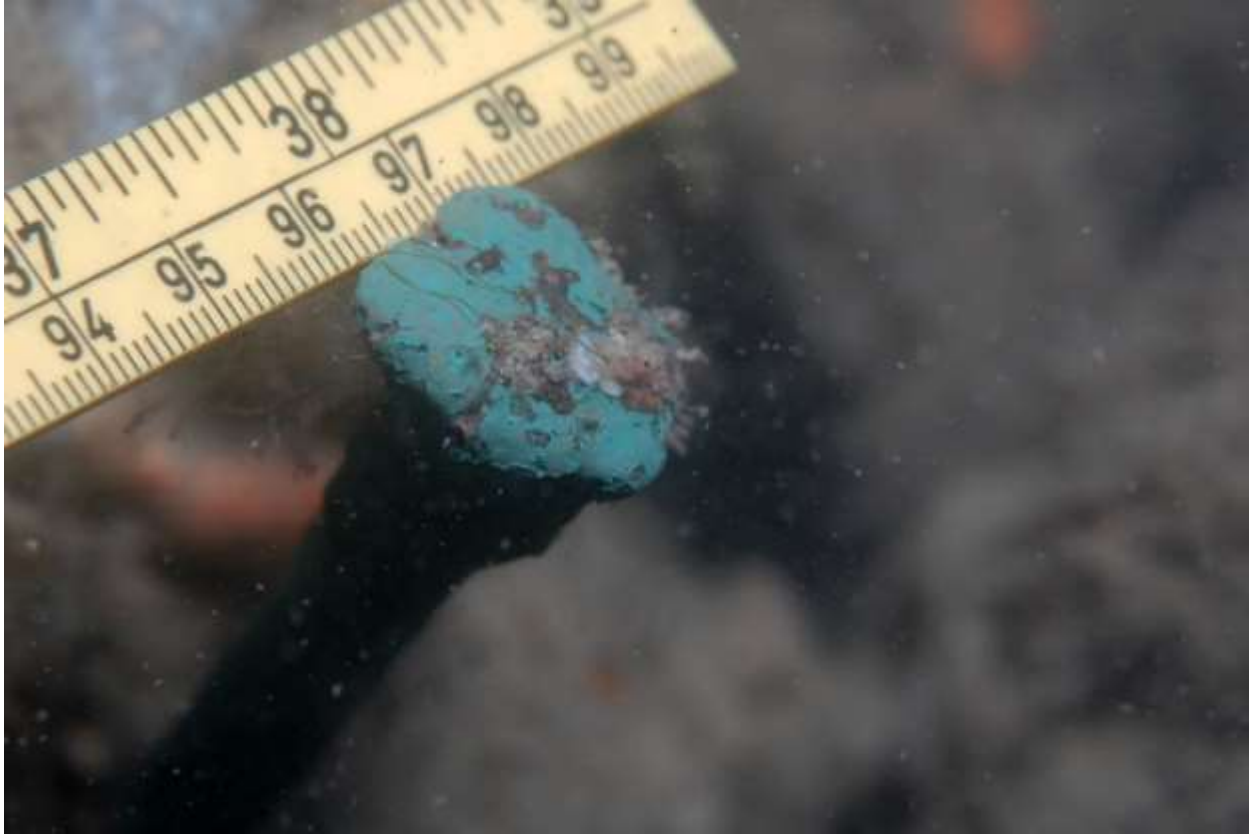
The round head of the nail is approx. 18mm across although it has a slightly irregular shape, indicating that it may have been handmade rather than by machine.

Figure 31 the head of the copper nail (© Martin Davies)

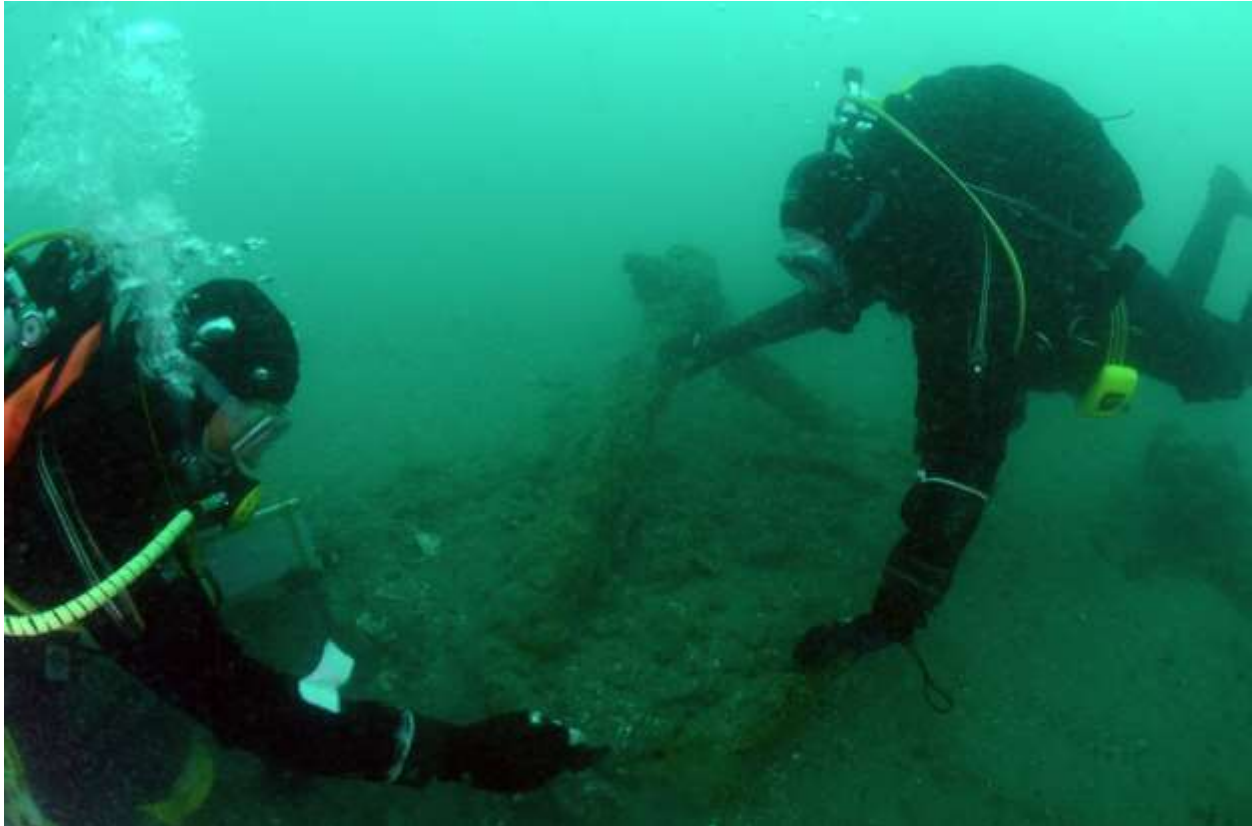
The anchor is an Admiralty style anchor though it is much degraded. It is smaller than the anchor at site 1 and partly buried. Part of the stock is missing and it is difficult to determine whether the anchor has one fluke or two. We assume it has two. Just visible near the fluke are what appear to be a couple of links of chain.

The presence of chain may indicate a more modern vessel as often anchors were secured with rope.

Figure 32 Divers surveying the anchor and fluke (© Martin Davies)

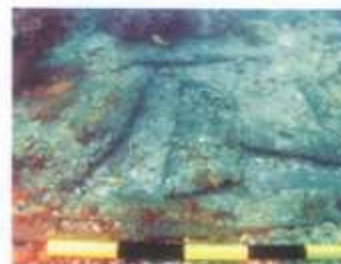
Starboard bow hull timbers

In the bow area the ship's sides are missing, so that floor timbers or first futtocks are visible. They are 15.5 cm wide and 15 cm deep, lying with 10 cm 15 cm spacing.

Their eroded ends are angled upwards, being only 5 cm deep. Outer planks and ceiling planks were observed with a thickness of 5 cm and 3.5 cm respectively and a width of 22 cm. Each frame is fastened to the planks with two 3.5 cm diameter treenails, approximately 7 cm apart. One of the floor timber futtocks observed consisted of two pieces. An unfastened filling piece is inserted between two frame timbers close to that position. The angle of the floor or futtock ends indicates that the chine area of the vessel must have been in or very close to the visible hull structure. The wrecked vessel was thus fairly flat-bottomed.

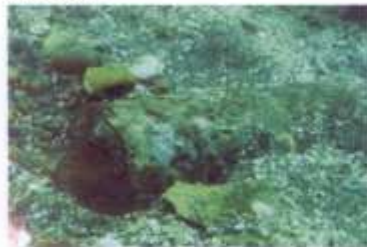
Pump pipe

Aft of the cargo, the end of a hollow pipe was observed, sticking out of the seabed sediment. The visible length is 1.65 m. The pipe has a diameter of 25 cm, widening to 35 cm towards the end. The inner diameter is 9.5 cm.

This could be a pump pipe, although the pipe wall seems to be very thick. In the far stern of the vessel, approx. 3 m from the stone cargo, a small cast iron stove was found and recorded. The 0.5 m high, 29 cm wide and 25 cm deep cast iron stove is lying on the side, attached to a broken iron baseplate. The main opening in the top has a diameter of 14.5 cm. The flue hole in a base at the back of the stove is 10 cm in diameter. The stove has an 11 cm base at the bottom, to which 5cm feet are attached. At the top, a 6 cm rim runs around the stove.

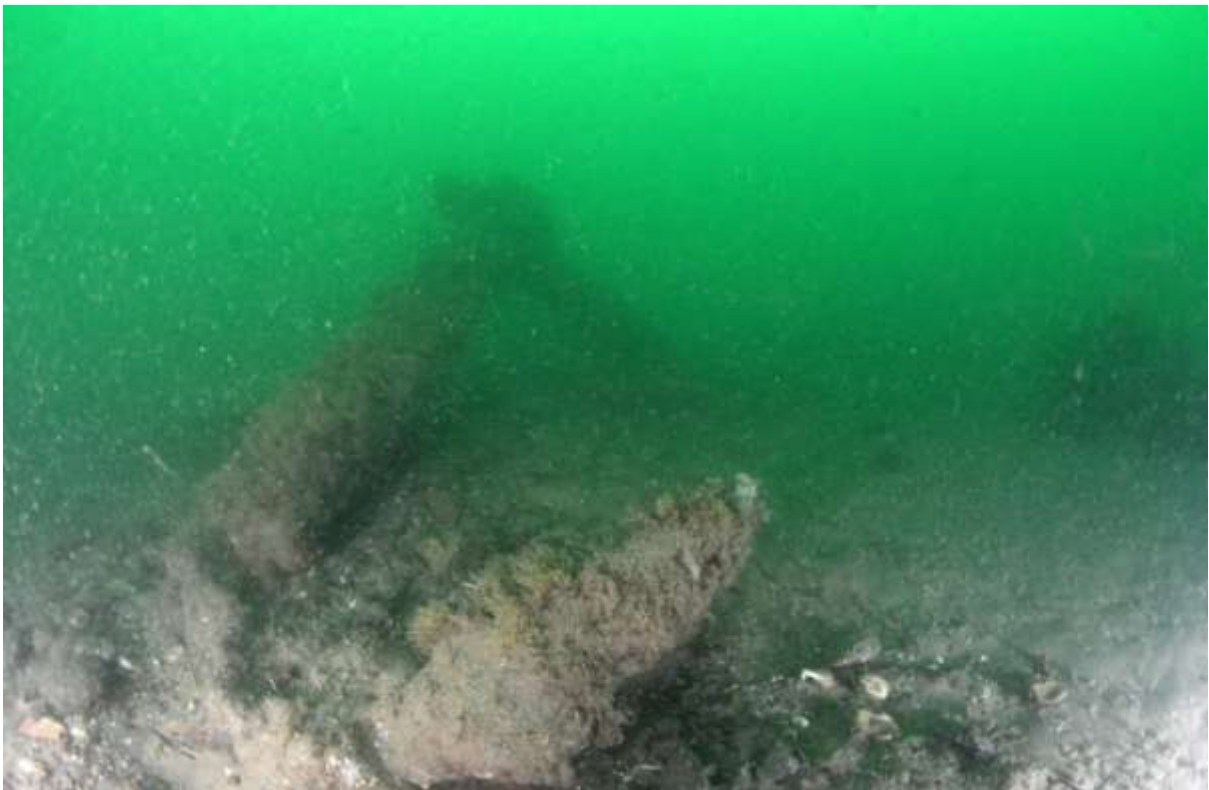
Figure 4. The anchor rests on the sandy sea bed. (© Martin Davies)

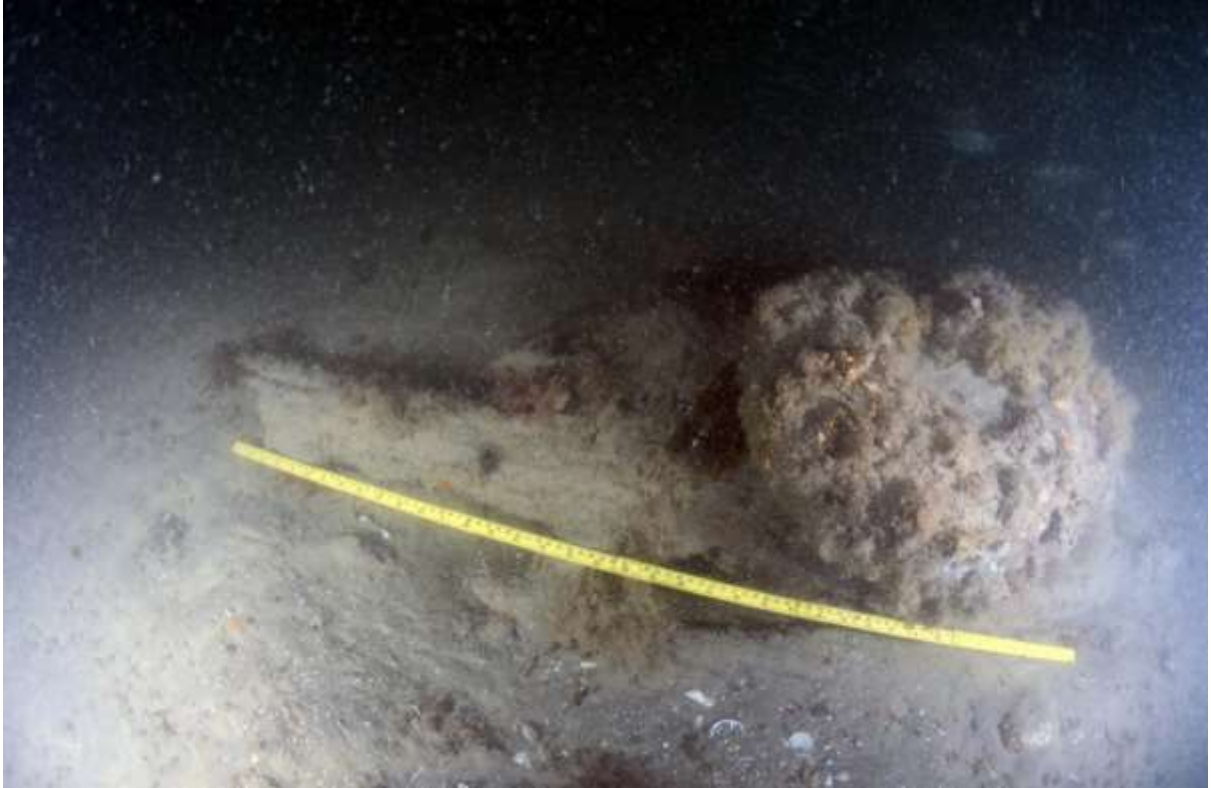
Figure 7 Exposed timbers and concreted objects. (© Martin Davies)

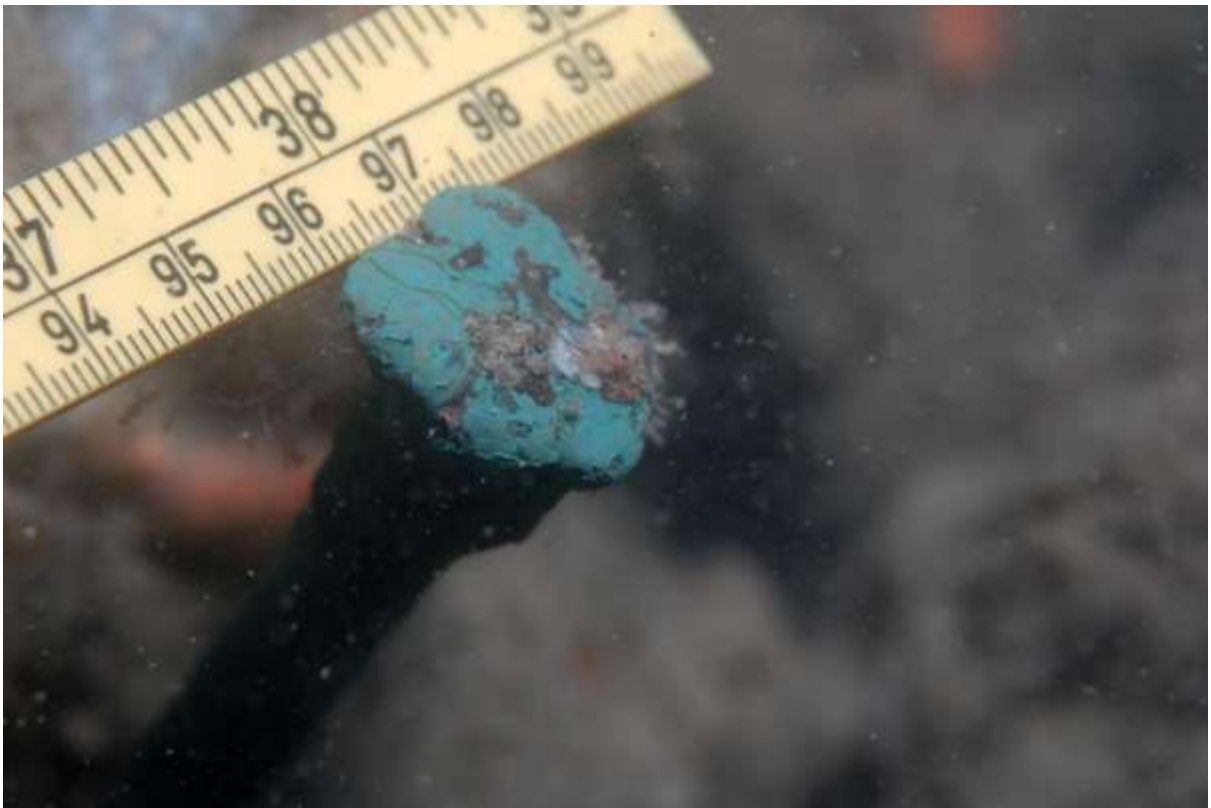
Figure 8 the copper nail protrudes from the rocks. (© Martin Davies)
