Expedition Report West Wales Wreck Exploration

Cardiff BSAC Branch 590
BEGS Grant Scheme

17 December 2010

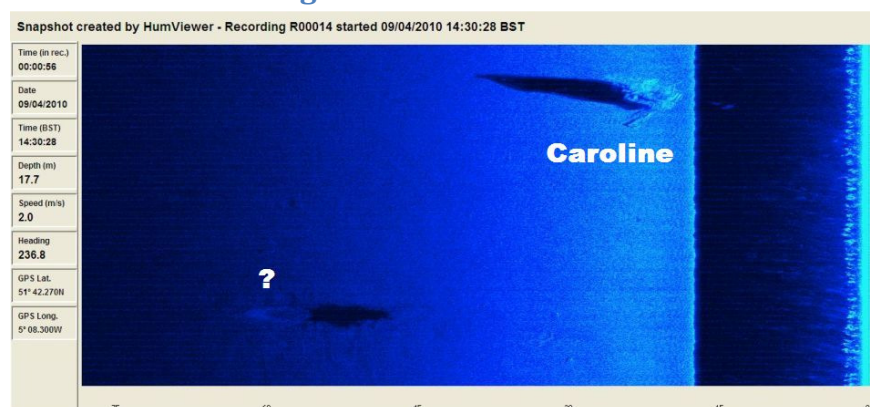
Side Scan Sonar Image

The *Caroline* is the bow of a converted fishing trawler. It has been severed in two amidships. The bow structure is completely intact, despite its missing stern, and you can swim directly into the holds and much of the internal ship from the broken section. It is a very small site, good for a maximum of 4-6 divers at any one time only.

Around 50 metres from the wreckage of the *Caroline* was a shadow marked with ? on the side scan image. It turned out to be a hole in the flat seabed around 3 metres in diameter and 2 metres deep. There were pieces of aluminium protruding from the sand in the bottom of the hole. Interesting to dive to see what it was but it probably won't become a popular dive site!

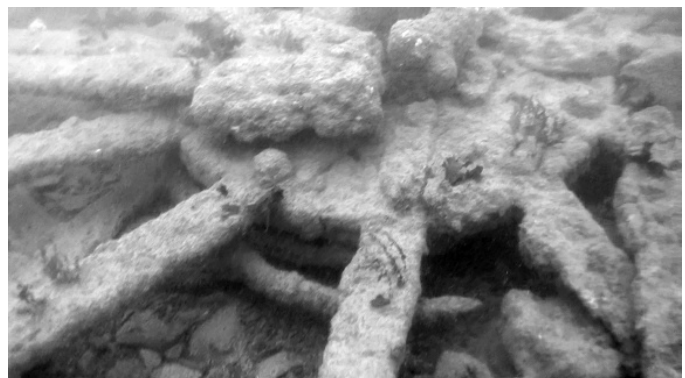
When you land on the wreck there is a large 'paddle wheel' which is perfectly flattened against the bottom, hence the name given to the site. However, there are none of the associated boilers and drive shafts expected so we queried as to whether it really was a paddle steamer. Mark posted some video of the wreck site on YouTube and asked a forum of paddle steamer experts to comment resulting in a lot of great feedback. This lead us to conclude that it is probably not a paddle steamer. The 'paddle wheel' may possibly be a cable reel but there is nothing conclusive yet. We need to go back and dive it again.

The wreck sits in a large 'bowl' of rock and is very broken up and concreted. There are still some small sections of the hull intact. The most striking part of the dive is the large flattened wheel which almost looks like a dart board.

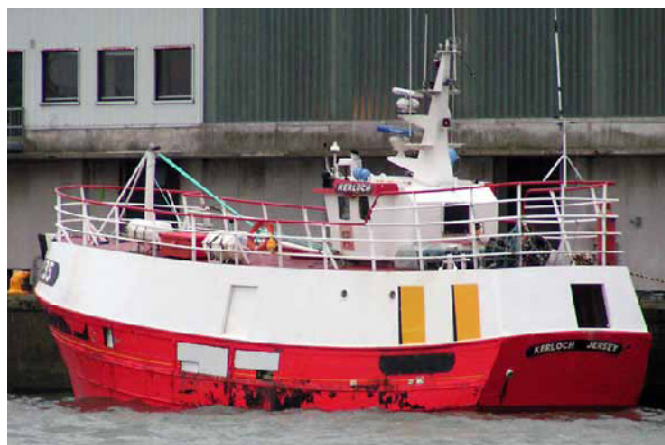
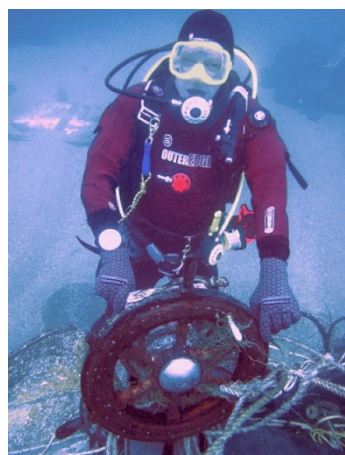
We had been looking for the *Balholm* and, not finding it, decided not to miss the slack and instead dive Crow Rock. We were surveying with the side scan sonar while our first pairs of divers kitted up when we discovered some anomalies. The seabed is very rocky with sand holes and gullies and we were not sure what we had found so the second pair of divers went in to investigate. We found a brand new wreck of a small fishing boat, badly broken up, but obviously new with boots and jumpers scattered in the sand.

We reported the find to the coastguard who told us that the wreck was that of the *Kerloch* which had sunk two months earlier on 20 January 2010 after hitting Crow Rock in the dark. We completed a Receiver of Wreck report on the new find at the request of the coastguard.
