## **Survey report of the Air Search Rescues craft known as the Cuckoo, lying off Selsey**

Submitted as part of the NAS Part II Underwater Archaeology

Jennifer Perrie  
January 2014

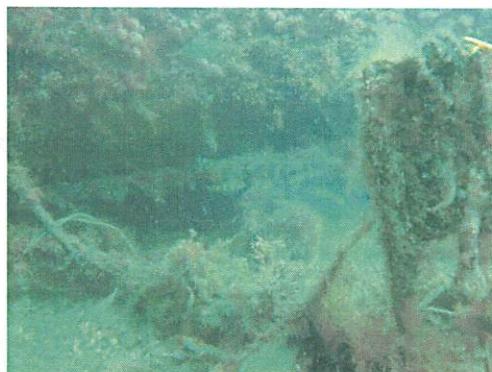
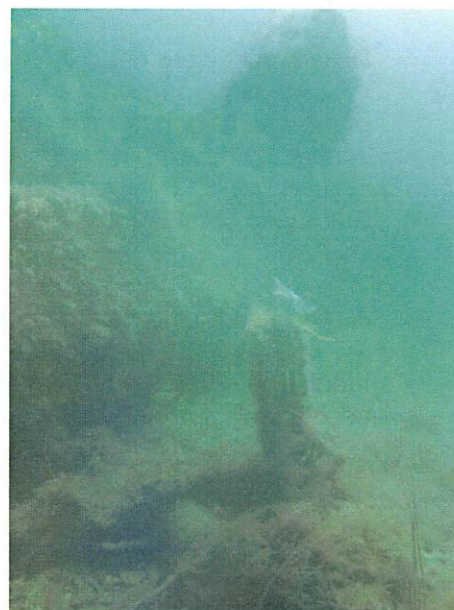
It was evident that the site had been prepared for surveying before. There were 6 control points located, 3 on the port and starboard sides of the wreck. They consisted of iron bars imbedded in the sandy seabed and cement filled tyres. I was unable to find any report or previous research relating to this wreck.

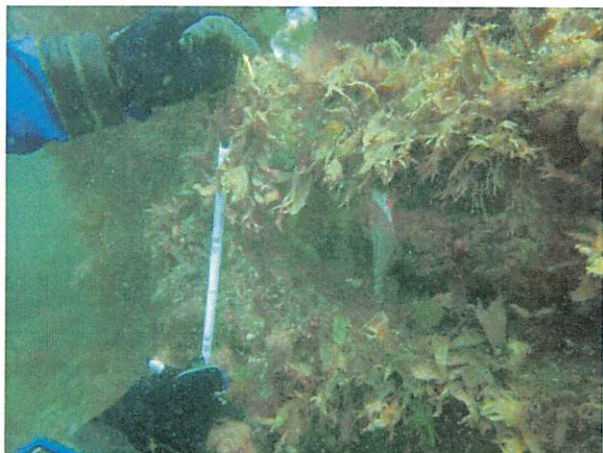
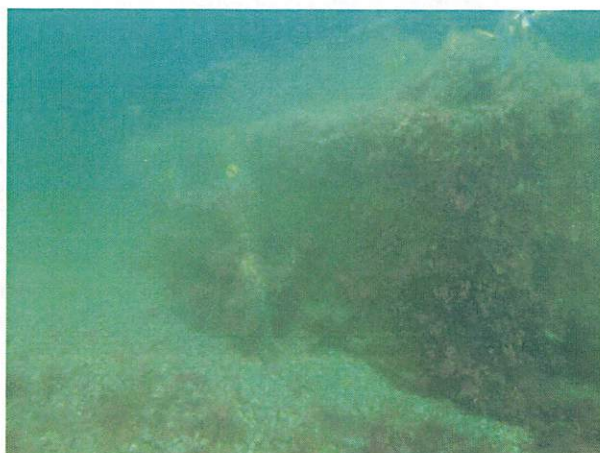
- Starboard ladder

The starboard ladder is slightly damaged and as a result is closer to the hull (in parts) of the boat. The handrails leading onto the deck of the boat have been corroded away and there are only 4 remaining rails of the ladder visible.  
See Annexure B

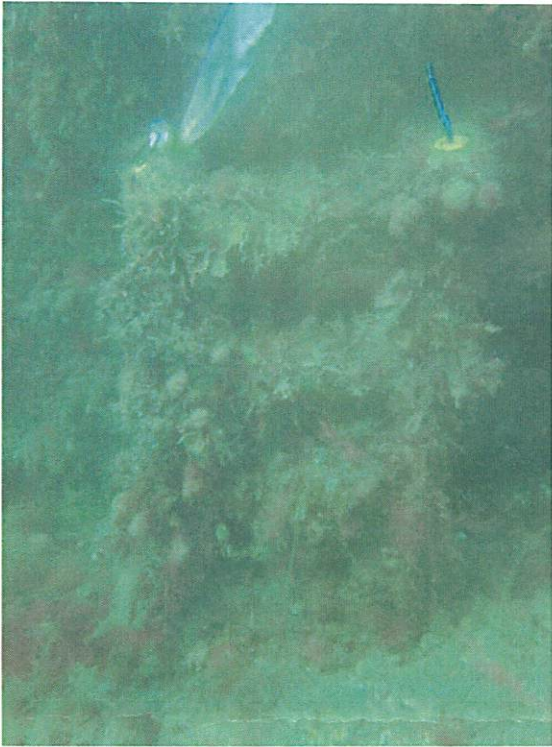
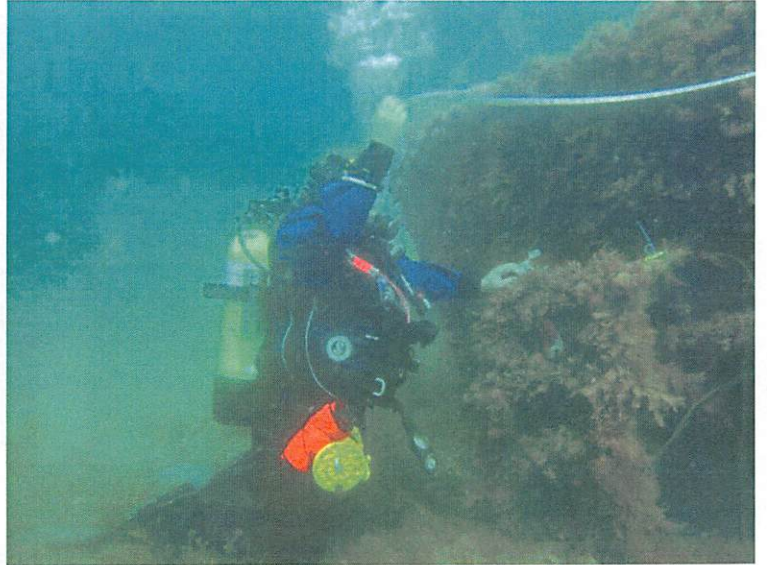
- Port Ladder

This is less damaged and sits 0.32m away from the hull. There are only 3 rungs visible. See Annexure C

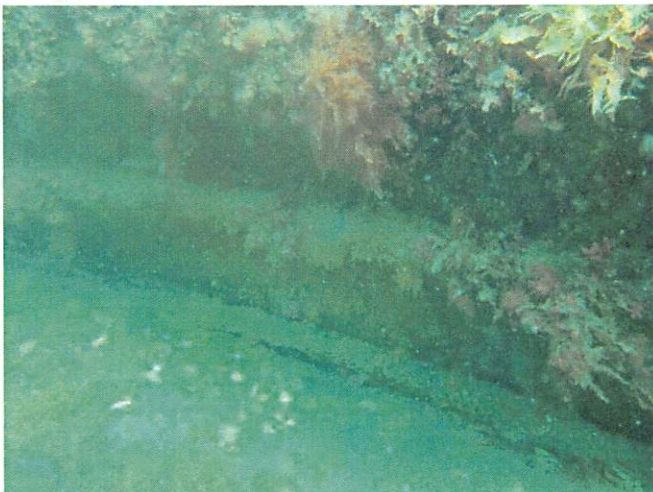
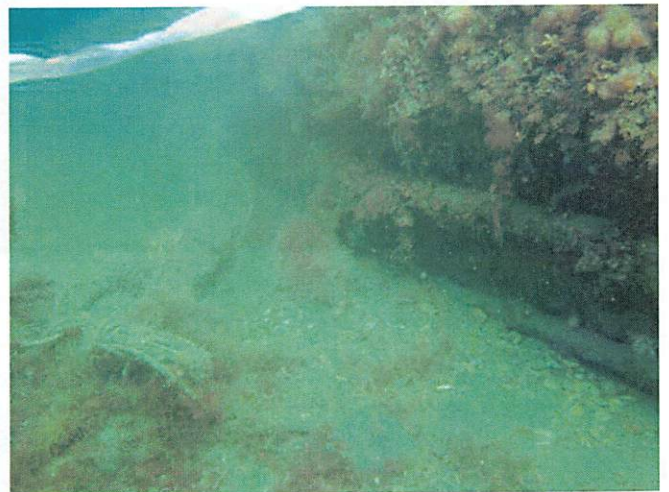
- Grab rails

No measurements were made of this feature of the wreck. These images do show that the hull is buried to this depth in the sandy bottom. See Annexure D

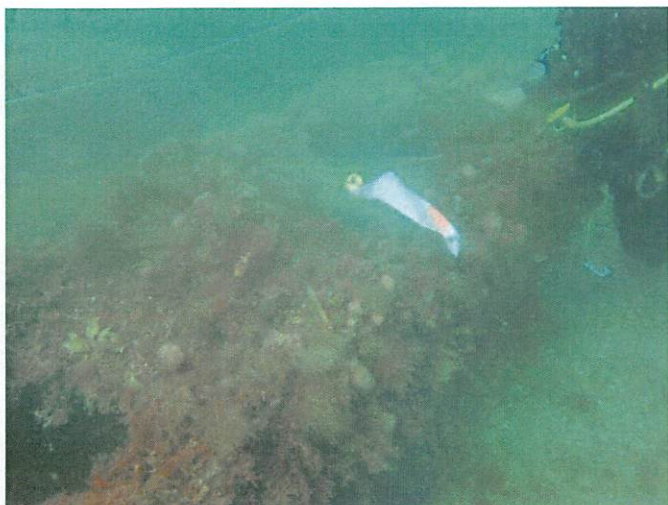
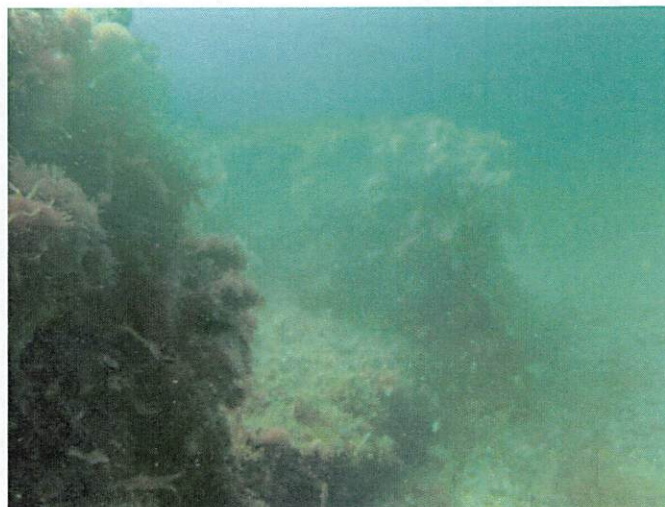
- Cut away stern section

There is only photographic evidence of this unique section of the wreck. There are no remains of the ladder that hung off the ramp section into the water and there is a lot of debris on this ramp leading to what remains of the entrance turret. It is evident from these photographs that the stern of the boat is sitting flat on the sandy bottom.

The plans are to revisit the site and confirm all the questionable 3D survey measurements. Verified dimensions will help me complete accurate drawings of the ladders, which will enable me to create an accurate drawing of the bow of the wreck. In addition a full survey of the cut-away stern section will be undertaken.

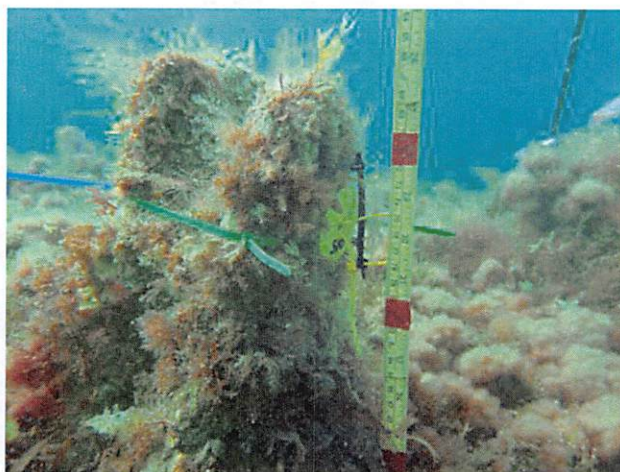
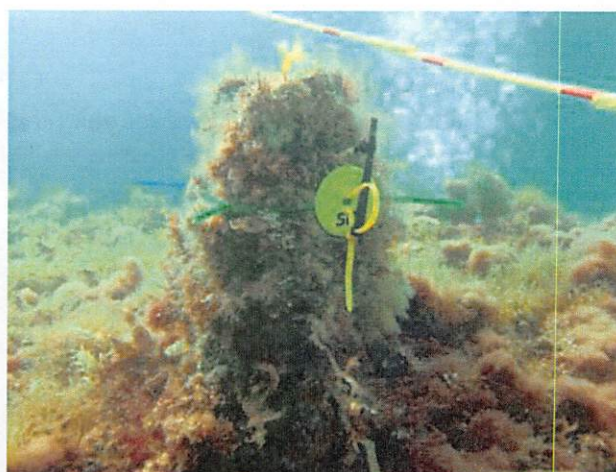
- Mast Remains

A prime feature of this craft was the mast had to be seen by downed airmen whilst in the water. A report produced on February 1942 suggested the boats were difficult to see so a circular top mark was erected as high as was practicably possible. Photographic evidence of the fittings for the mast are shown below

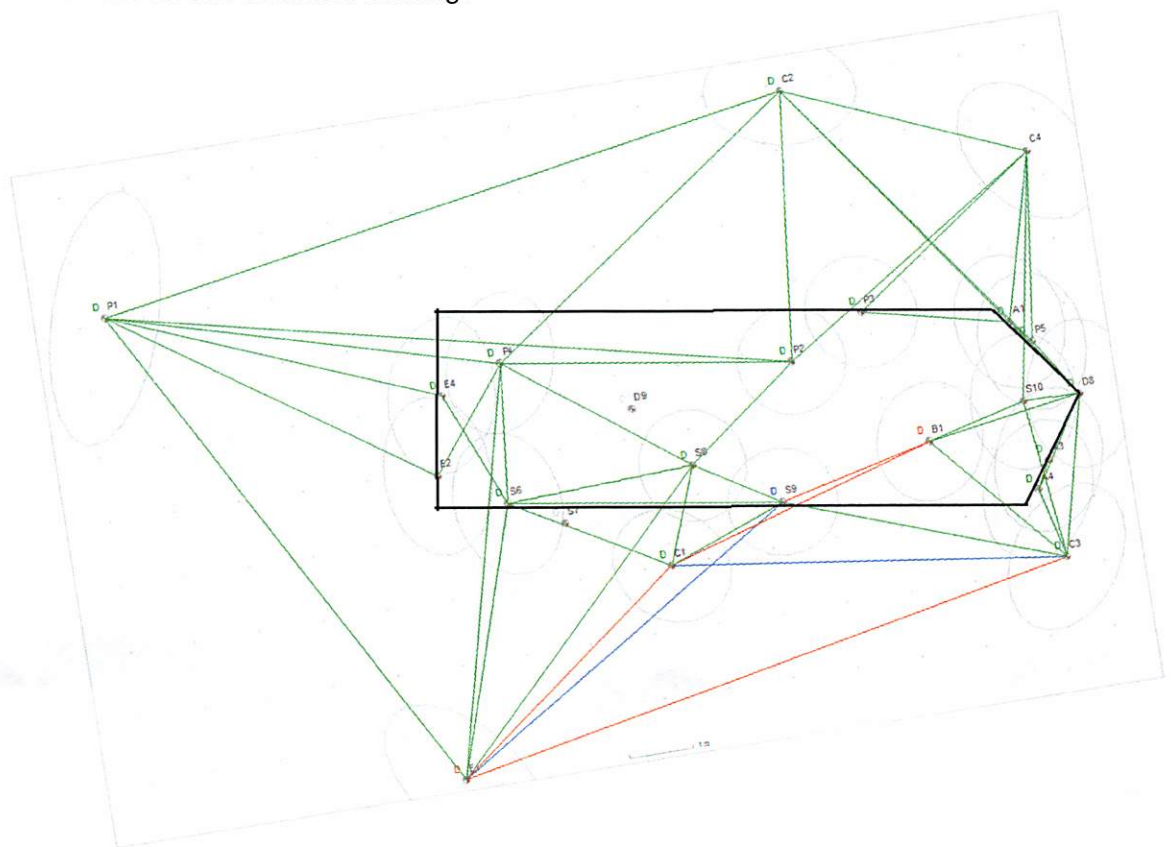
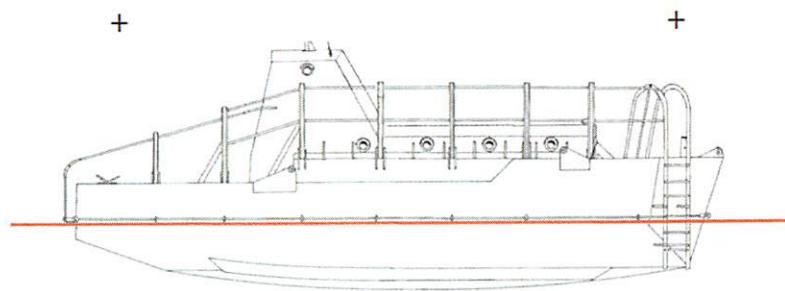
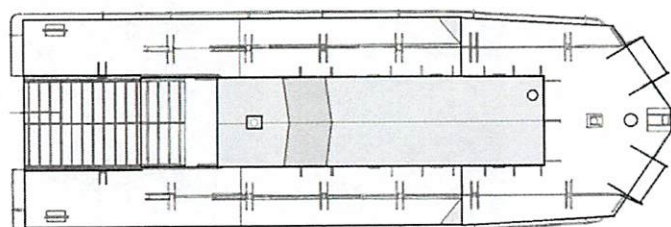
A = 3D model and technical drawings

Using the survey measurements recorded by the divers and 3H Consulting's Site Recorder 4 a 3D model of the wreck was created. Using a modified original technical drawing as an overlay it was easy to see the wreck was one of the ASR craft as the overall shape of the wreck matched. There was a slight distortion because the bow of wreck is not lying totally flat on the seabed whilst the stern is sitting flush on the sandy bottom. It is therefore assumed that the craft must have twisted whilst sinking.

- Hull dimensions: Length 32' 02". The wreck measured as being 9.7m in length
- Beam 10' 0". With the aid of the 3D model and overlay I am able to confirm the width as 3m
- Moulded Depth 6' 0". As the boat was buried in the sandy bottom no measurements of the depth or draft of the wreck were recorded

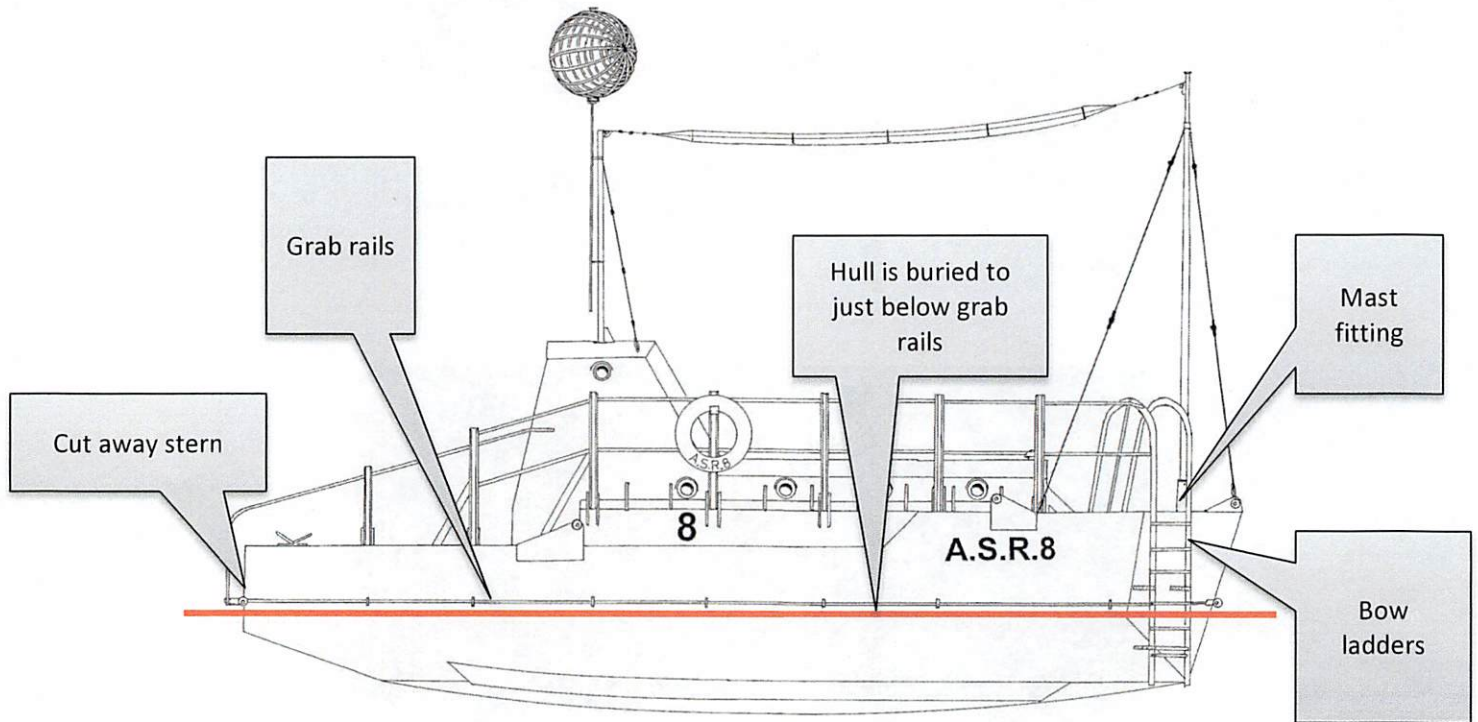
D = 32ft Rescue Float drawing

Built by Carrier Engineering in Wembley they were made of welded mild steel plates (1/4"), using only flat stock plates. They had a steel superstructure and mast. Dimensions: Length 32' 02", Beam 10' 0" with a 3'3" draft. They were fitted with bars extending below the surface to give foot and hand holds, with the stern of the float cut away. On the bow were 2 ladders and a stern ladder hanging straight down, all of which could be easily climbed whilst in the water.

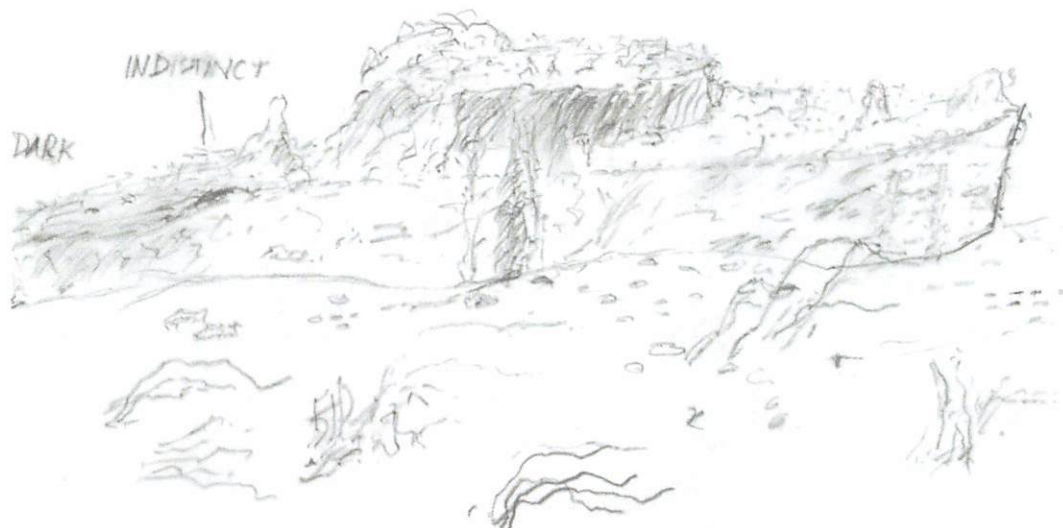
E = sketch of wreck from the starboard side by Martin Steggall

A sketch of the starboard side of the wreck as she lies on the sandy bottom was made.
