# PROJECT SEAHUND

The Search and Survey of U5377

Report written for British Sub-Aqua Jubilee Trust award 2012

OPERATION SEAHUNDE  
THE SEARCH AND SURVEY FOR *U5377*  
Project Report

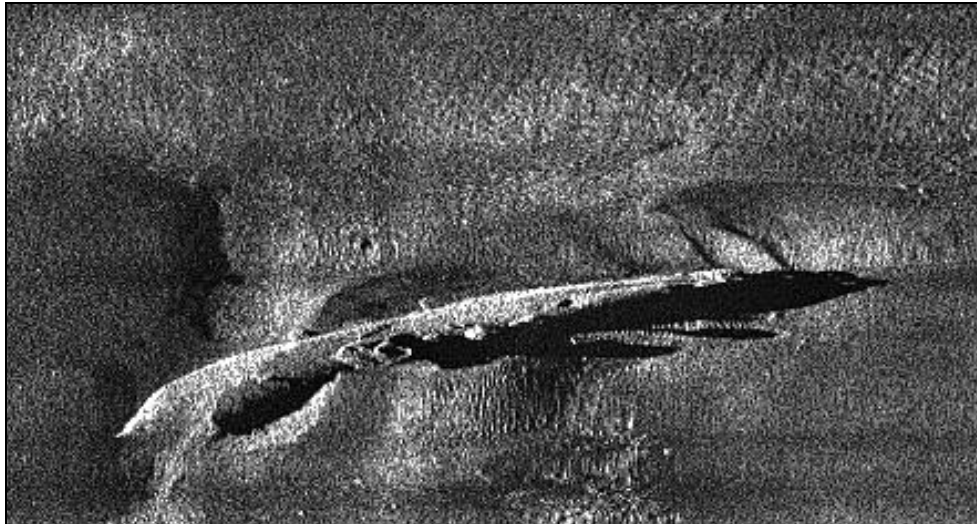
A hull mounted side scan sonar was used to carry out a box search of the prime target area. From the read out of this side scan sonar a number of anomalies fitting the known size of a Seahunde would then be selected for diving to see if they were *U5377*. A single anomaly which was the correct length and looked like a submarine and was surveyed within the prime location of *U5377* sinking was considered to be *U5377* (Fig. 13).

Fig 13 Sidescan sonar image of U5377. (Peacock)

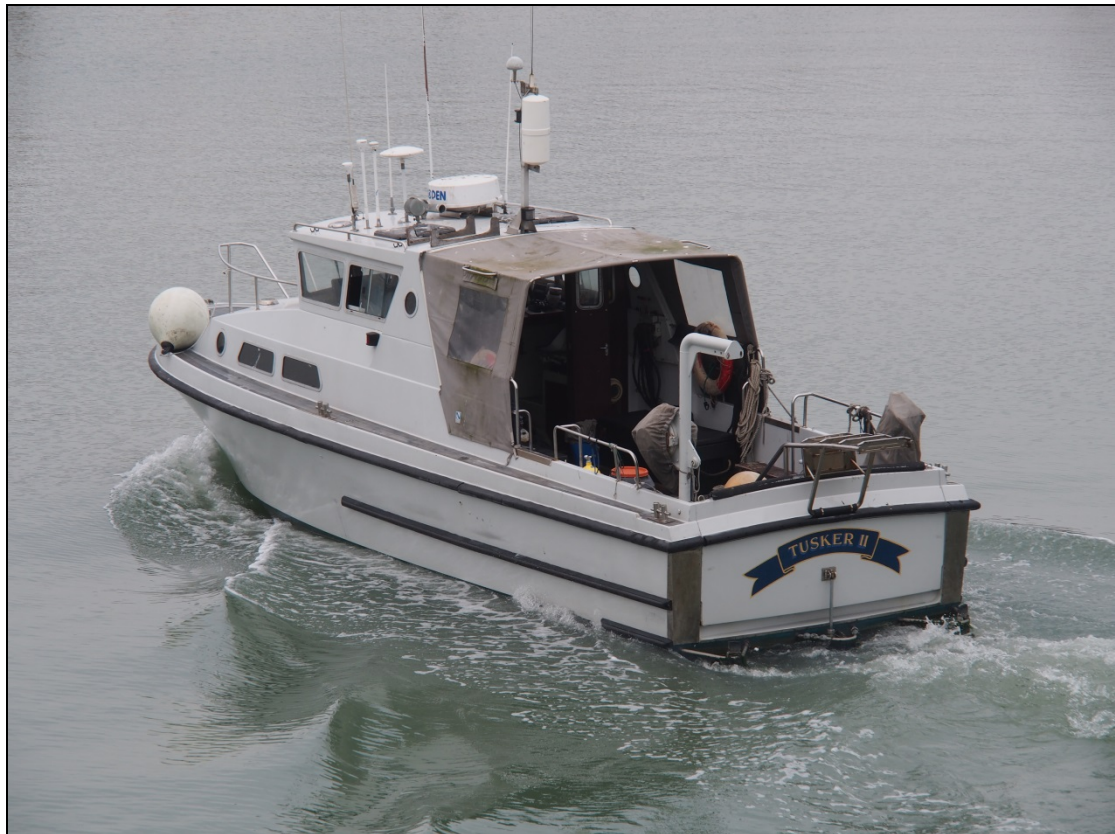
All diving operations were carried out from the privately owned and previously MCA coded diving support vessel *Tusker II* (Fig. 15). The capacity of the boat is 12 divers and it proved to have excellent facilities for undertaking archaeological and biological projects including;

- Open rear deck,
- Dive ladder
- 1 ton winch
- 1 ton crane for diver recovery if required
- Toilet
- Galley for cooking and hot drinks provision
- O<sub>2</sub> if required.

Fig. 15 Tusker II used for all diving and surveying. (Peacock).
