# Understanding the Klein Hollandia Shipwreck

## 2023 Investigation Report

Prepared for the  
**The British Sub-Aqua Jubilee Trust**

April 2024

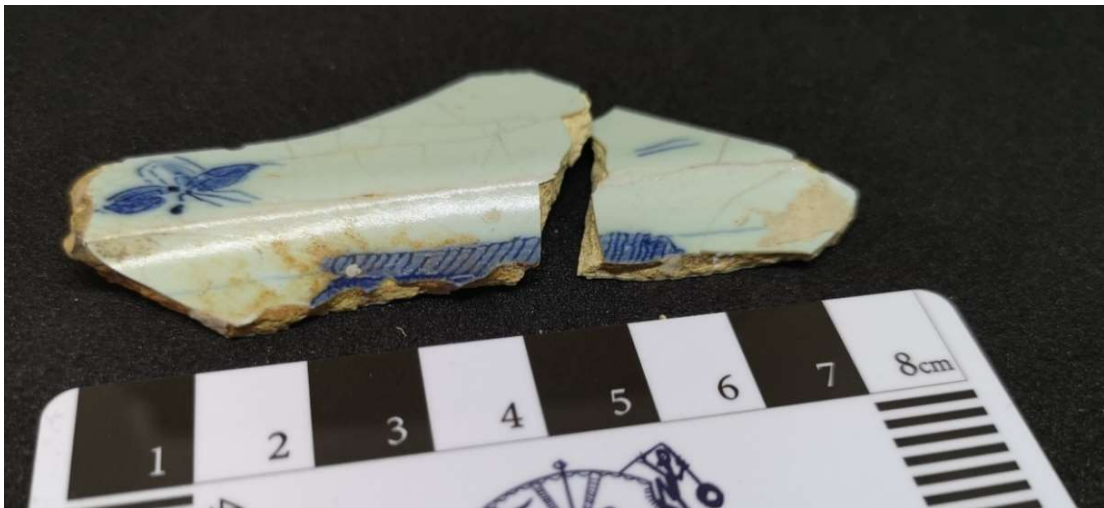
- 5.1.4 On the first dive Tom recovered two small pieces of white ceramics. One of these pieces was stamped *Limoge FRANCE* and was considered to be modern intrusion. The other piece (UID 001) was identified by a specialist as most likely being of Italian origin and dating to the 17<sup>th</sup> century (Fig.4). These recoveries were reported to the UK Receiver of Wreck.

**Figure 4: UID 001 recovered on the first dive in April 2019 (Scale 8cm) © NAS.**

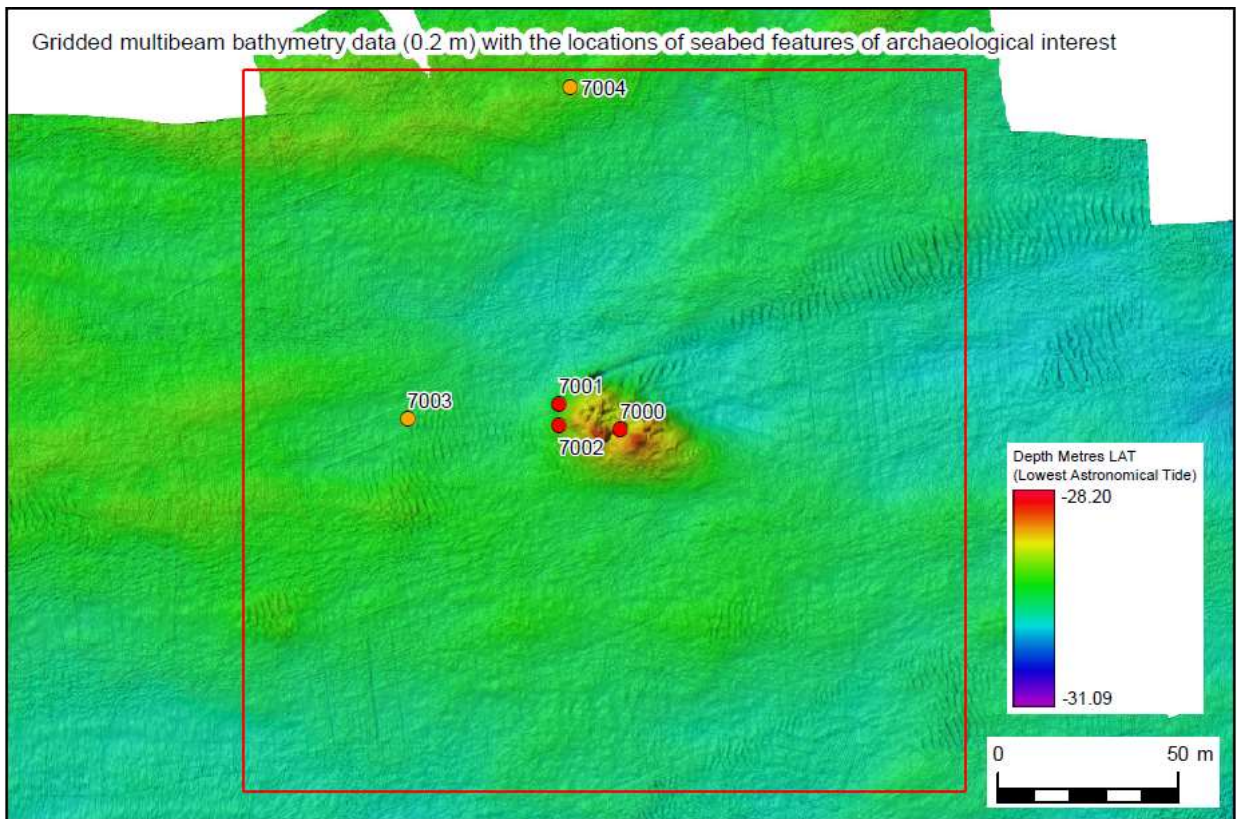
- 5.2.5 In the 2019 multibeam survey a total of five features of interest were identified (Fig.5). One feature (7000) was characterised as a large mound with a corresponding magnetic anomaly, thought to represent the main wreck site. This was assigned an A1 archaeological discrimination, which is anthropogenic origin of archaeological interest. The remaining four features (7001 – 4) were mounds which are thought to possibly represent associated items of debris. Two of these (7001 and 7002) were located close to the wreck and, as such, were classified as items of debris and assigned an A1 discrimination. The remaining two features (7003 and 7004) were located further away from the main wreckage and therefore, as their origin was less certain, they were assigned an A2 rating, which is a feature of uncertain origin of possible archaeological interest (Wessex Archaeology 2019).

**Figure 5: Multibeam bathymetry with the five main seabed features of archaeological interest (7000 – 7004). Wessex Archaeology for Historic England © Wessex Archaeology.**

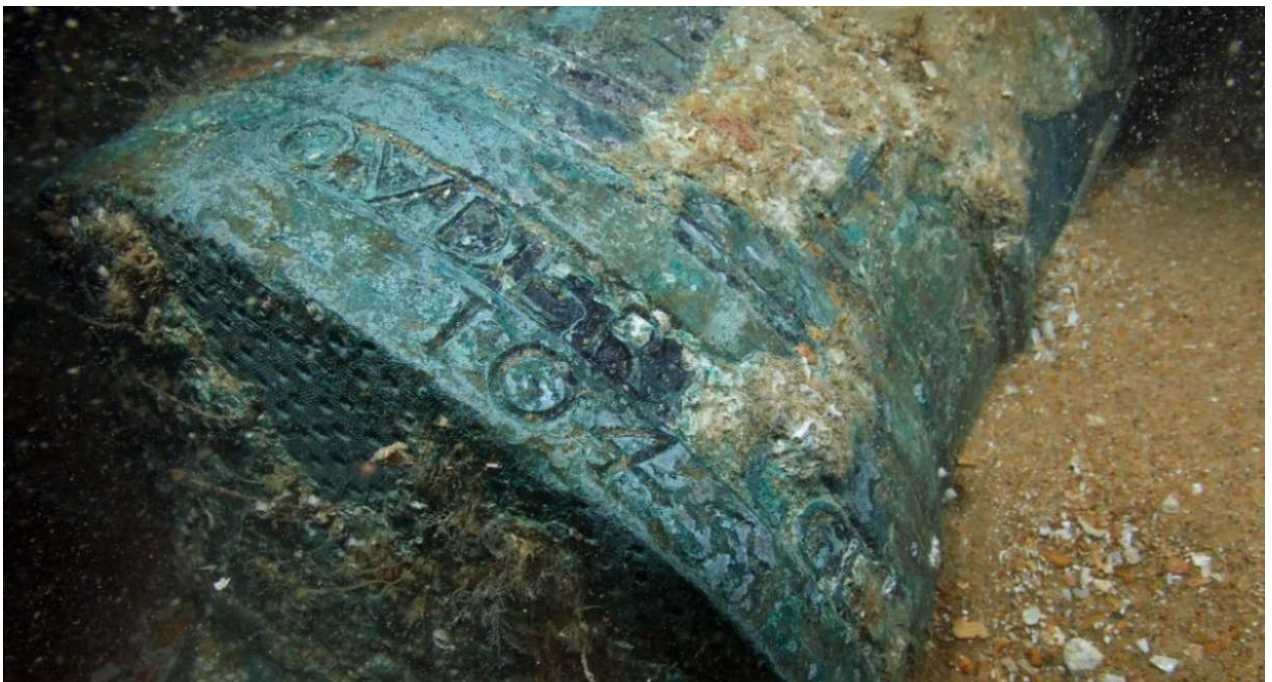
- 5.3.5 Markings have been recorded on three of the bronze cannons. Makers names on cannon No.1 and No.8 show that they were both made by Cornelis Ouderogge (1599-1672) (Fig.7). The Ouderogge's were a family of bronze founders that cast cannons, clock, bells and sculptures in Amsterdam and Rotterdam. Cornellis made cannons for the Rotterdam Council as well as the Admiralty of Rotterdam (also known as the Admiralty of the Maze) based in Rotterdam.

*Figure 7: Cannon No.1 made by Cornelis Ouderogge © James Clarke.*

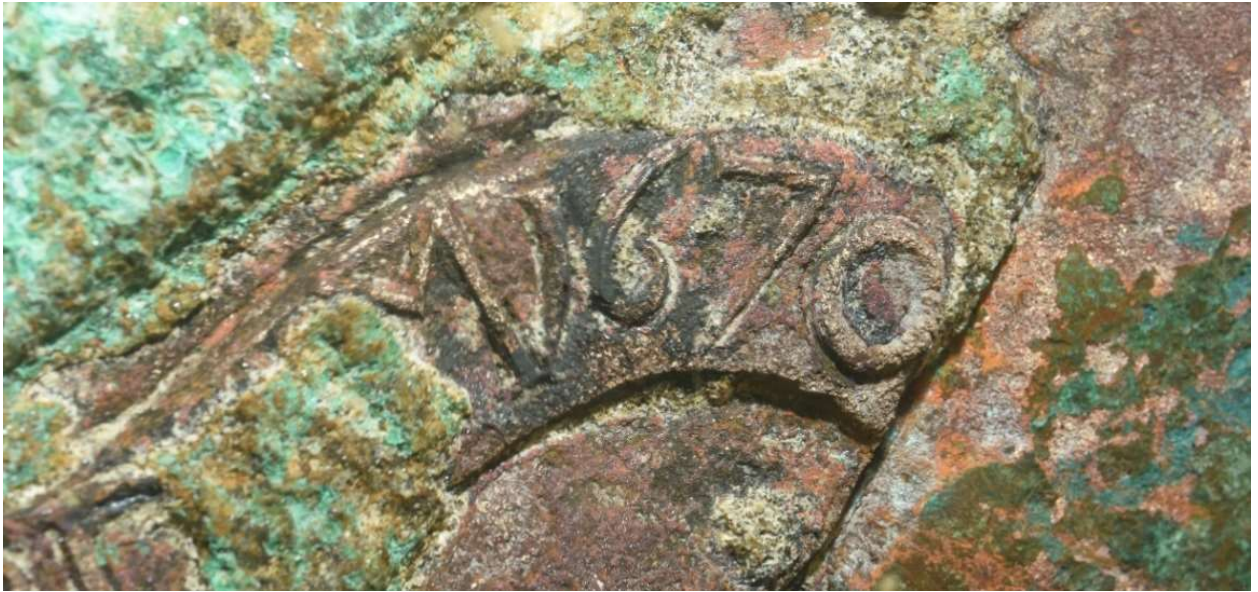
5.3.6 Cannon No.1 has a date stamp of 1670 (Fig.8).

*Figure 8: The 1670 date visible on cannon No.1 © Martin Davies.*

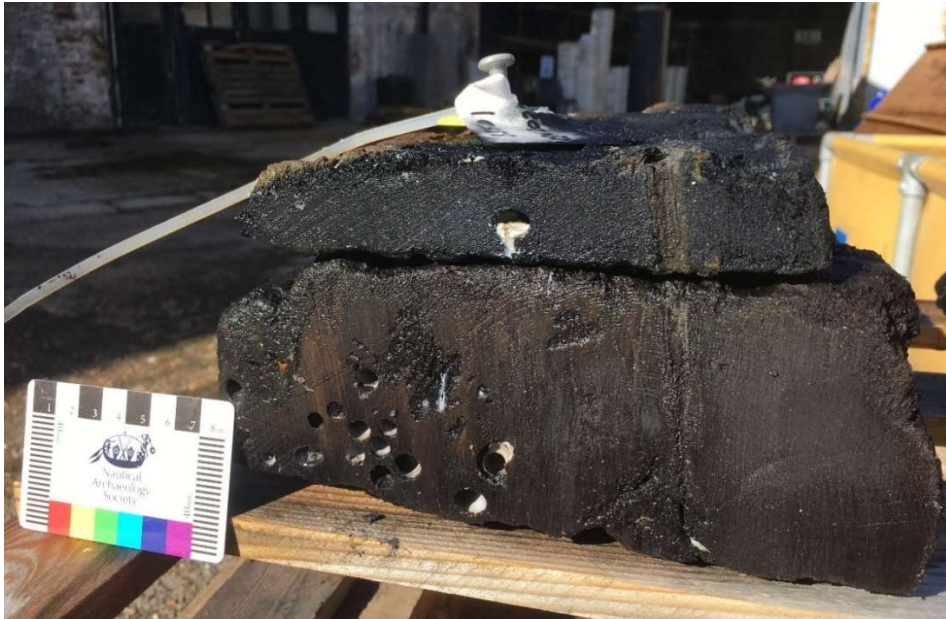
- 5.3.14 In 2022 a small number of wood samples were recovered from the site for dendrochronological analysis. To date only two conifer hull internal ceiling planks (T1 and T5) and a single oak ceiling plank (T8) have been sampled (Fig.10). The analysis of the only structural oak timber (undertaken by DendroArch and funded by Historic England) indicates that at least some of the timbers employed in the ship's construction was sourced from modern Germany, an area where the Dutch sourced their wood in the 17th century. The report highlights the dating potential of the oak structural timbers which await future sampling stating that *“only sampling and analysis of timbers which retain partial or complete sapwood will improve dating precision”* (Nayling & Tyers 2023).

*Figure 10: Timber samples T1 (upper) and T8 (lower). Scale 8cm © NAS*

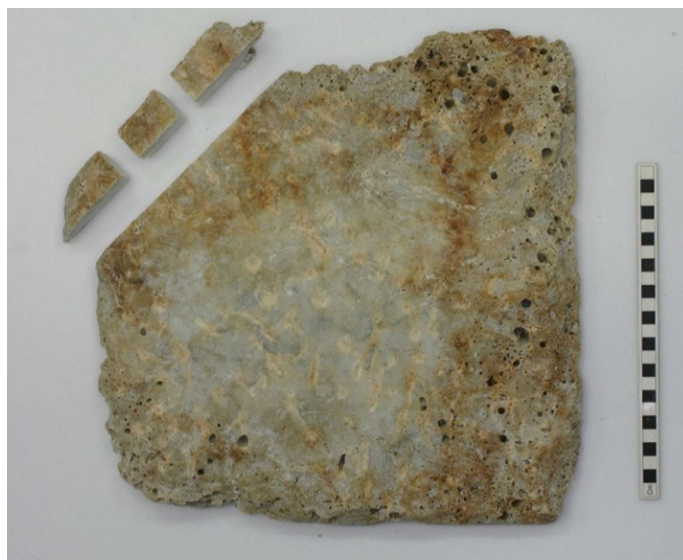
- 5.3.16 **Marble Tiles:** In the western area of the main assemblage there is a significant number of cut stone tiles that form a distinct mound. The exact number of tiles is yet to be determined, but in 2023 divers counted at least 109 tiles. Most appear square in shape and measure around 37cm x 37cm, but they do appear to be of two different thicknesses, either 2cm or 4cm thick.
- 5.3.17 In 2020 the RCE funded a survey by the NAS, that included the recovery of two cut stone tiles for analysis by Historic England material scientists (Fig.11). Petrographic examination including mineral composition and isotope analysis identified the stone as being marble from the Apuan Alps quarries close to Carrara, Italy, home to some of the finest marble in the world (Gherardi 2021).

*Figure 11: Marble tile UID 8 recovered for analysis (Scale 20cm) © Historic England.*

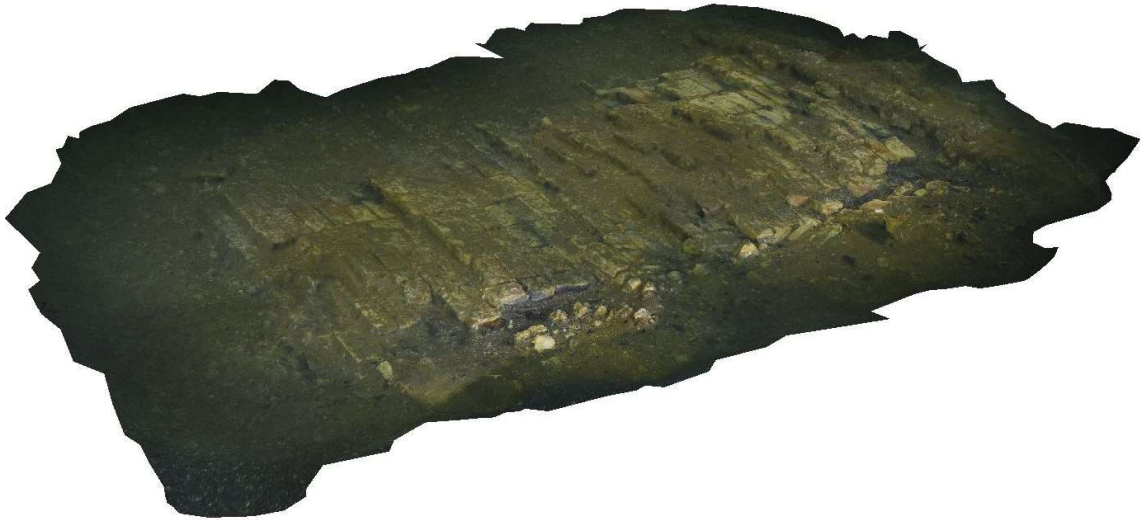
5.3.18 **Hearth Bricks:** Since the first pre-designation dives undertaken on the wreck in April 2019, it has been noticed that a large number of yellow bricks were scattered all over the site. During the 2020 investigation a coherent area of bricks to the south-east of the main assemblage was recorded (Fig.12).

*Figure 12: Photogrammetry survey of galley hearth © NAS / Martin Davies.*

5.3.19 The bricks appear to form a floor, presumed to be the hearth in the galley area of the ship. Whilst other single bricks are scattered over the site, the bricks in the hearth area are bonded together with cement. Subsequent investigation has shown the floor of bricks to be at least twelve courses thick, but without excavation it is not possible to determine conclusively just how the hearth was constructed. In the 17<sup>th</sup> century ships galleys were normally located on the forward area of the ship, forward of the main mast.

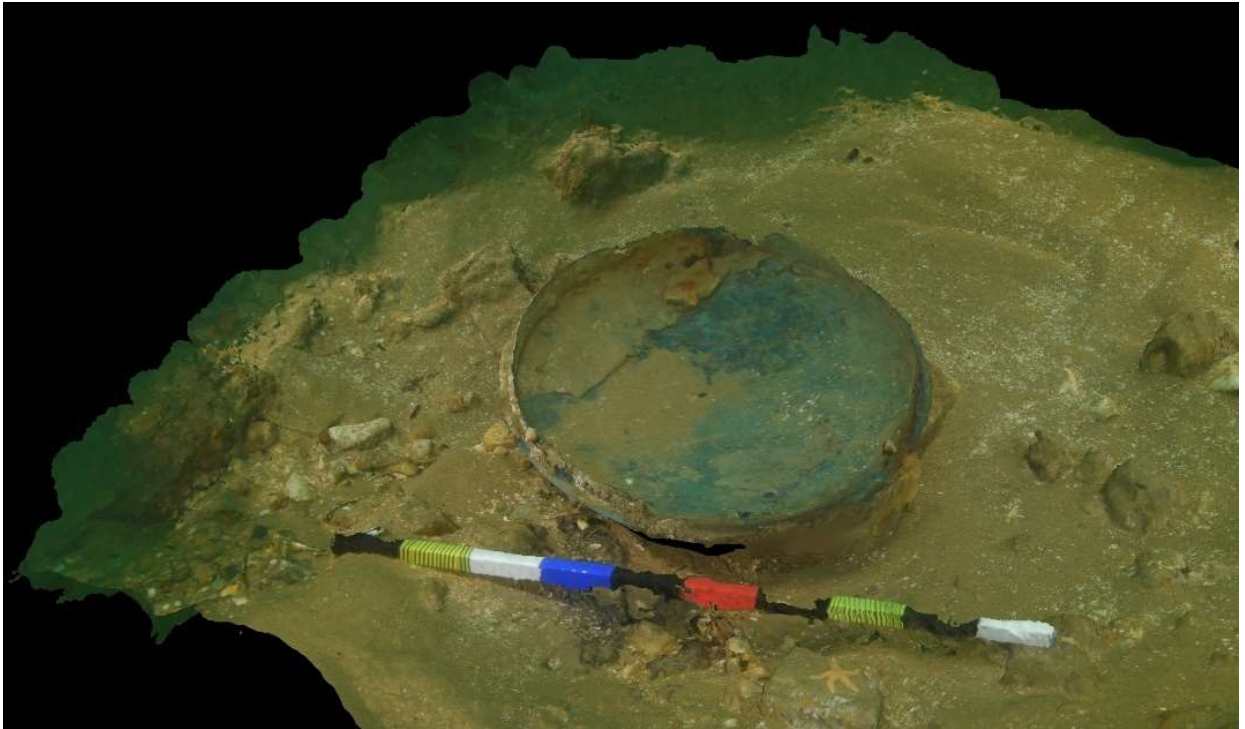
5.3.23 **Other finds:** Other objects recovered from the site include a copper cauldron lid, several pewter plates and bowls and a bronze pulley sheave that was probably used as part of the ship's rigging. Since 2019 what is thought to be the base of a copper cauldron has been seen on the wreck (Fig.14). The burial state of the cauldron base changes periodically, sometimes being more buried than on subsequent visits. It is noticeable from the surveys undertaken in 2021 and 2022 that the cauldron base is not stable and clearly moves around the site.

*Figure 14: Photogrammetry of copper cauldron base (Scale 1m) © Martin Davies.*

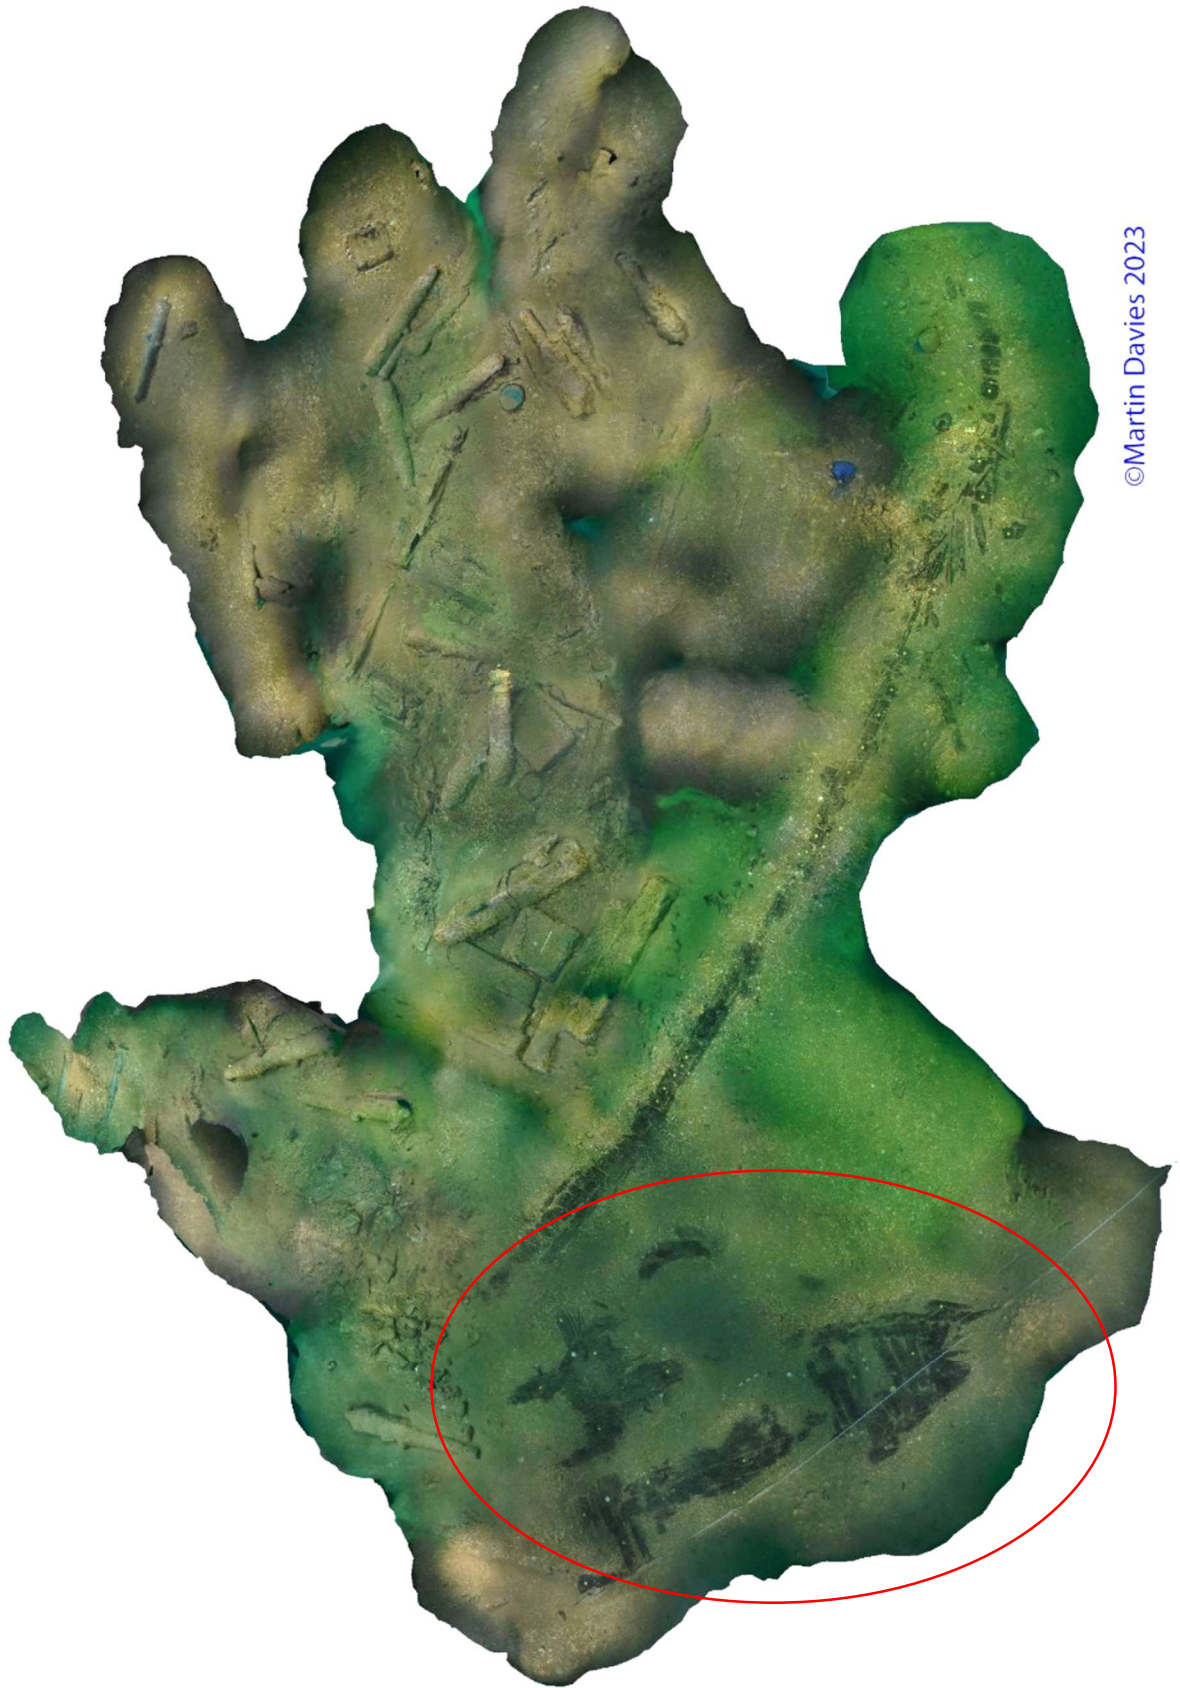
6.4.7 From the evidence documented on the seabed, what appears to have happened is that after the ship landed on the seabed and came to rest, it naturally broke up over time. Over the years parts of the ship's hull that would have been upstanding and exposed to the tidal currents and to wood boring organisms would have fallen on to the seabed below.

**Figure 19: Full photogrammetry model of the Klein Hollandia site showing the newly exposed section of hull timbers © Martin Davies**

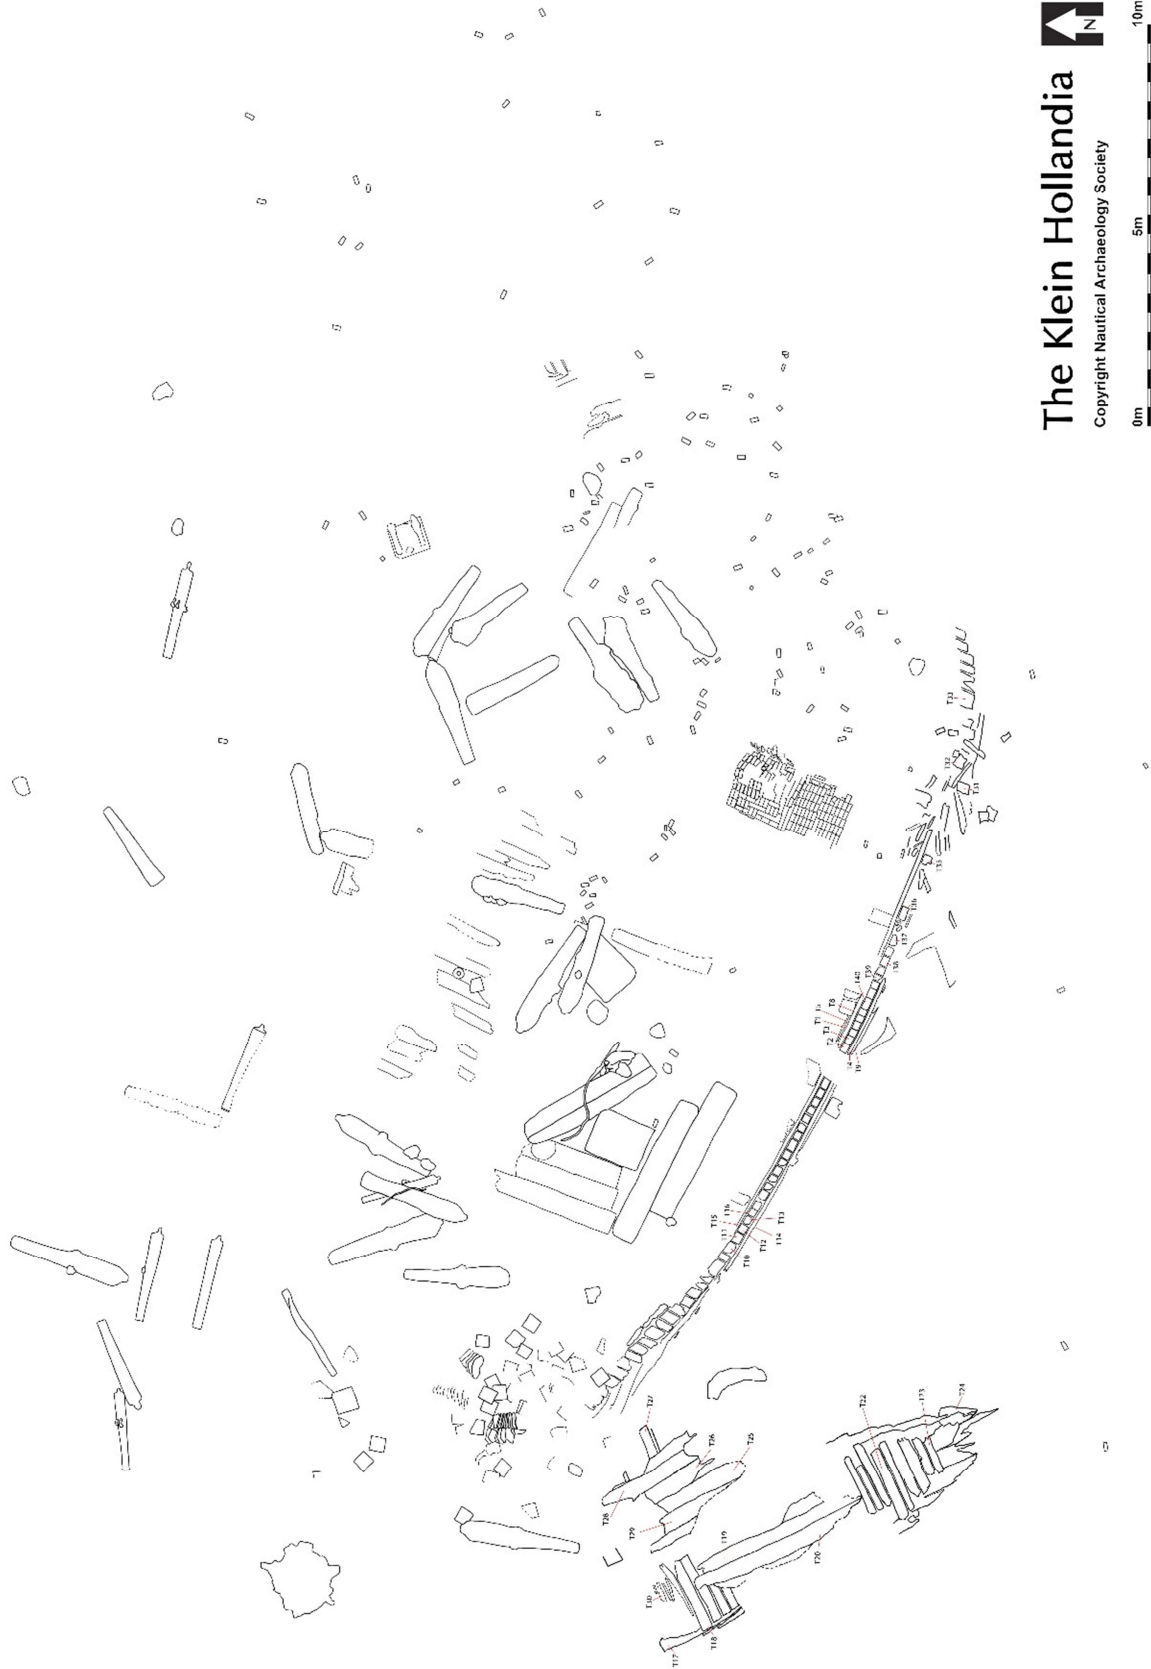
**Figure 20: Klein Hollandia site plan 2023 © NAS**

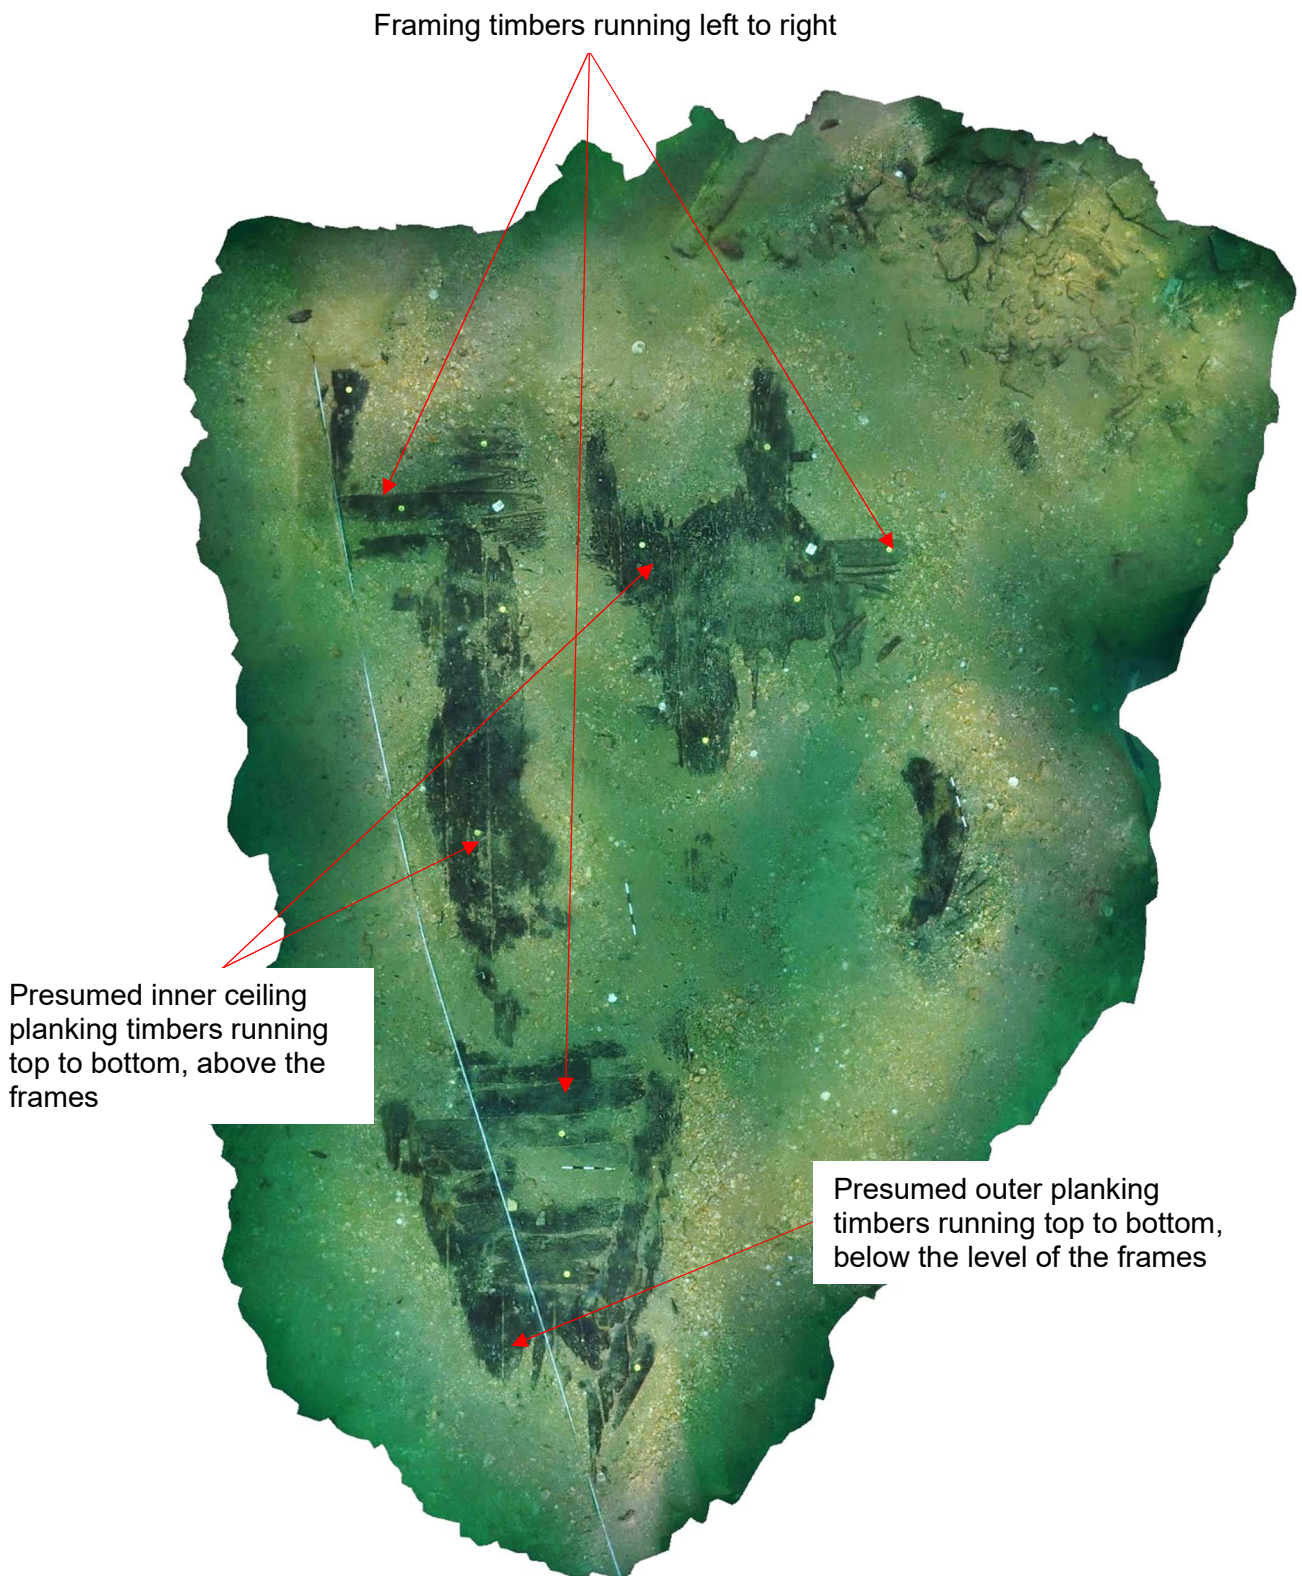
**Figure 21: Photogrammetry survey of timbers to the south of the site © Martin Davies**

- 6.4.8 The believed orientation of the ship on the seabed would make these timbers the starboard side hull that became disarticulated and broke and fell to the seabed. It cannot be said with certainty at this stage whether the hull is lying face up (with inner planks being uppermost) or face-down (with outer planks being uppermost), but it seems most likely that the hull simply fell or collapsed down on to the seabed with outer planks resting on the sand with the inner planks uppermost. We are therefore looking down at the inside of the ship.

- 6.4.9 It was hoped, and still is hoped, that something might have been found, such as slots for beams or even a gun port, that would have made it clear which way the timbers are lying. Future investigation of the area should be able to illuminate exactly what is on the seabed.

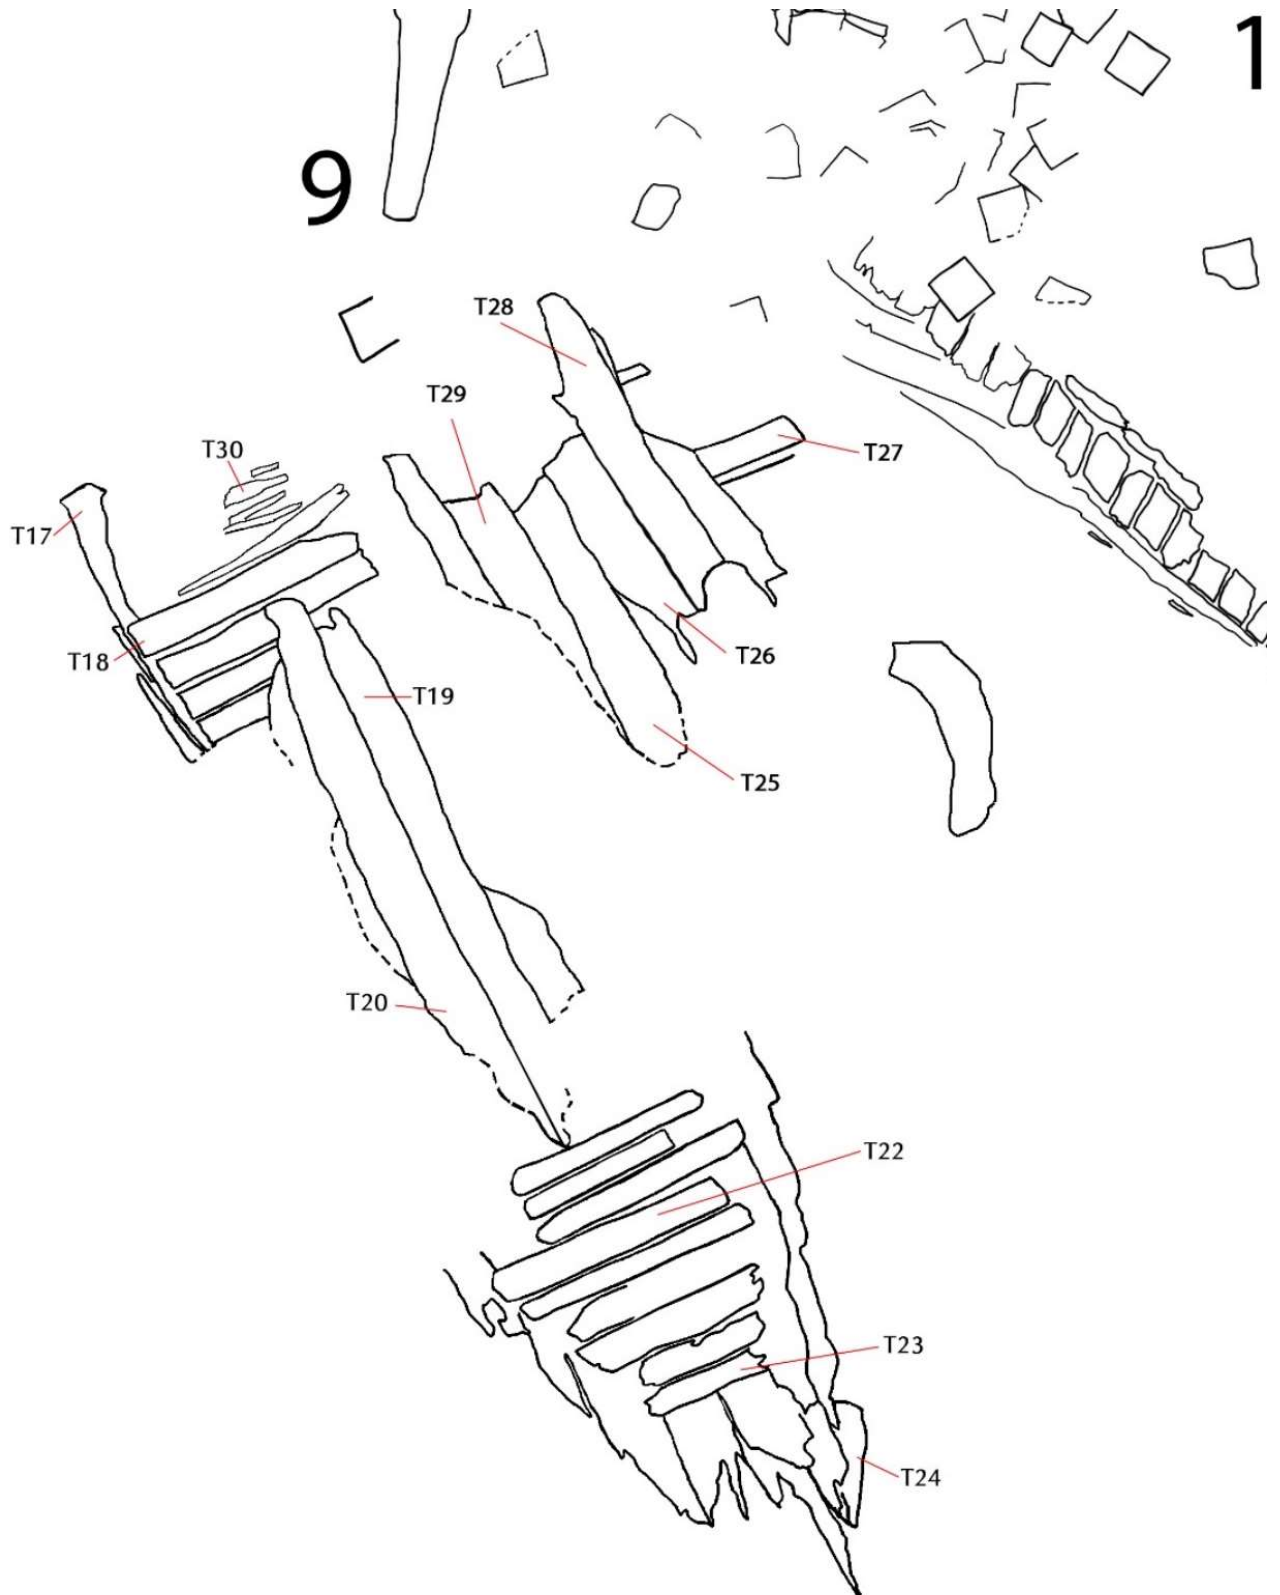
**Figure 22: Site plan of timbers to the south of the site © NAS**

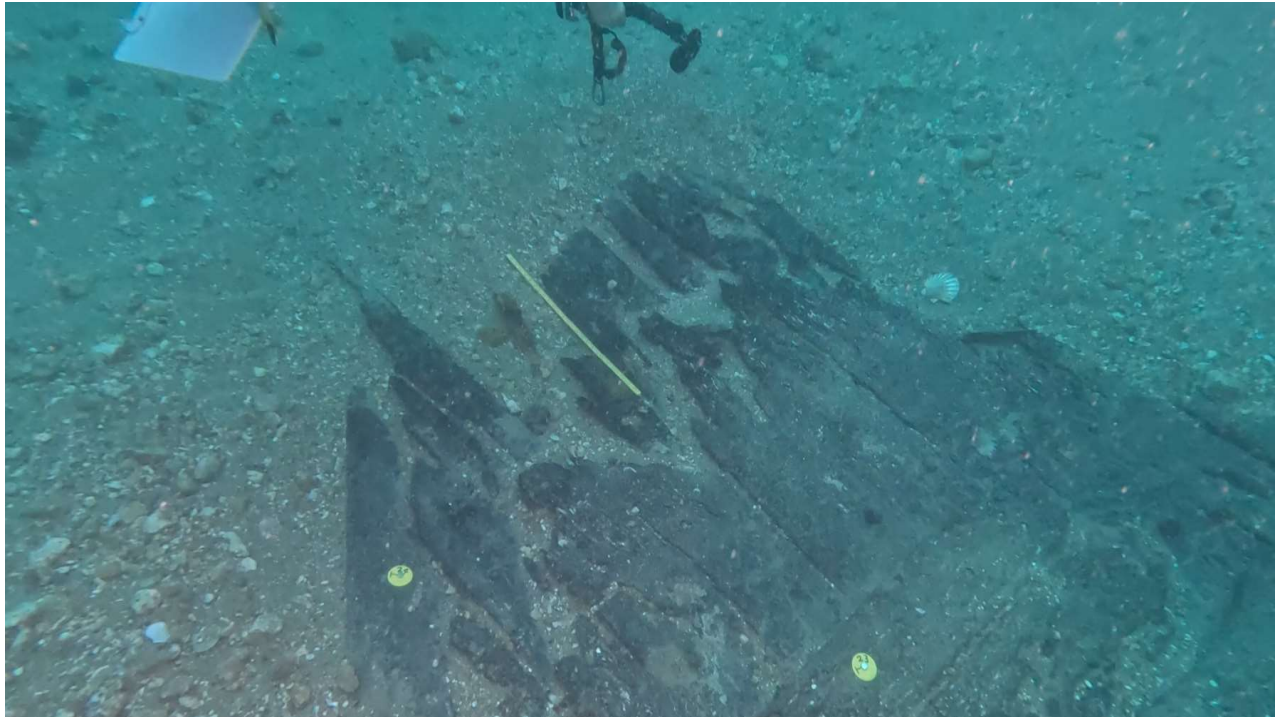
*Figure 23: Video capture of the southernmost area of the hull remains including Tags T23 and T24*  
© NASAC

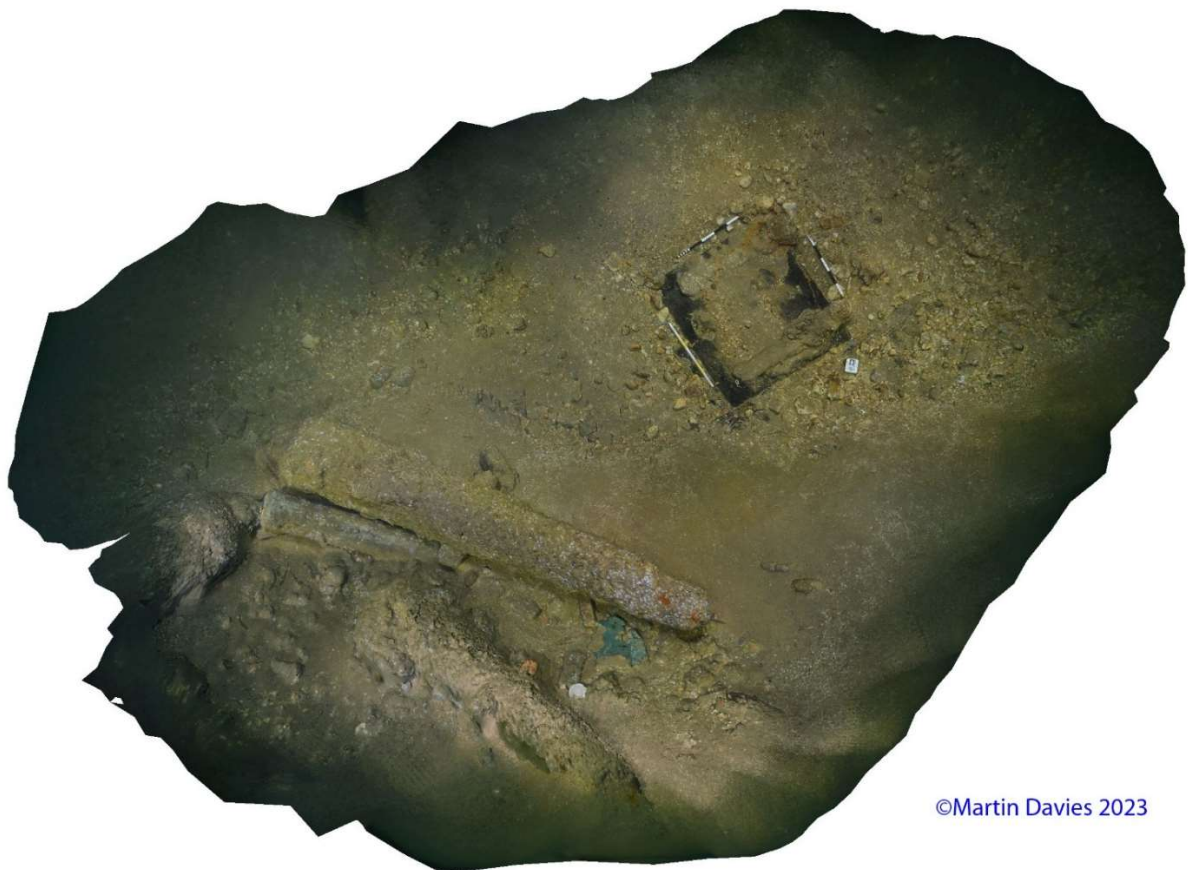
- 6.4.15 On the final day of the expedition, diver Martin Woodward and his buddy Robert Hunt recognised and reported the discovery of a wooden gun port lid. As a 56 gun ship there would have been 56 gun ports and gun port lids. The discovery was made in the northeastern area of the site near to bronze and iron cannon. Martin Davies was able to record the gun port lid with photogrammetry during a later visit to the wreck in September 2023 (Figs. 24 & 25).

**Figure 24: Photogrammetry survey of gun port lid © Martin Davies**

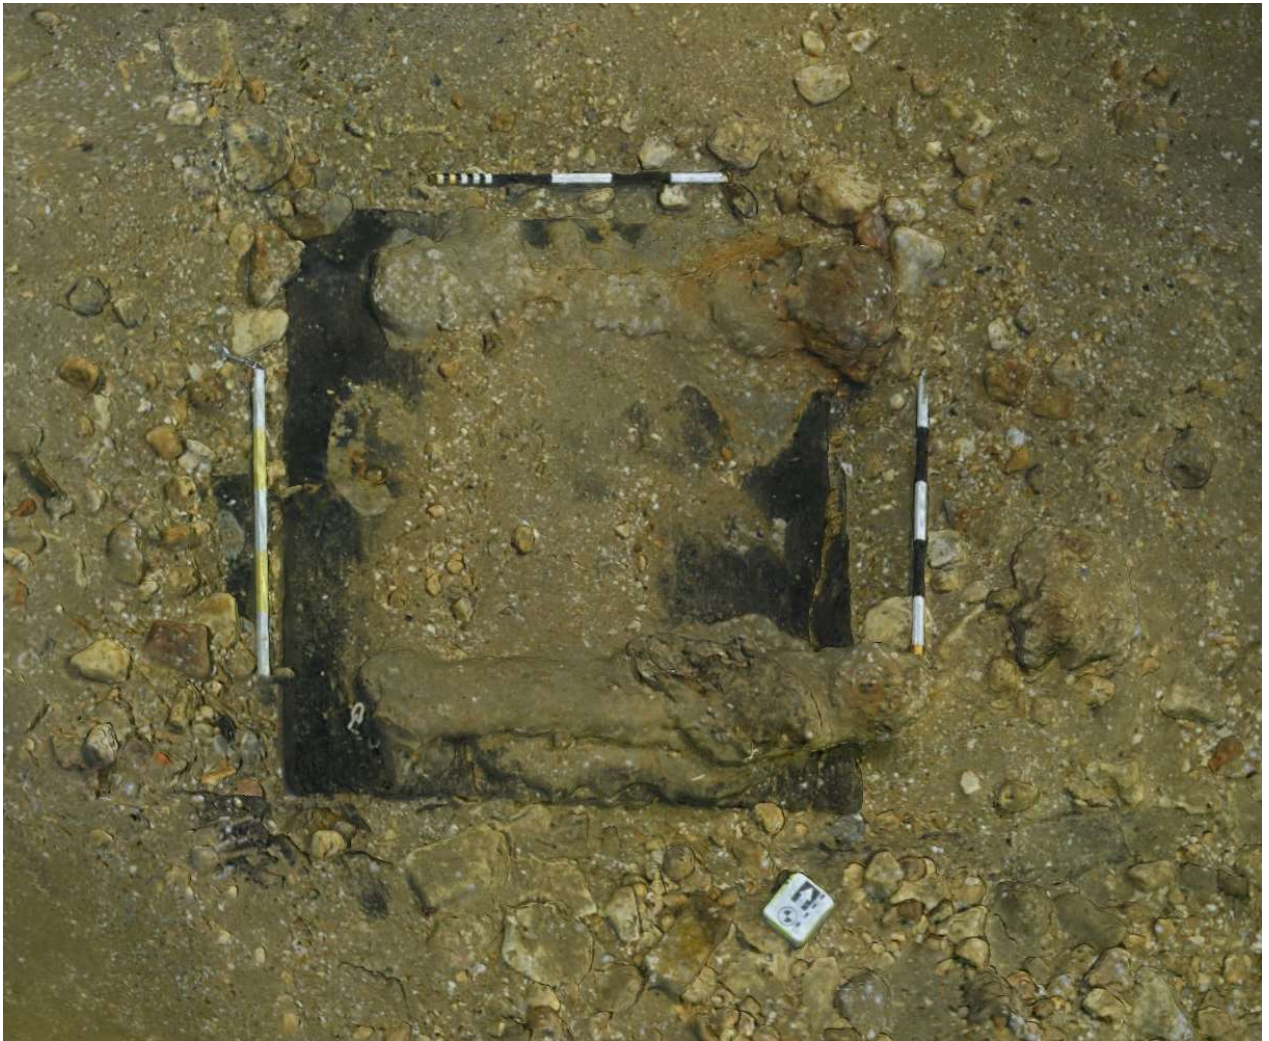
*Figure 25: Close up of photogrammetry survey of gun port lid. Scales 50cm  
© Martin Davies*

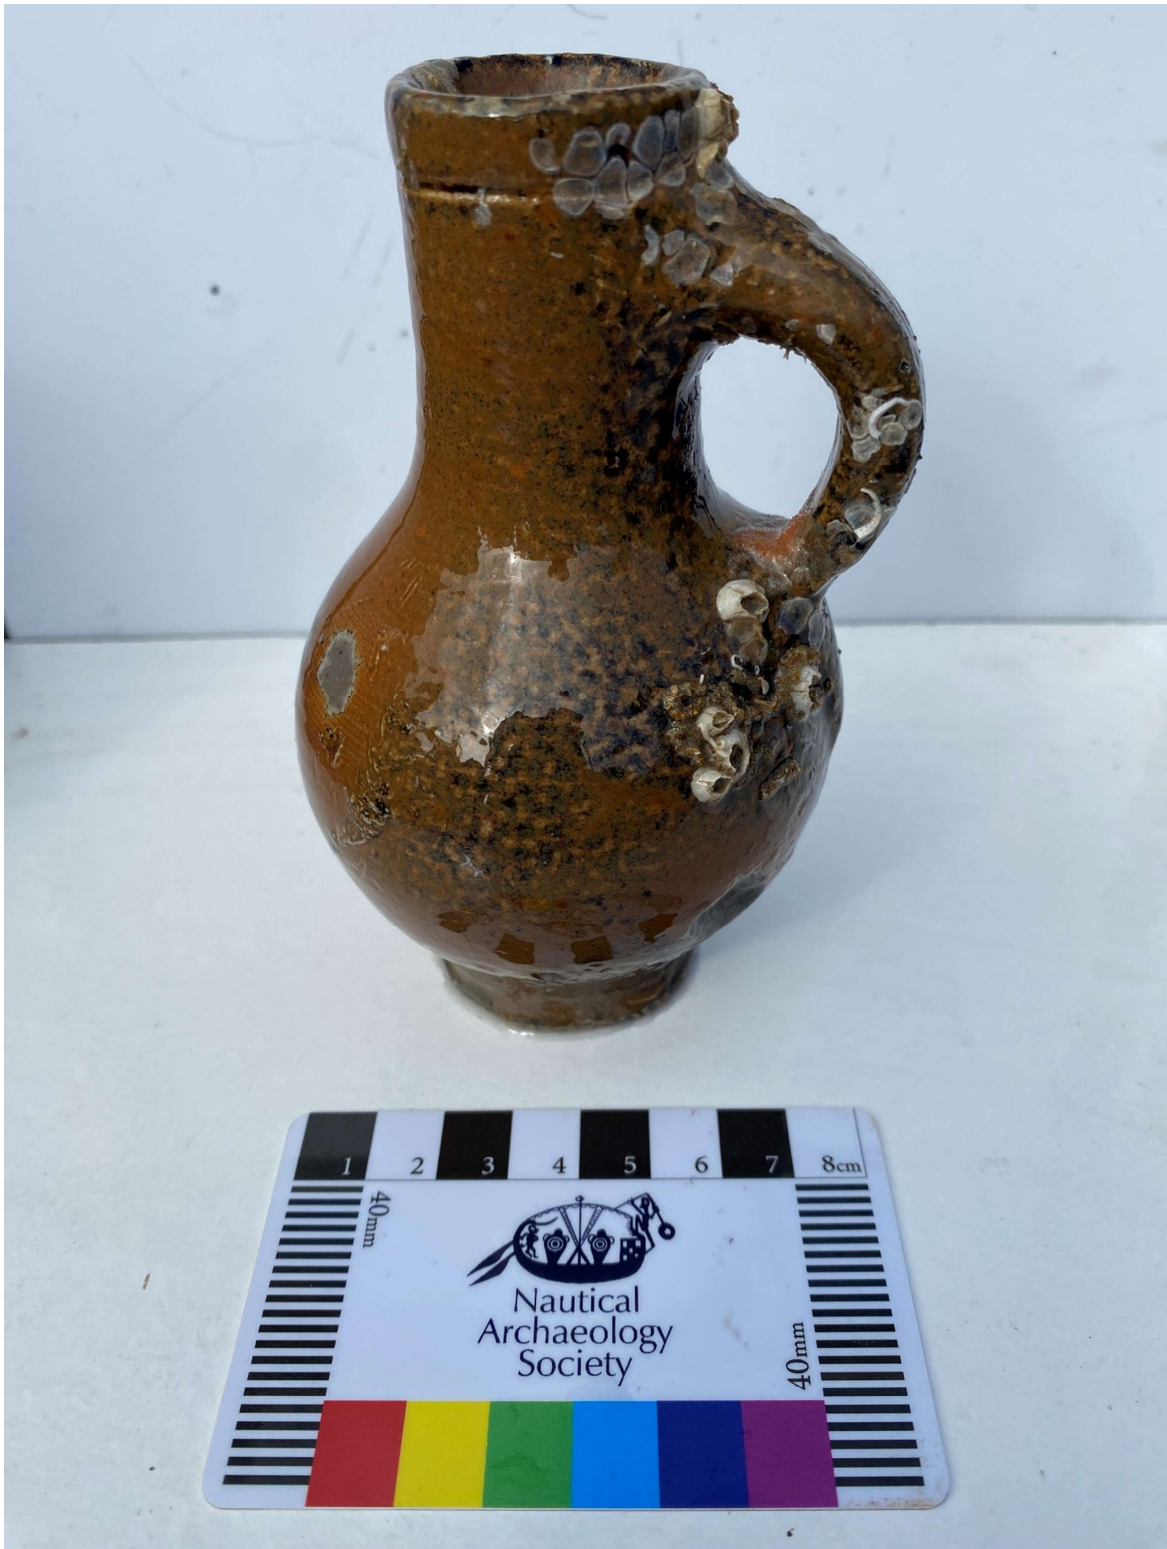
**Figure 26: Small ceramic jug recovered from the Klein Hollandia © NAS**

- 6.4.16 **Recovered finds** – three recoveries of small finds were made during the August week. All recoveries were made with permission and under licence from Historic England. To make a recovery the licensee had to contact Historic England to describe and justify why the finds needed to be recovered. Once permission had been obtained the recoveries could be made.
- 6.4.17 The three recovered finds were a complete ceramic jug and two parts of rope that were found to be eroding out of the seabed and were likely to wash away in future tides (Figs 26, 27 & 28). At the time of writing the research into the recovered finds is ongoing.

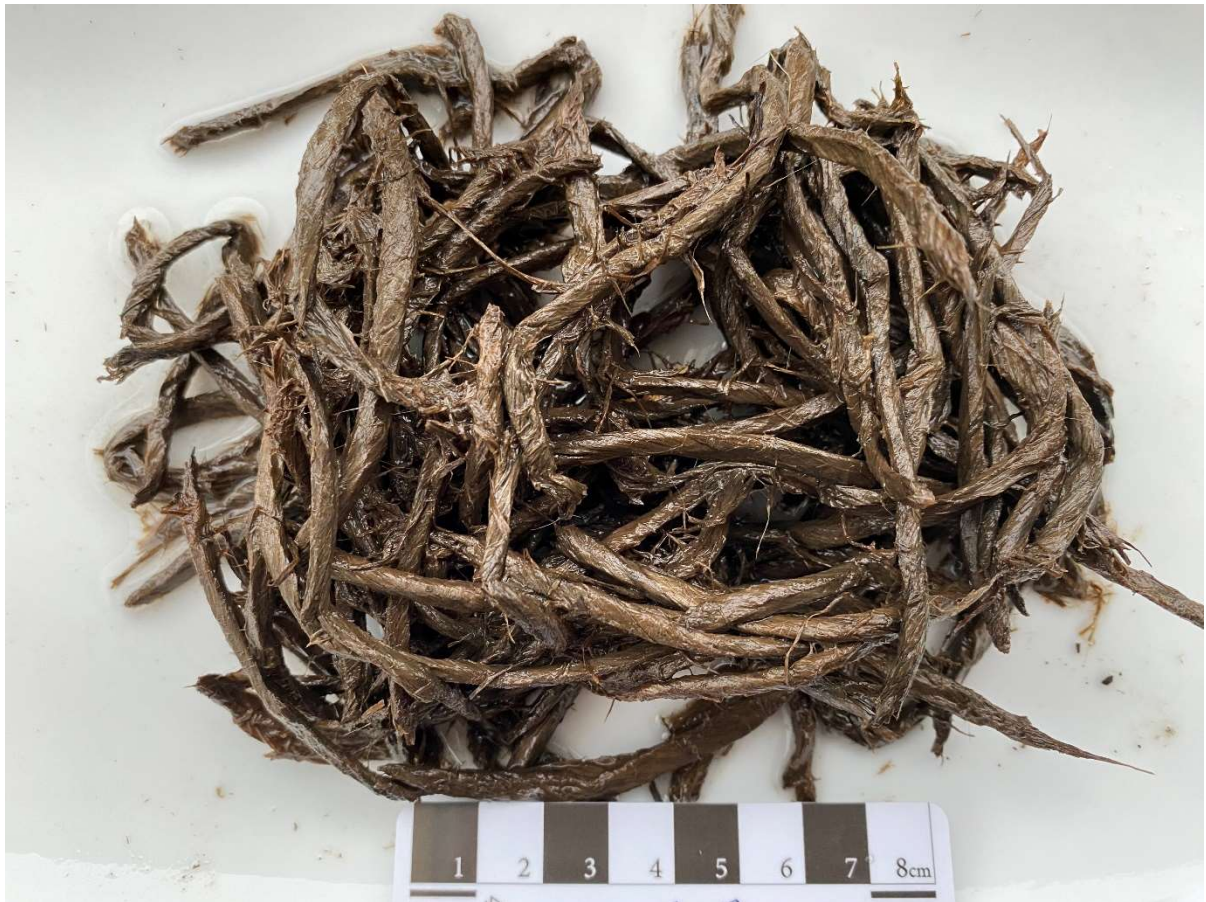
**Figure 27: Strands of rope fibre recovered from the Klein Hollandia © NAS**

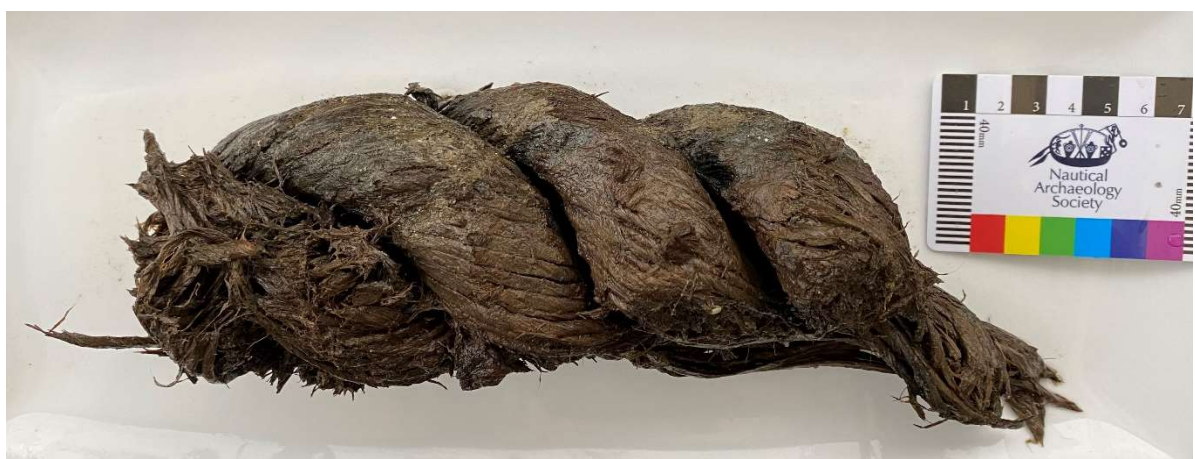
**Figure 28: Small section of rope recovered from the Klein Hollandia © NAS**
