# Understanding the Klein Hollandia Shipwreck

## 2023 Investigation Report

Prepared for the  
**The British Sub-Aqua Jubilee Trust**

April 2024

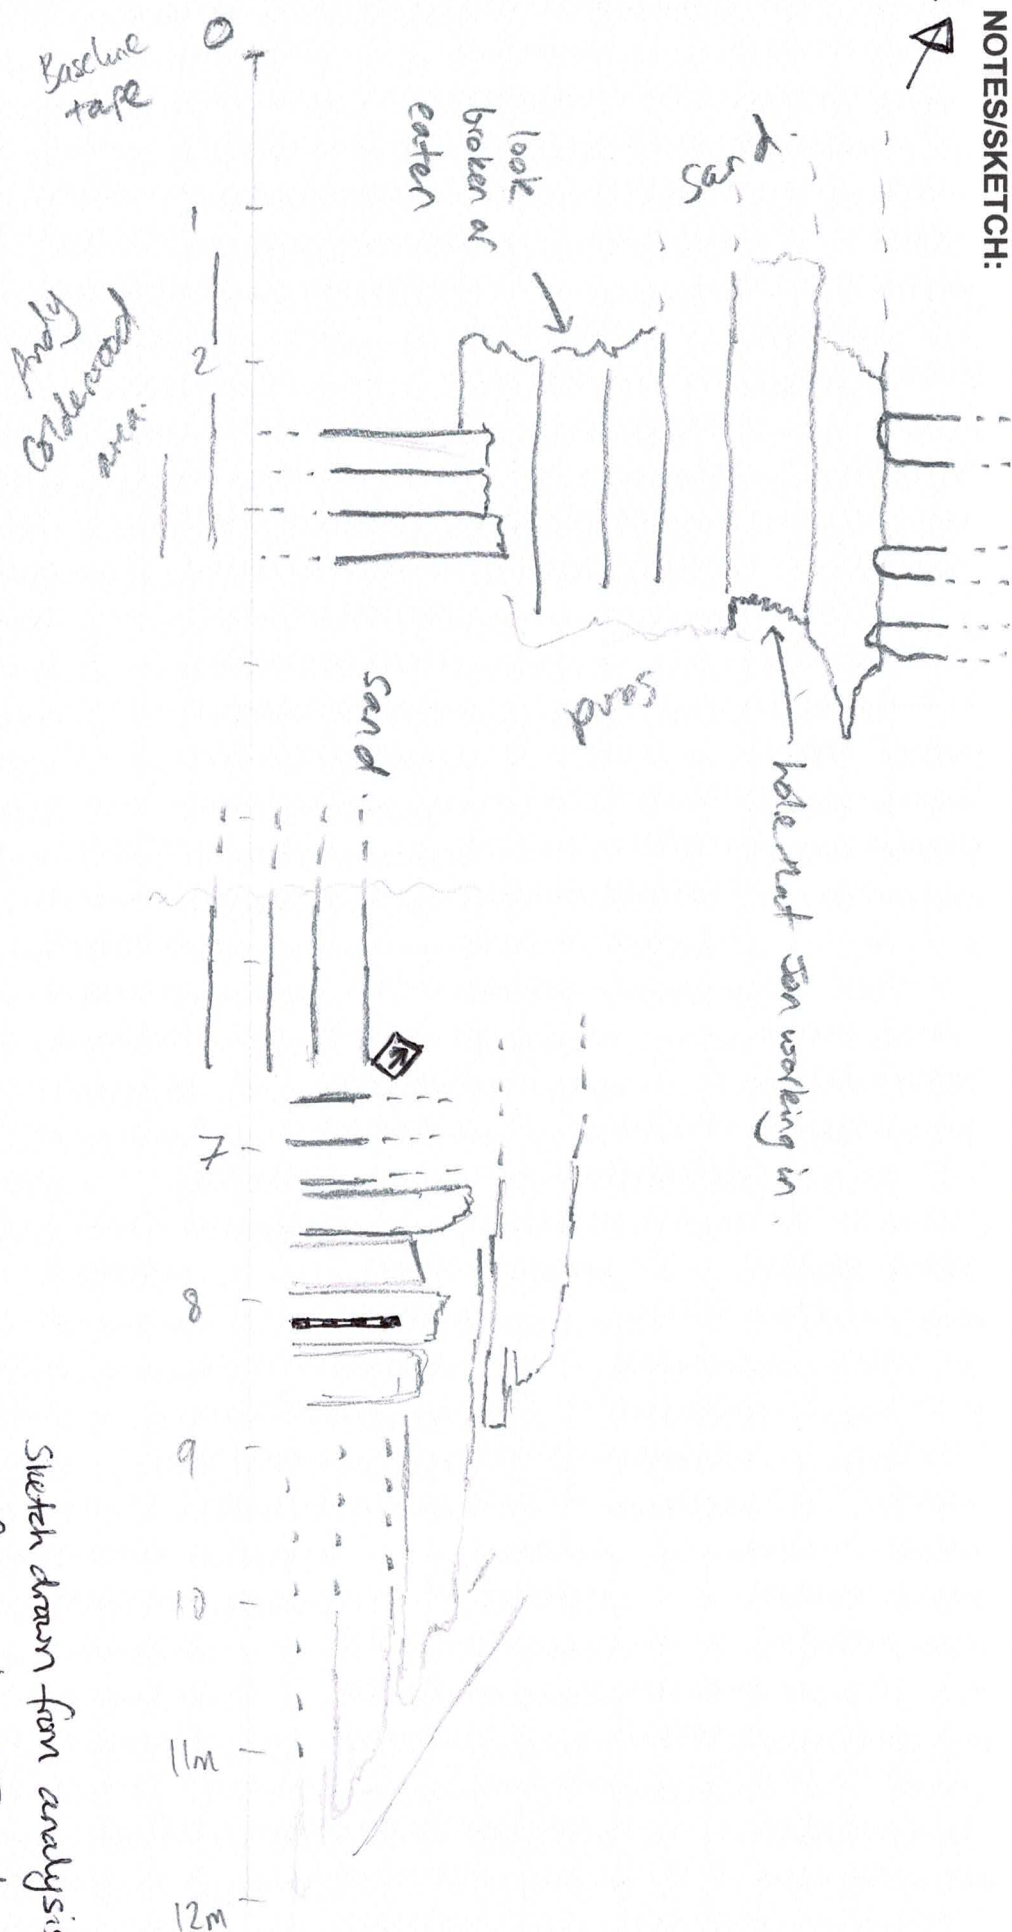
PERSONAL DETAILS		SITE DETAILS	
Name:	Mark Beattie Edwards	Site Name:	UK HO 83501
Date:	22. 8. 23	Sector/Area:	South timbers
		Cross Ref Dive Log:	174 - 2023
		Form No:	176 - 2023
		U1060 U06 REF:	175. 2023

Sketch drawn from analysis  
of videos by N&E and  
Jon Padlow.
