BSAC West Midlands Regional Expedition Scheme

Lofoten Islands Expedition

Biodiversity Survey

Lofoten Wrecks

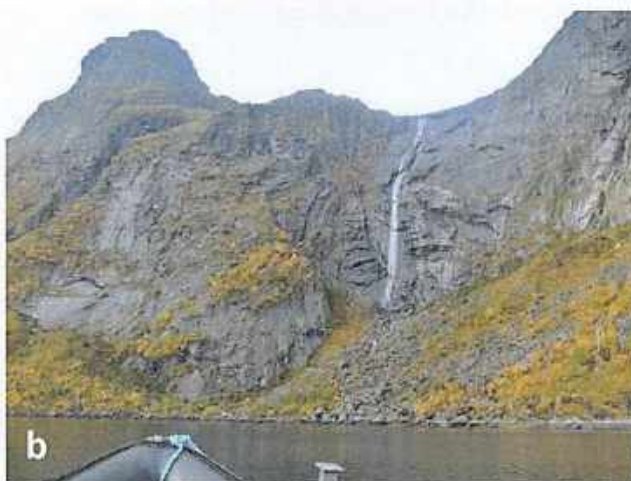
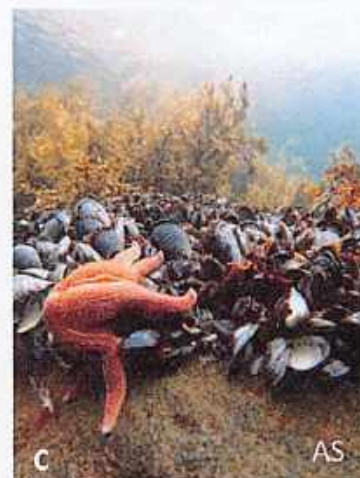
Fig 5. a) Chart to show location of Forsfjorden (1) and Engelsneset (2) dive sites. b) The waterfall above Forsfjorden dive site. c) Shallow water community showing a bed of common mussels, knotted wrack and a common star fish feeding on the mussels.

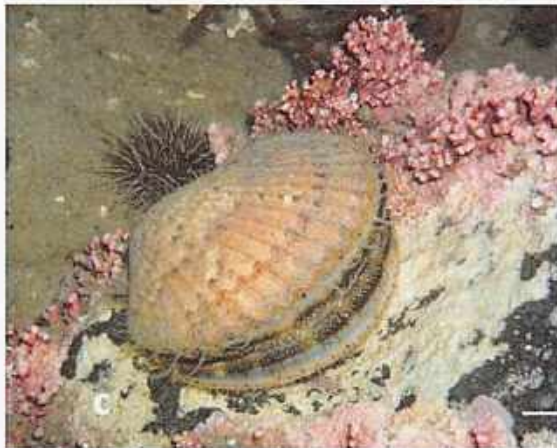
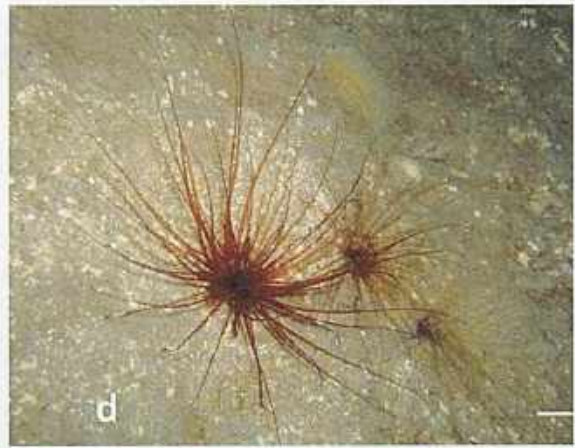
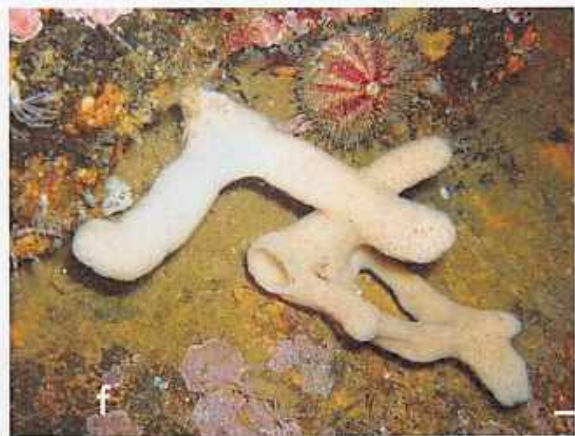
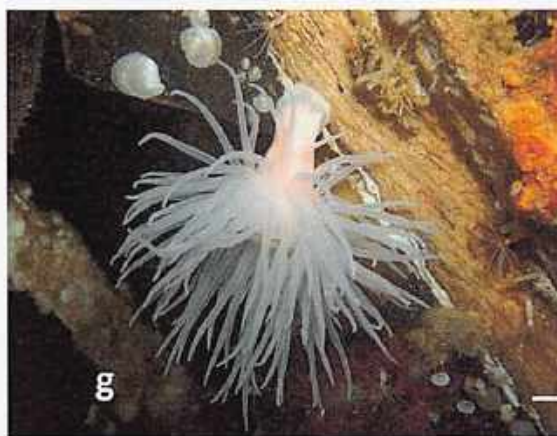
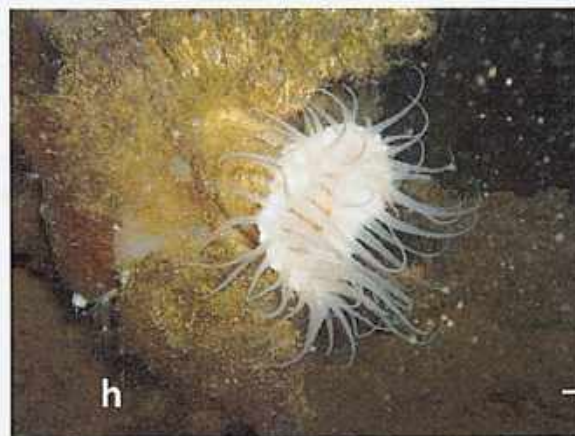
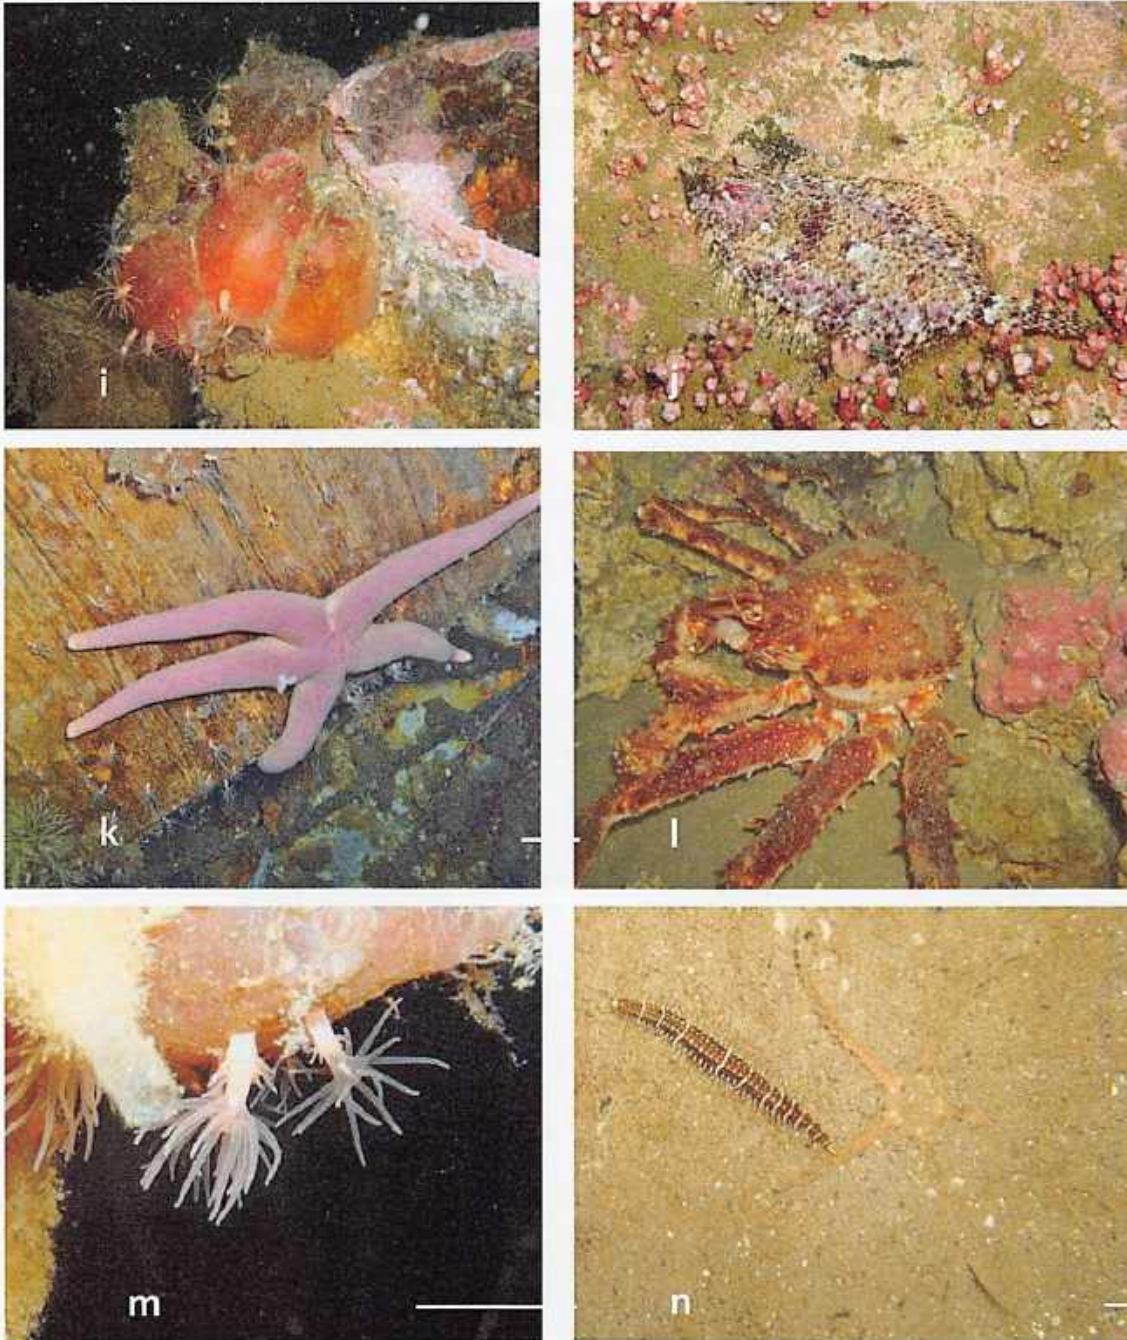
Fig 6. Forsfjorden flora and fauna. a) black brittle star and common urchin, b) dragonet, c) queen scallop and northern sea urchin with outcrops of pink calcareous alga, d) burrowing anemones, e) sea cucumber *Cucumaria*, f) sponge *Haliclona*, g) sea loch anemone and saddle oysters, h) large anemone, *Hormathia*, i) red sea squirts, *Ascidia*, with small proliferating anemones attached, j) Norwegian topknot, k) bloody henry star fish, l) large stone crab, m) proliferating anemones also showing the siphon of purple sponge, n) sand brittle star and annelid worm *Ophiodromus*. Images taken on the wrecks are as follows: f, g, h, i, k and m. Unfortunately, there are no images of the large pink calcareous algal structures because more sophisticated camera equipment would be required. (White lines indicate approx. 10 mm scale).

The two small wrecks were lying at depths of about 27 m to 30 m, on a silty slope. They were lying about 20 m apart. The marine life on the wrecks was quite sparse, but anemones of several species were found here: the sea loch anemone, the large anemone *Hormathia*, and the tiny proliferating anemone which was very common. Four species of sponge were found on the wrecks and whilst they were not common, there were more sponge species here than at any other site.

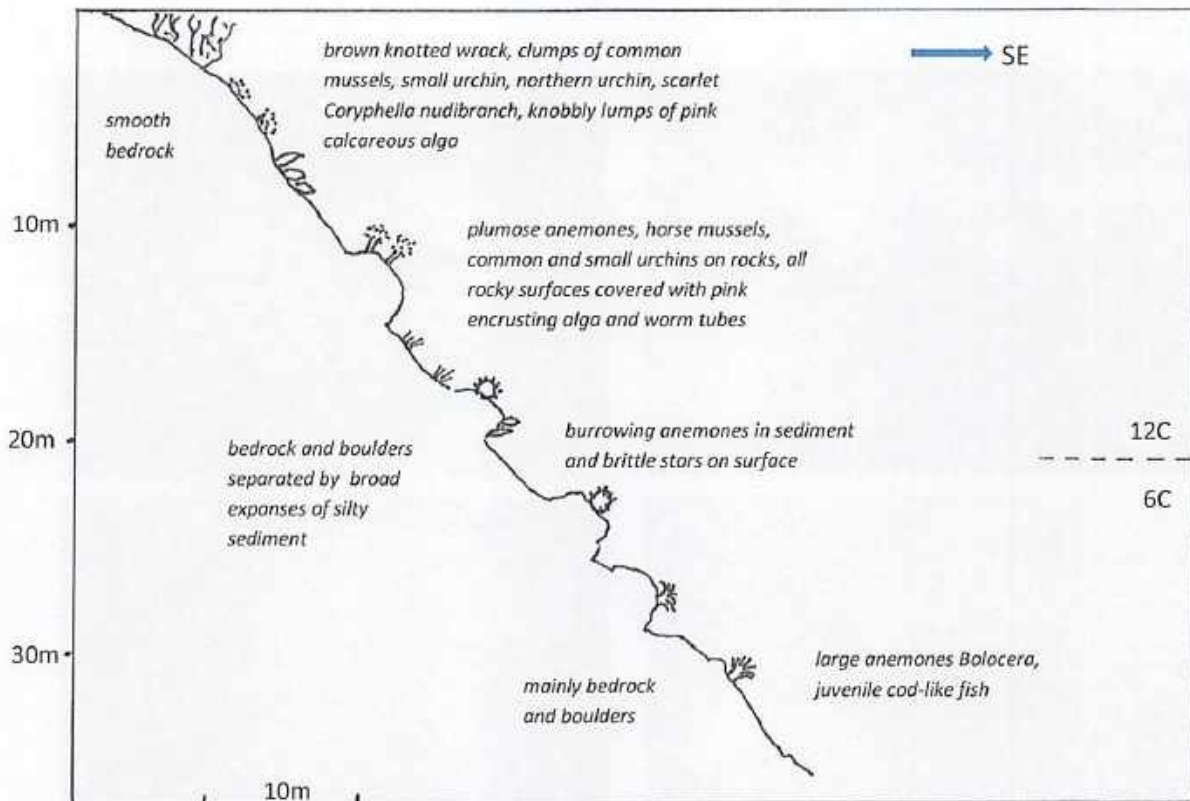
Fig 7. Angel Point profile showing different habitats and communities

At shallow depths the substrate was smooth bedrock with scattered lumps of knobby pink calcareous alga. The brown seaweed knotted wrack was present in the first few meters, with colonies of common mussels. Horse mussels were also found here, as were common star fish, common periwinkle, common urchins and smaller dark-coloured northern urchins. Large numbers of scarlet nudibranchs, *Coryphella*, were seen apparently feeding on a dead compass jelly fish together with northern urchins and common whelks. The rocks were covered with pink encrusting alga and worm tubes at all depths.

Below about 20m, individuals of the large anemone *Bolocera* were found attached to rock outcrops and boulders. Also at these depths, the small foliose red alga, *Turnerella* was present.

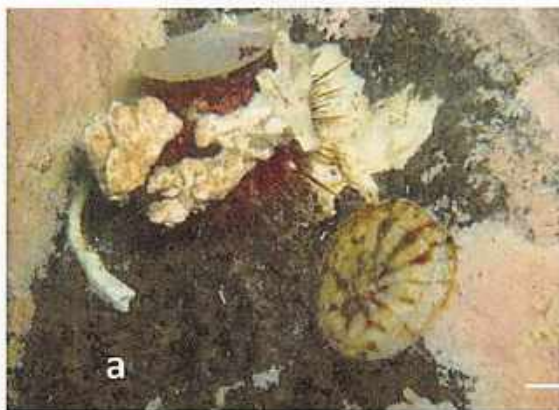
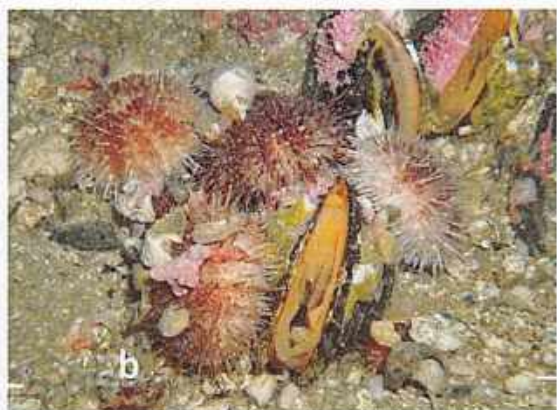
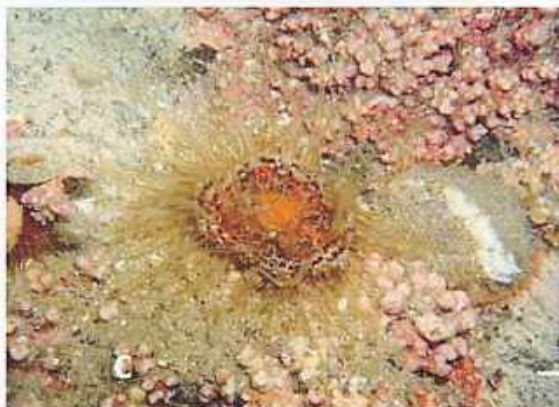
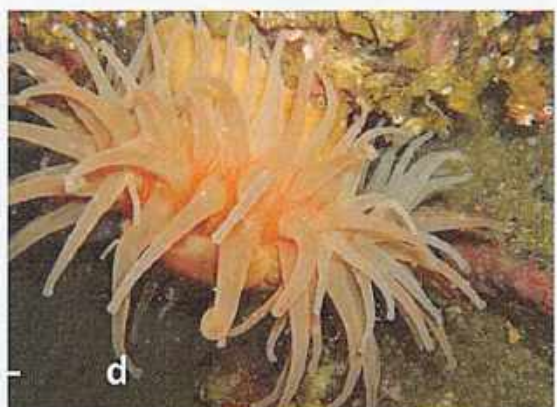
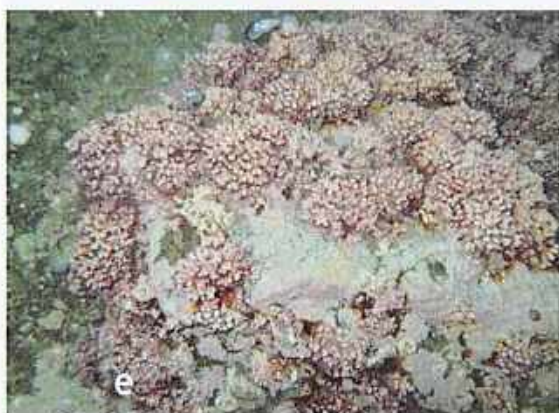
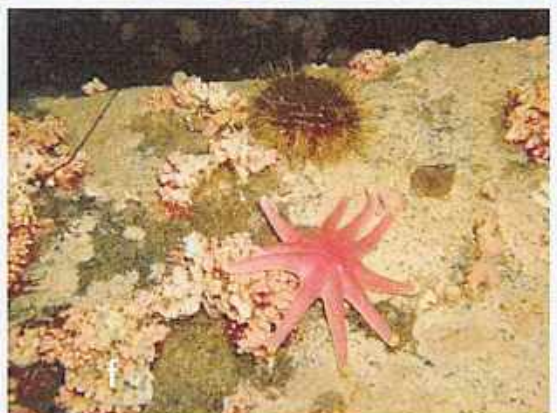
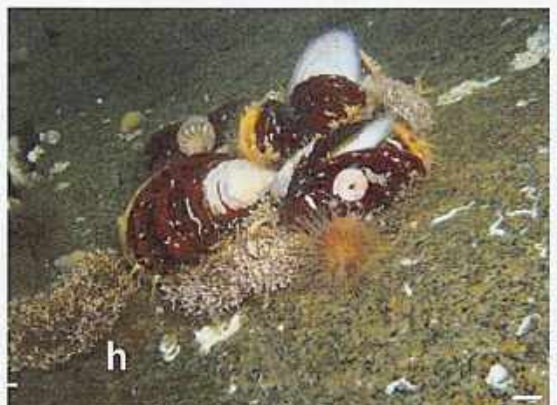
Fig 8. Engelsneset flora and fauna. a) small urchin covered with shells and debris, limpet *Tectura*, b) clump of small urchins with horse mussel, c) elegant anemone *Bolocera* e) lumps of knobbly pink calcareous alga on rock outcrop, f) purple sunstar with northern urchin, part of a bootlace worm can be seen top left, g) northern urchins, h) horse mussel colony, i) scarlet *Coryphella nudibranch*, feeding on a dead compass jellyfish, j) *Coryphella nudibranch* with northern urchins on compass jellyfish, k) colony of plumose anemones on smooth rock surface, l) pink calcareous algal 'garden' with northern urchins, a plumose anemone and crevice brittle star arms projecting into the water. (White lines indicate about 10mm scale).

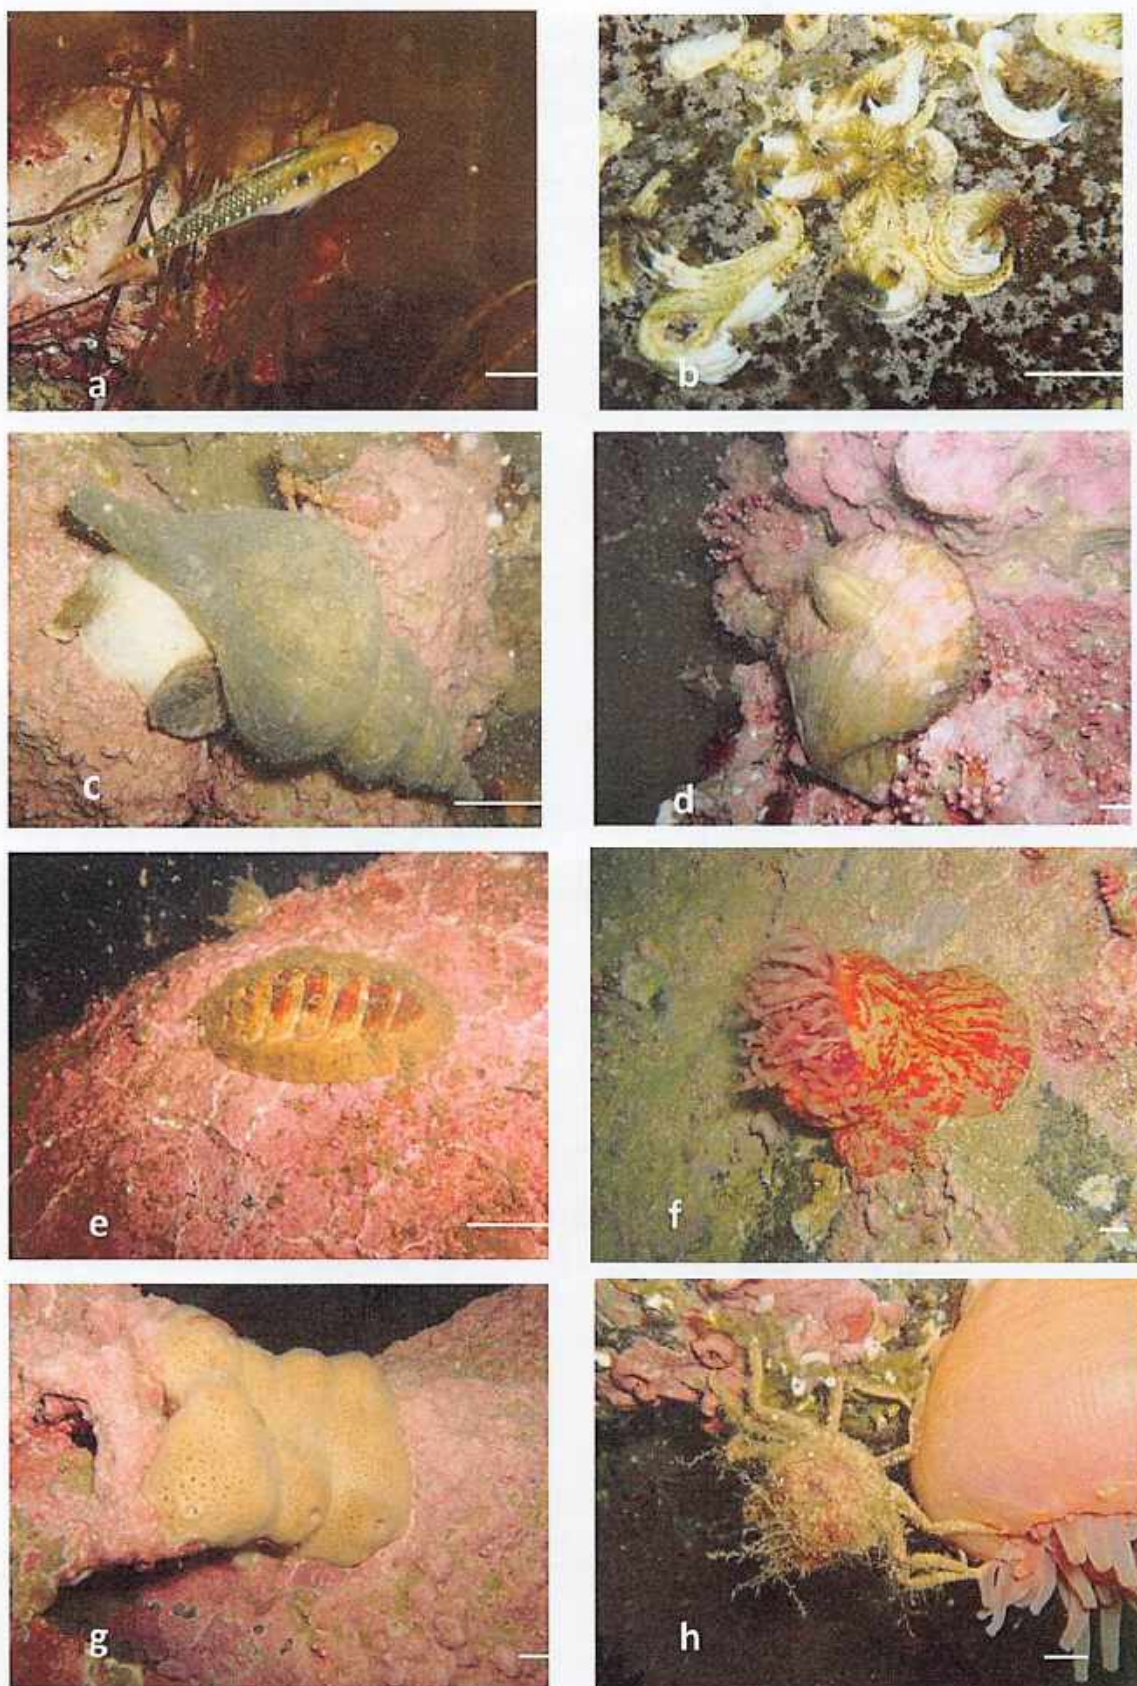
Fig 11. a) two-spot goby amongst bootlace weed, b) keel worms with calcareous tubes; crown of tentacles visible, c) Neptune whelk, d) Icelandic clam with barnacle attached, e) chiton on pink encrusting alga, f) large anemone *Urtecina eques*, g) unidentified sponge, h) spider crab molesting *Bolocera* anemone. (White lines indicate approx. 10mm scale).

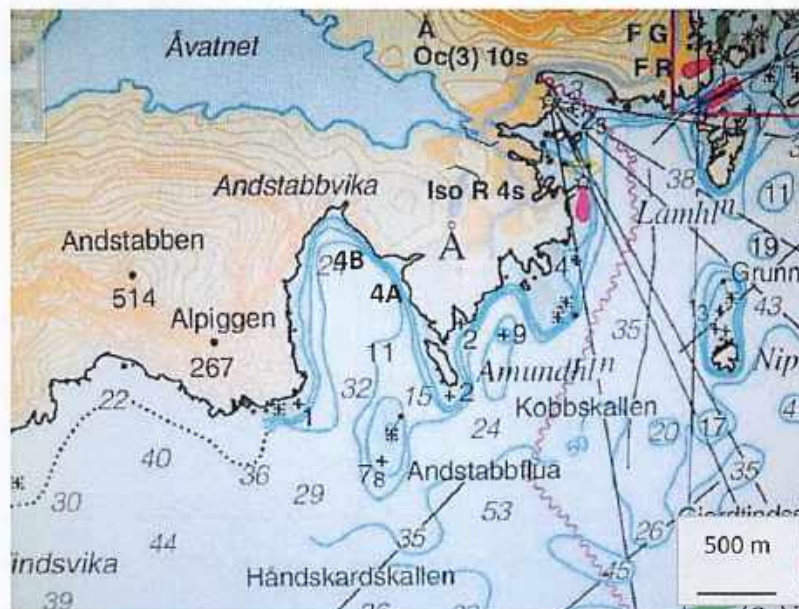
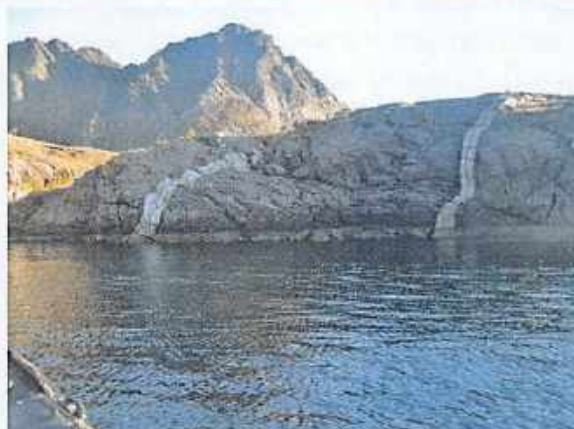
Fig 13. Chart showing the bay at Anstabviken and the two dive sites 4A and 4B.

View of 'White Stripes' showing the quartz seams; to the left is the inlet shown on the chart.

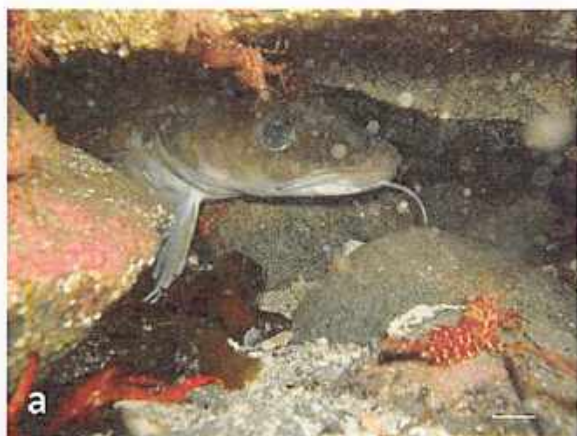
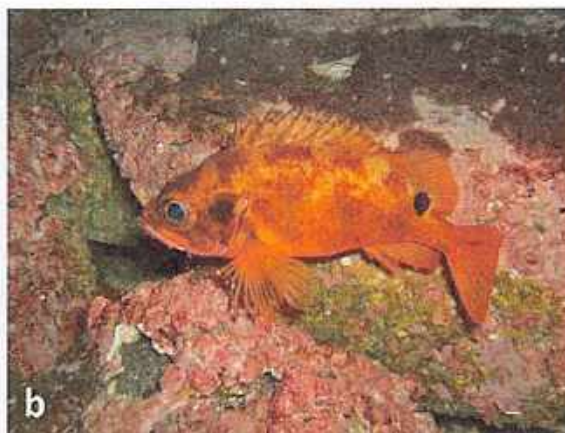
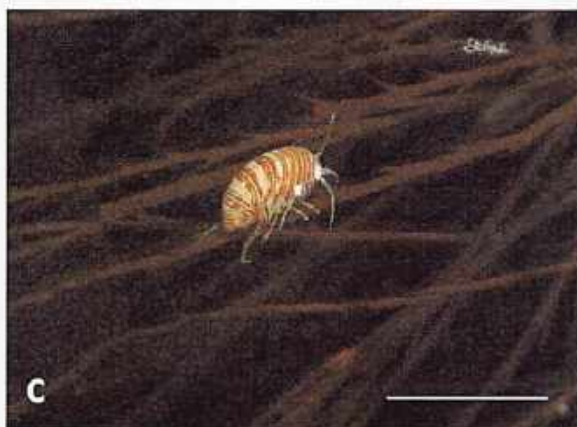
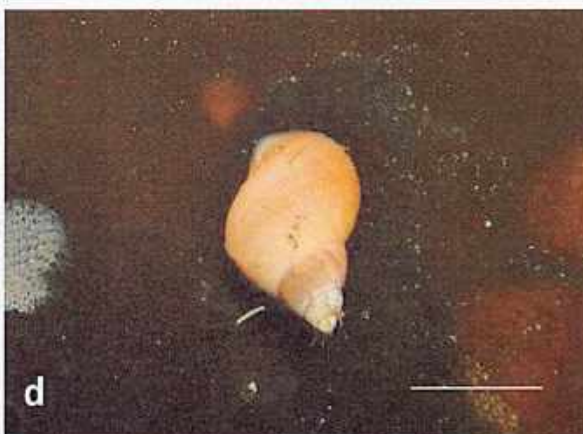
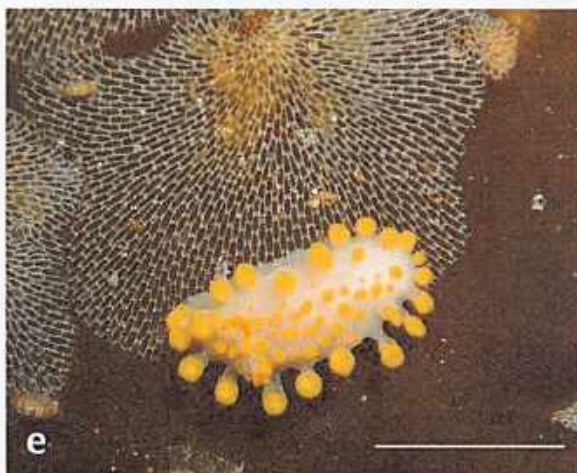
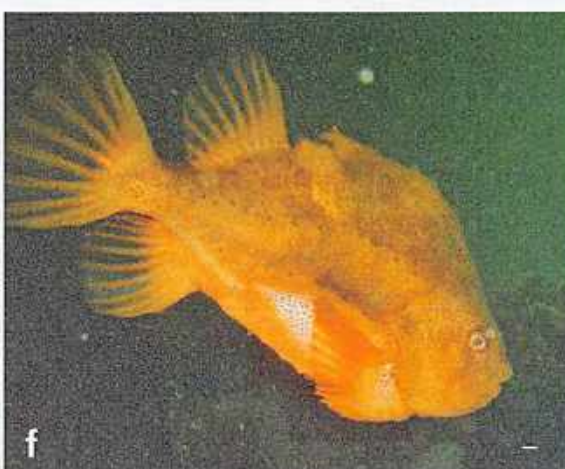
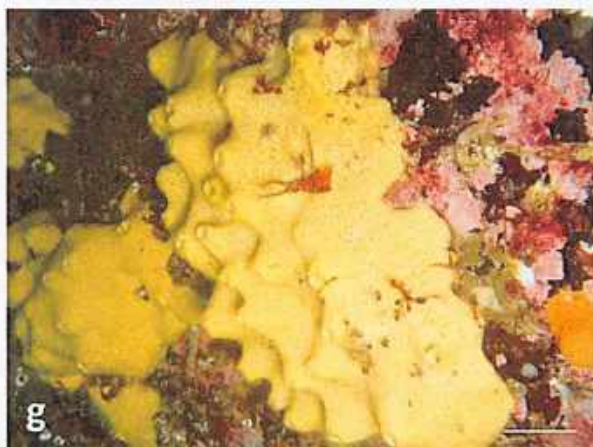
Fig 14. a) Ling with prawns *Lebbeus polaris*, b) Norway redfish, encrusting pink alga on rocks, c) amphipod *Iphimedia* on brown prickly weed, d) chink shell on kelp frond, e) nudibranch *Limacea* feeding on sea mat on kelp frond, f) lump sucker, g) yellow volcano sponge. (White lines indicate approx. 10mm scale)

Several fish species were recorded here: a large school of saithe swam past heading down the slope, a large ling was seen hiding beneath a boulder, together with prawns guarding the entrance. Other species included the Norway redfish, lump sucker, goldsinney and pogge.

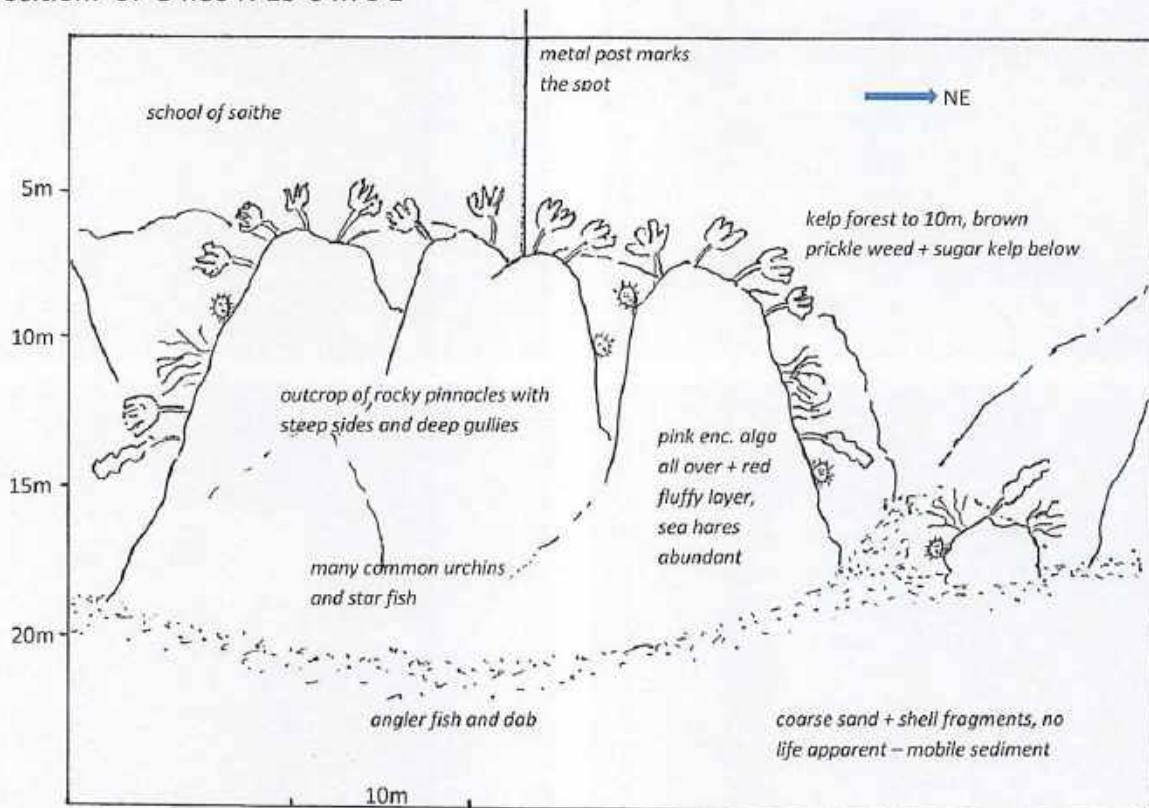
Fig 15. Diagram to illustrate dive site at the entrance to Djupfjorden, on the seaward side.

This site is on the open coast, exposed to weather from the S and E. Being situated near the entrance to Djupfjorden, the site would be subjected to tidal flow at certain times. There is a metal post marking the site, which makes it easy to find. There are 3 posts, which can be seen marked on the chart, and the dive began at the middle one at a depth of 6m. Dense kelp forest grew over the top of the rocks which were steep-sided pinnacles clustered together and separated by deep gullies. Vertical walls surrounded the outcrop, and dropped down to a sandy sea bed at about 18m. On the walls, forest kelp gave way to brown prickly weed and sugar kelp from about 10 m. The vertical walls were plastered with pink encrusting alga, often growing over keel worm tubes and with a covering of fluffy filamentous red alga. Sea hares seemed to be everywhere, and common urchins, hermit crabs and common starfish were frequently seen.

The sediment sea bed was of coarse sand with many shell fragments. There was no burrowing life apparent since the sand was probably quite mobile, but a few fish were seen here: an angler fish at the base of the rock, a dab on the sand, also some juvenile cod-like fish, and a school of saithe in the water column.

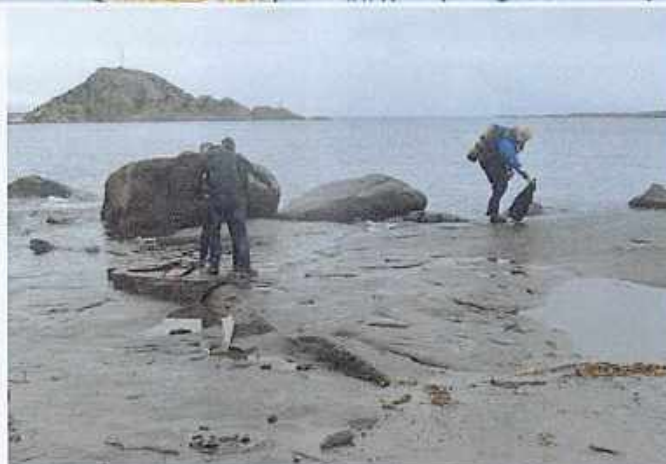
Fig 18. Chart showing location of the four dive sites in the Reine area. Entry point for shore dive at Reine Rocks over smooth bedrock and boulders.

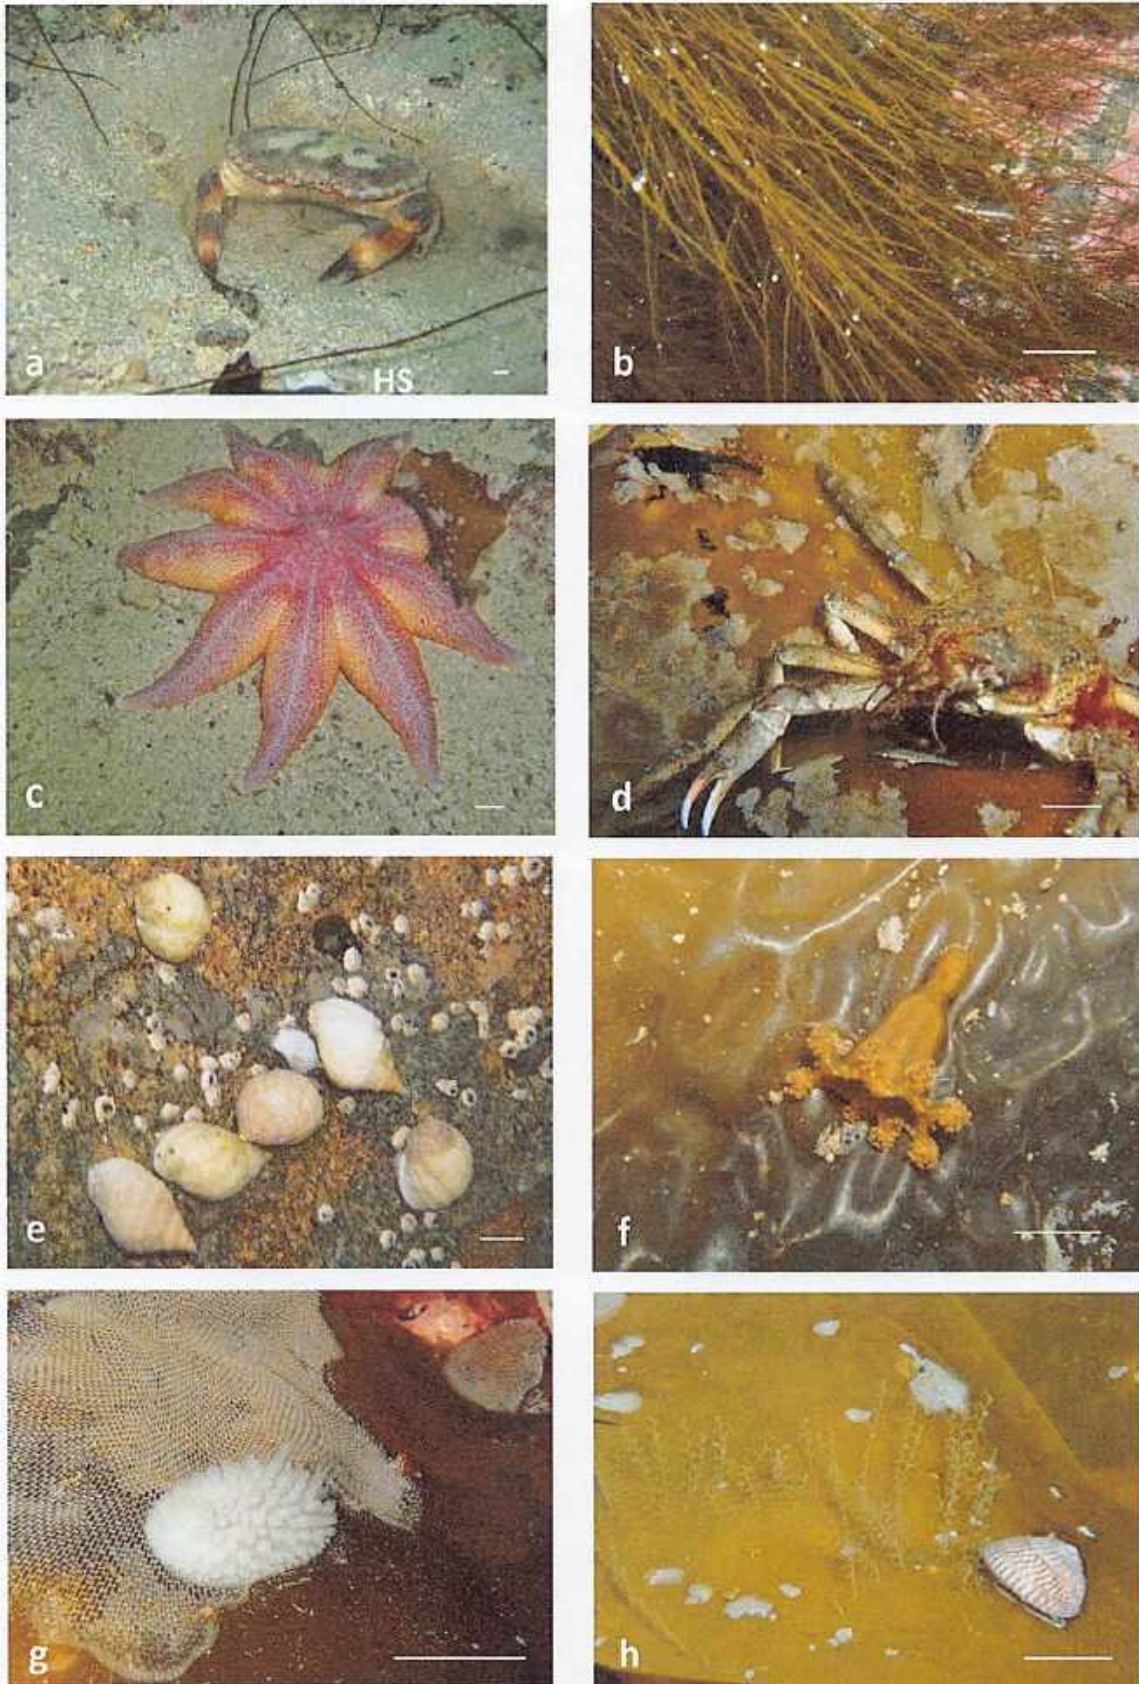
Fig 19. a) edible crab in sand hollow, b) brown prickly weed, c) purple sunstar, d) spider crab, e) barnacles and dog whelks, f) stalked jellyfish on kelp frond, g) nudibranch *Onchidoris* feeding on sea mat, h) top shell and hydroid *Obelia* on kelp frond. (White lines indicate approx. 10mm scale)

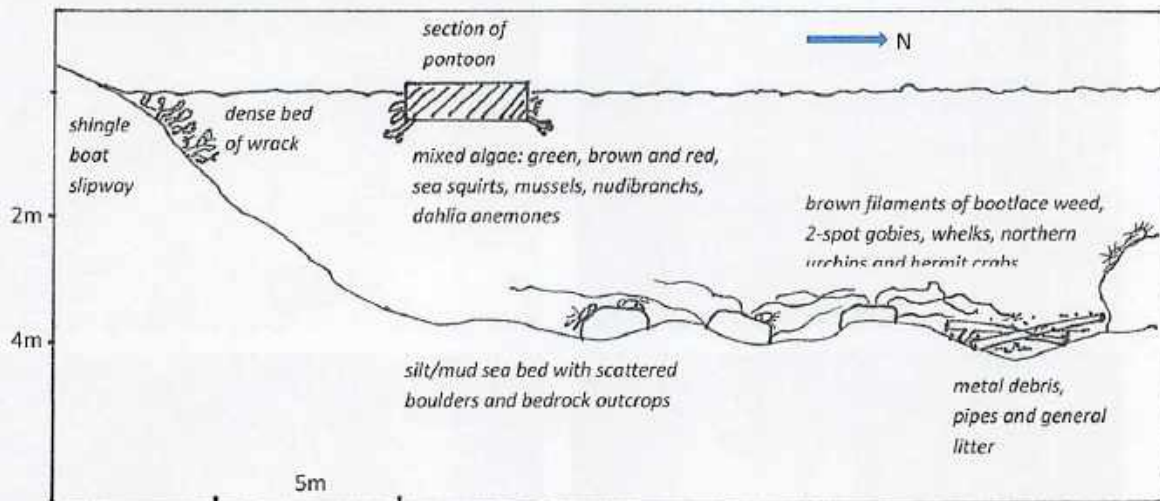
Fig 20. Harbour profile showing shallow sea bed and section through pontoon.

Life on the pontoon was rich and varied. Seaweeds present included green and red filamentous algae, and brown seaweeds including wrack and sugar kelp. Transparent yellow-edged sea squirts, dahlia anemones, two species of nudibranchs (*Coryphella* and *Dendronotus*), and common mussels could all be seen on the pontoon, also a small juvenile lump sucker. This habitat is easily observed from on top of the pontoon or by snorkelling.

Heading in a northerly direction, round the boat jetties and harbour wall, the sea bed was undulating with boulders, bedrock outcrops and a soft muddy sediment. Much litter and debris was in evidence. Visibility was good, given the location, and was reported to be about 8m. Long brown filaments of the bootlace weed were common draped over rocks and across the sea bed and burrowing in the sediment were eyelash worms. Pink encrusting alga was present on hard surfaces, and the northern urchin was common on rocks and boulders, as were hermit crabs and common whelks. Some of the hermit crabs were carrying parasitic anemones and hydroids on their shells.

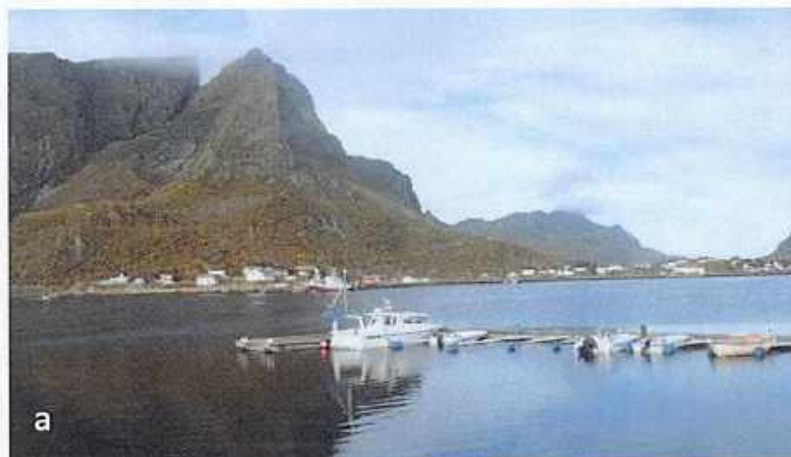
Fig 21. a) View of Reine Harbour looking north, b) harbour seabed with rock outcrops, soft sediment, bootlace weed and hermit crabs, c) hermit crab with parasitic anemones, bootlace weed, knobbly pink calcareous alga and plastic debris. On pontoon: d) dahlia anemone, e) yellow-edged sea squirt and common mussels, f) *Coryphella nudibranch* on green seaweed, g) *Dendronotus nudibranch*. (White lines indicate approx 10mm scale).

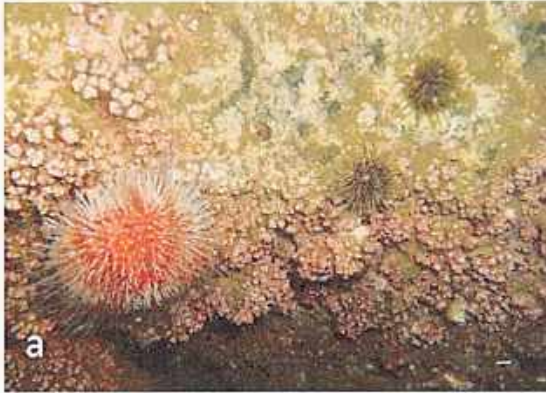
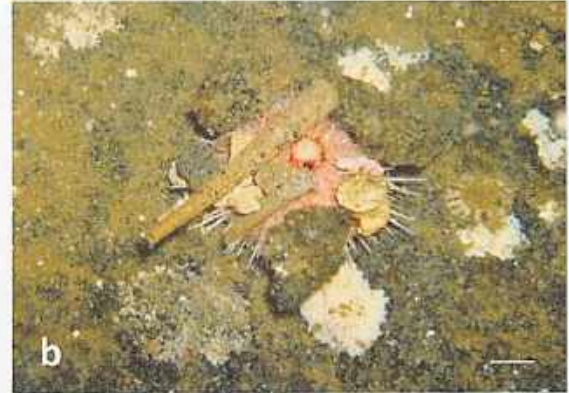
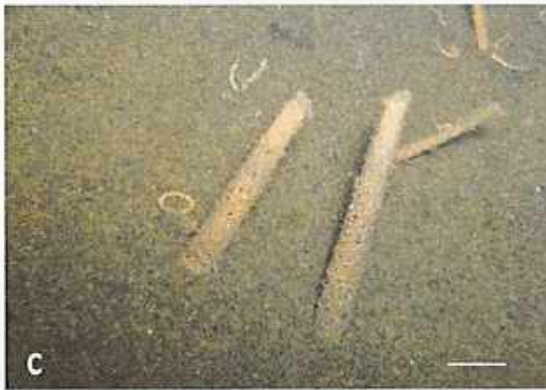
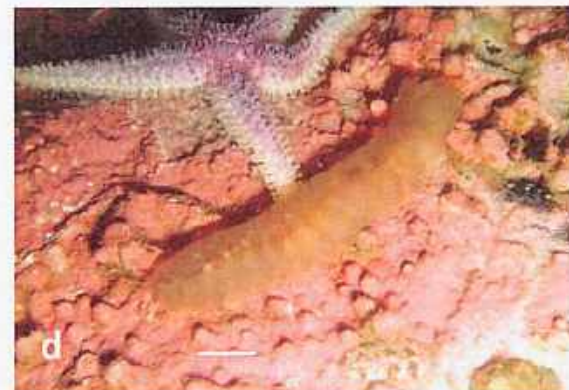
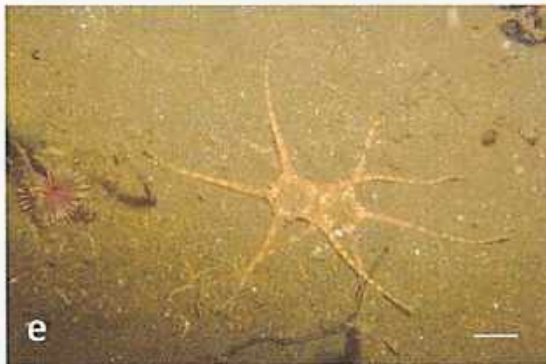
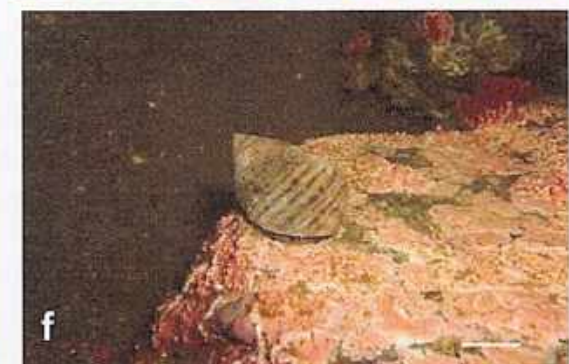
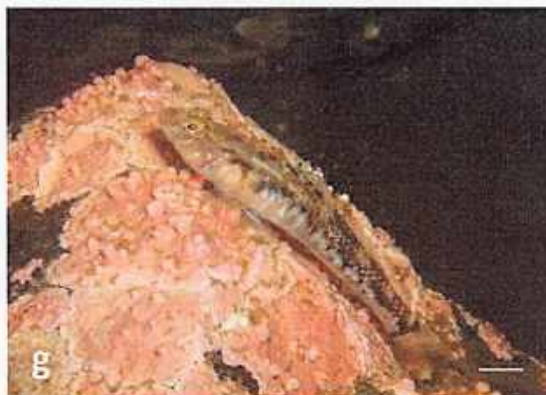
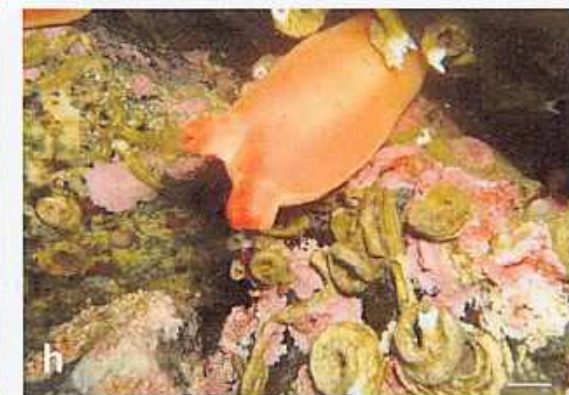
Fig 23. a) common and northern urchins, b) small urchin well-camouflaged by shells, bristle worm tube and other debris, c) bristle worms in fine silty sediment, d) jelly worm with starfish *Leptasterias*, e) sand brittle stars, eyelash worm to left, long thin *Phyllodoce* worm at bottom, f) periwinkle on pink encrusting alga, g) painted goby, h) orange solitary sea squirt, i) proliferating anemone, arms of black brittle star, j) northern prawn, k) hermit crab in shell of flat periwinkle, l) common whelk, and keel worms on rocks, m) intertidal barnacles, tiny goby near top of image, n) knotted wrack. (White lines indicate approx. 10mm scale)

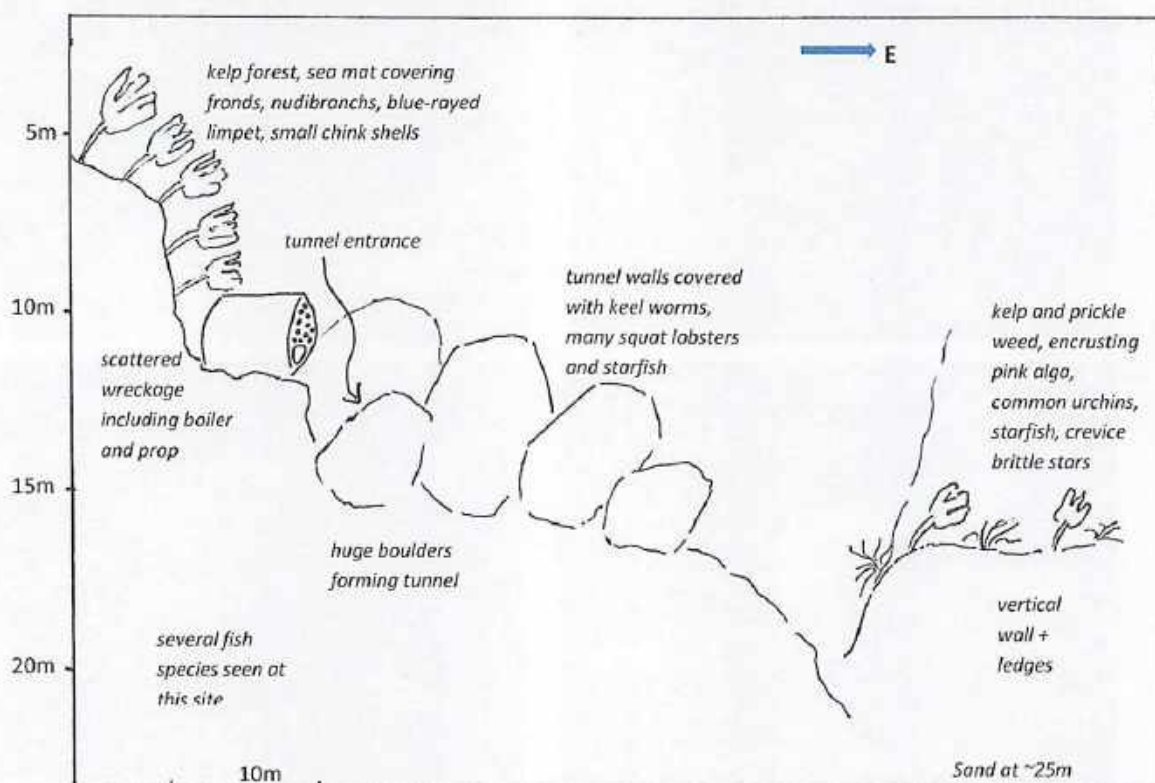
Fig 24. Diagram to illustrate main features of the tunnel dive

The dive starts at the head of this small bay to the west of the entrance to Nusfjord harbour, dropping into kelp forest at about 6m. This site was very rich in species, especially echinoderms, molluscs, crustaceans and fish. The kelp fronds were covered with sea mat and feeding on this were nudibranchs (*Polycera*, *Limacea*, *Onchidoris*) and the chink shell. Stalked jelly fish and blue-rayed limpet were seen attached to the kelp fronds, and juvenile lump suckers were observed. Squat lobsters, the keel worm and common star fish were present throughout the dive.

Within the tunnel the walls were covered with calcareous worm tubes, mainly the keel worm and *Hydroides*. Starfish seen in the tunnel included the common and purple sunstars, and the cushion star *Hippasteria*. Other creatures found in the tunnel included squat lobsters, edible crabs, dahlia anemones, scorpion fish and Norwegian topknot.

Beyond the tunnel, the walls and ledges were covered with forest kelp, prickly weed and encrusting pink alga. Another starfish species, *Stichastrella*, was observed on the wall and common urchins were present here. Fish species recorded included butterfish, scorpionfish, pogge and Norway redfish. In fact, of all the sites dived, the largest number of fish species

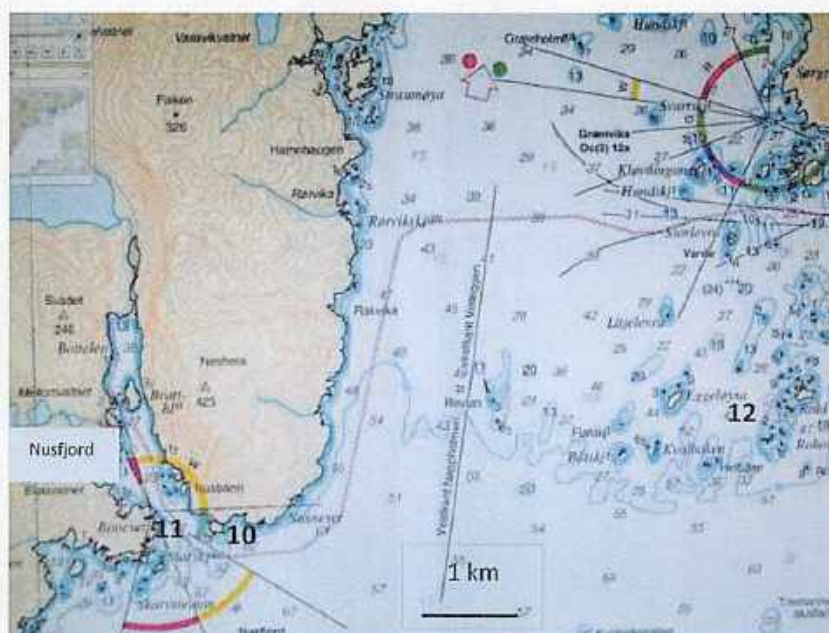
Fig 25. Chart to show location of sites near Nusfjord, and the wreck of the Karlshorst. a) shore crab, b) blue-rayed limpet on kelp frond, c) hermit crab in dog whelk shell, d) squat lobster.

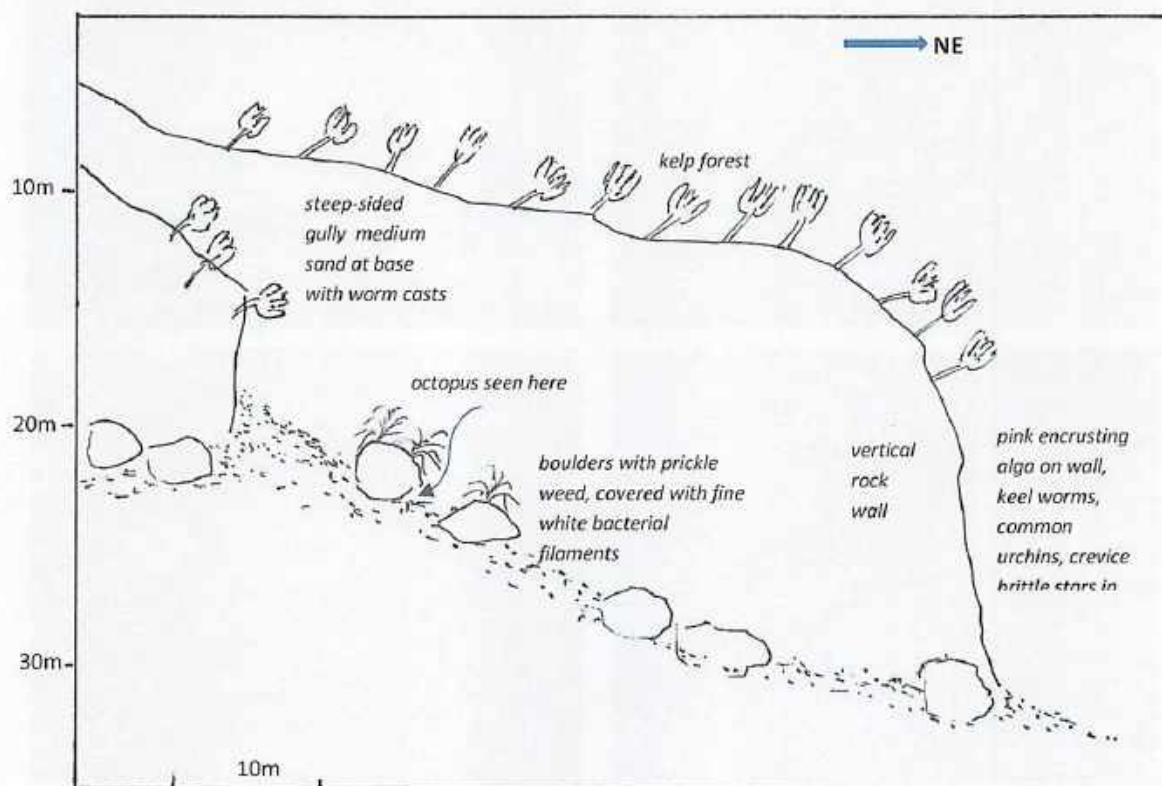
Fig 27. Diagram to illustrate profile and habitats of the lighthouse dive site.

At the base of the wall was a sandy slope and large boulders with prickly weed growing on them. At this point much of the brown alga and rock surface was covered with a network of fine white bacterial filaments. An octopus was spotted in about 18m, hiding in amongst small boulders. The vertical wall was, as usual, covered with pink encrusting alga growing over aggregations of keel worms and rock surfaces were frequently over-grown by a layer of fine red algal 'fuzz'. Common sea urchins were on the rocks and the arms of crevice brittle stars emerged from cracks in the wall. The edible crab and spider crab were recorded and two species of fish were seen here: short-spined scorpionfish and pogge.

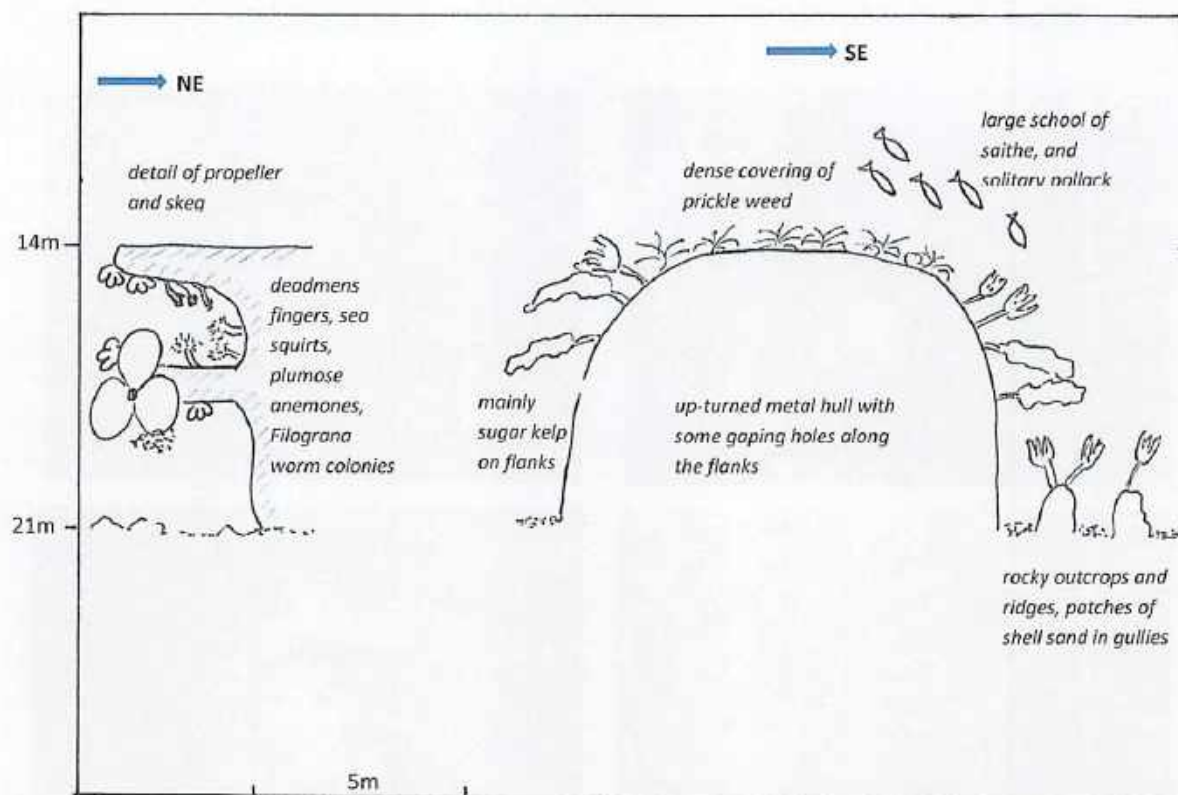
Fig 29. Section of wreck showing upside down hull, and detail of stern.

The MV Karlshorst was a German cargo ship, built in 1967 by Neptune Werft A.G. Rostock. She had a single diesel engine, single screw and a speed of 12kn. She was 92.93m long, 14m wide and had a hold depth of 7m.

The vessel was extensively salvaged and is now an empty hull. The vessel is upside down and all traces of the bridge have disappeared.
