BSAC West Midlands Regional Expedition Scheme

Lofoten Islands Expedition

Biodiversity Survey

Lofoten Wrecks

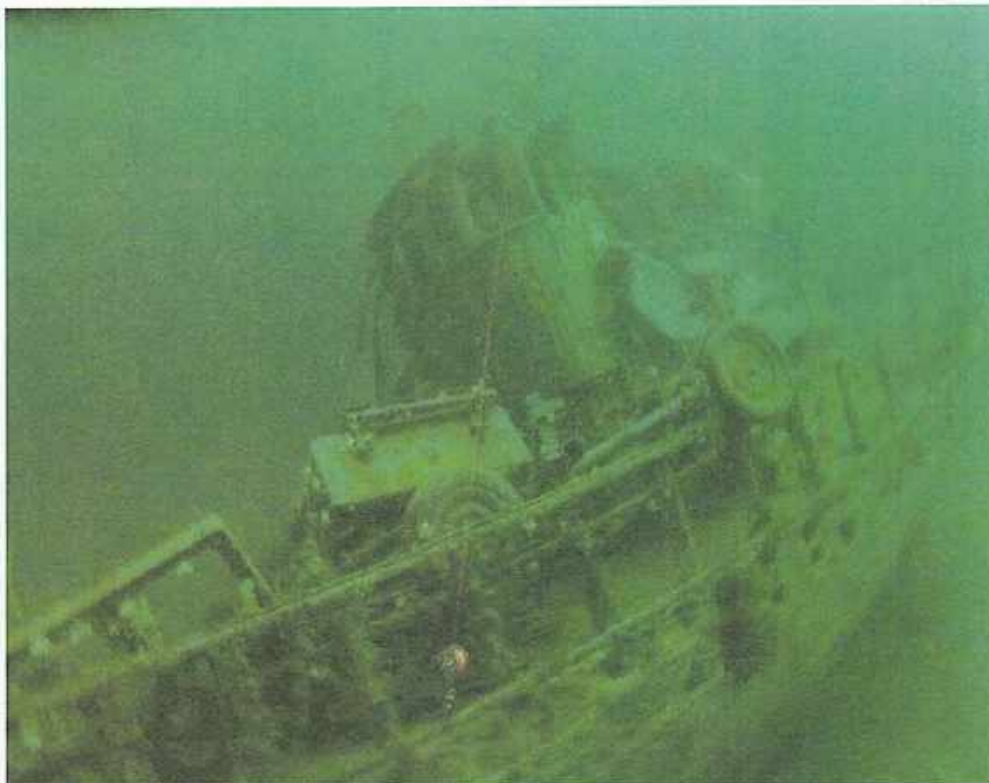
The two boats had been deliberately scuttled at the end of their working lives. It is against Norwegian law to scuttle worn out boats but it still happens, usually at night and in secret.

The large fishing vessel © Adam Stevens 2013.

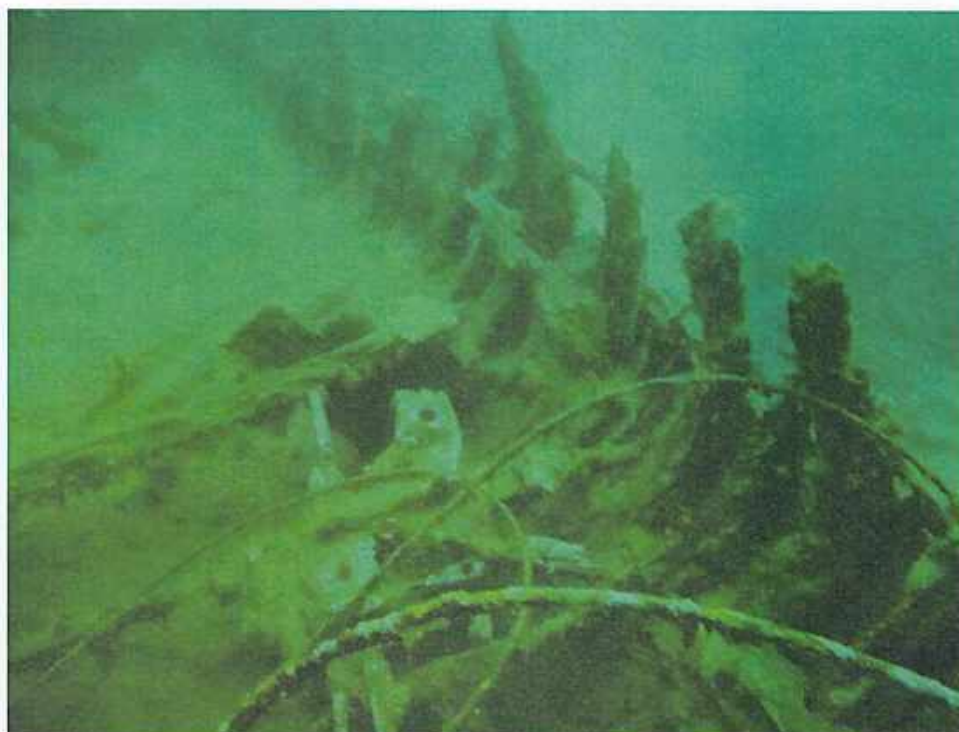
The smaller vessel lies close to the larger one. This was a small motorised fishing boat. She was open, with internal structure visible, lying on her port side. The port side disappeared into thick sediment and the frames on that side were damaged.

Parts of the engine were visible, indicating a simple Petter type engine. Pipe work and cables were evident as were the propeller and rudder. She is more lightly built than the larger vessel and is quite fragile. Her frames are showing evidence of deterioration.

Smaller fishing vessel showing damaged frames © Harold Sach 2013

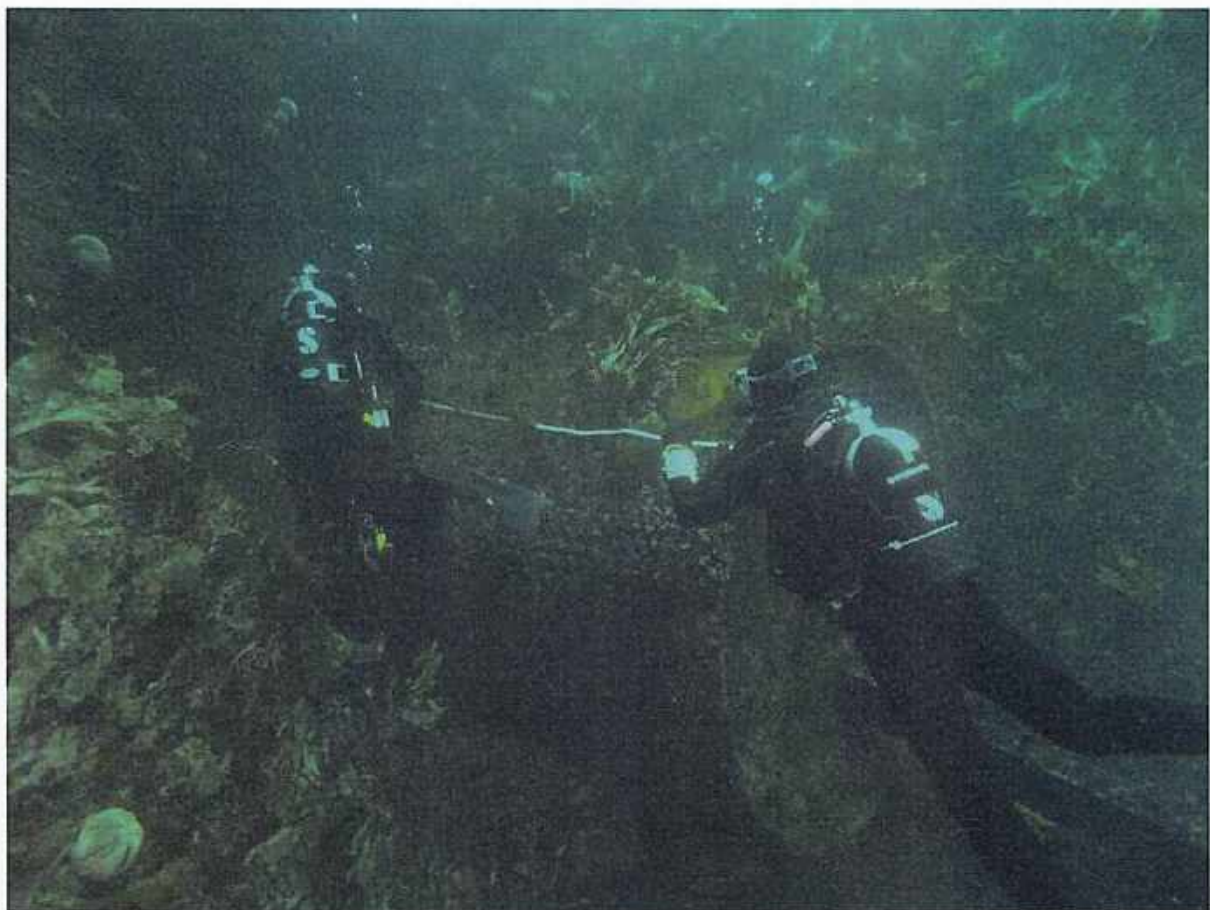
The Nero's remains consist of a boiler, propeller shaft, and scattered structure in a rocky, kelpy background.

Divers measuring the boiler © Jim Seymour 2013

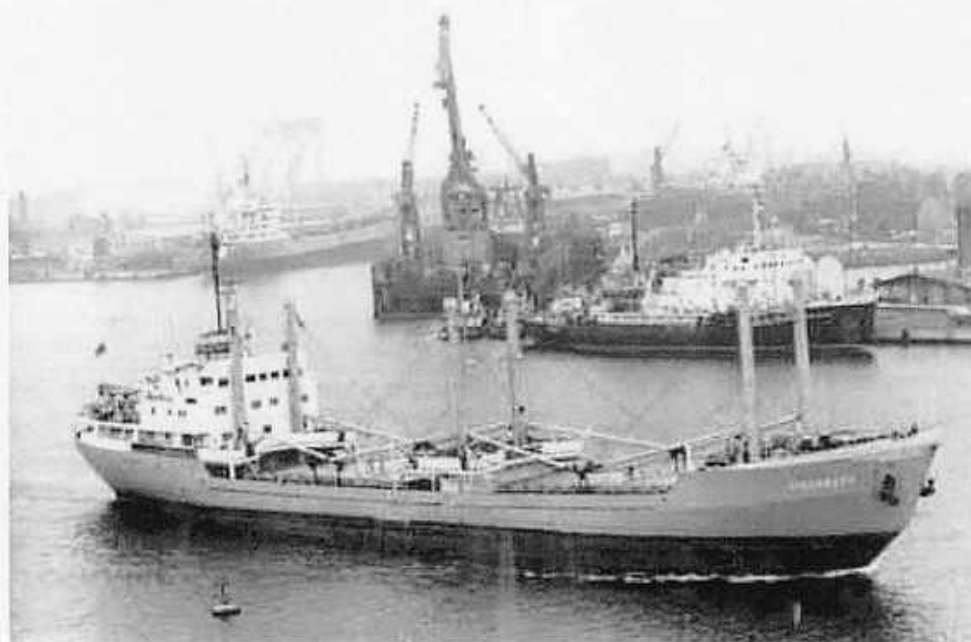
MV Hellerau. Sister ship of MV Karlshorst © Wrecksite Eu.

On 27th October 1977 she was lost off the Lofoten islands *en route* to Rostock from Archangel as her cargo of 3829 tons of wood shifted in bad weather and suddenly increasing seas. The crew were rescued, but the salvage tug Atlas was lost because of damage sustained during the tow. The tug has not yet been located.

The vessel was extensively salvaged and is now an empty hull. The vessel is upside down and all traces of the bridge have disappeared.

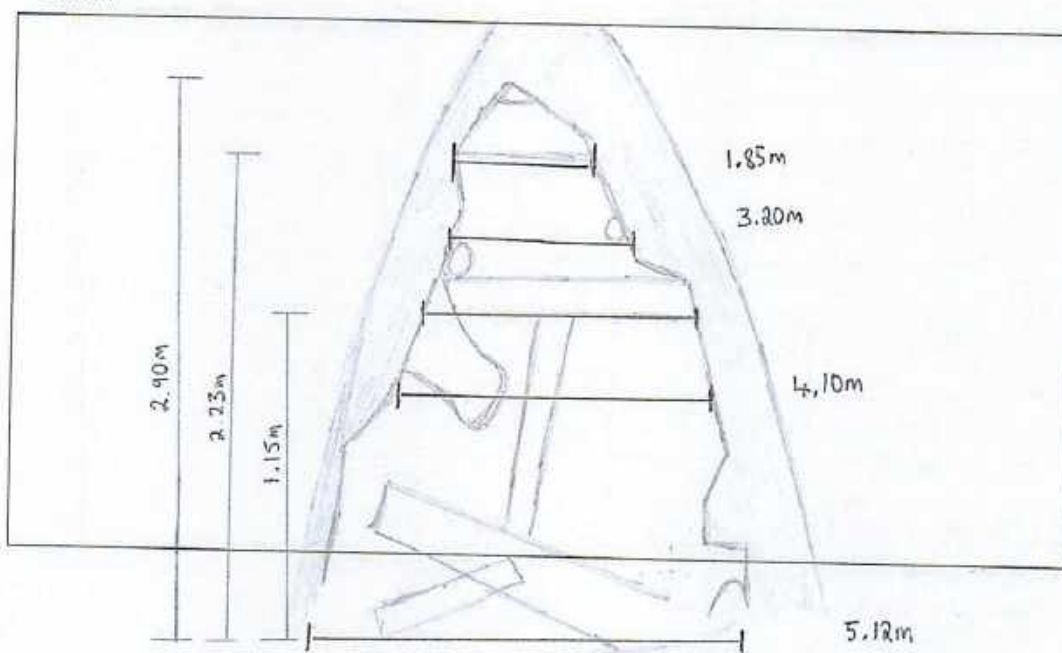
Summary of survey on MV Karlshorst

Task/objectives:	<u>SKETCH AND MEASURE THE EXTENT OF THE DAMAGE TO THE BOW AREA</u>
Outcome/procedures:	<u>ROUGH SKETCH OF BOW. MEASUREMENTS WERE TAKEN OF THE OPEN AREA AT THE SEA BED AND AT POINTS UP THE DAMAGED/ OPEN AREA AT POINTS WHICH COULD BE IDENTIFIED. A FINAL MEASUREMENT WAS TAKEN OF THE HEIGHT OF THE OPENING.</u>

It is clear that proper cutting equipment has been used to access the hull. The damage is not the sort that would happen if the holes had been caused by hitting the rocks. The team were briefed not to go inside the wreck. There was quite a lot of noise from plates and structure working inside the hull, so we stayed on the outside.

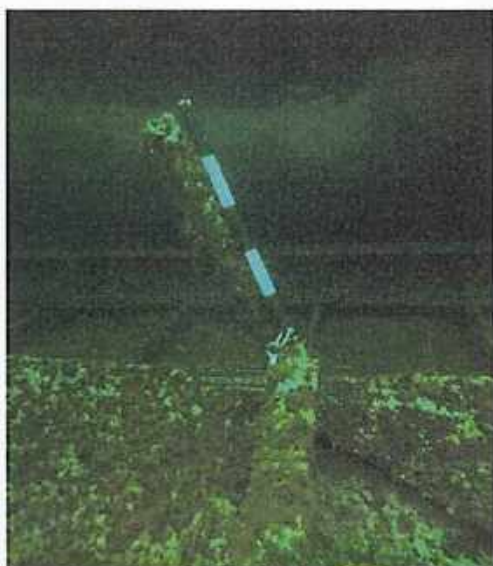
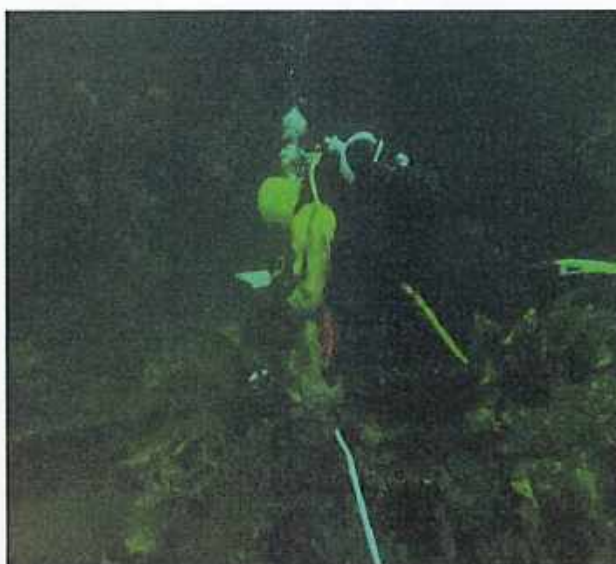
The visibility was good, and at 21m depth it was possible to stay down for some time. Marine life on the wreck tended to be short 'turf' and there were lots of fish using the wreck as a reef.

Recording structure on MV Karlshorst © Jim Seymour 2013
