Project report for the British Sub-Aqua Jubilee Trust

# Project Baseline Midland Pools

10<sup>th</sup> November 2021

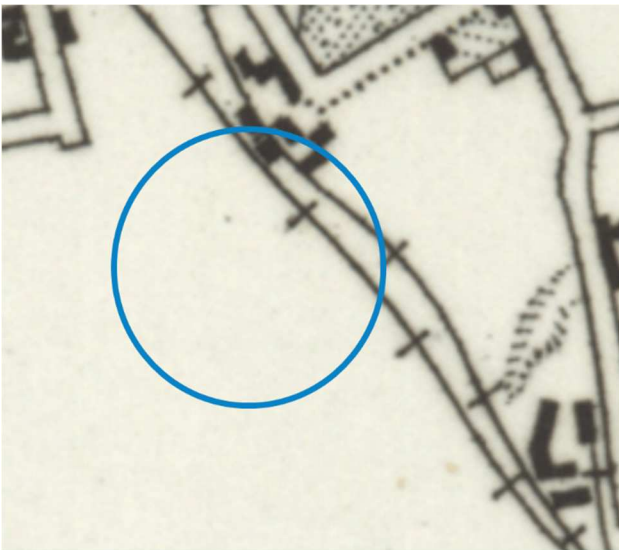
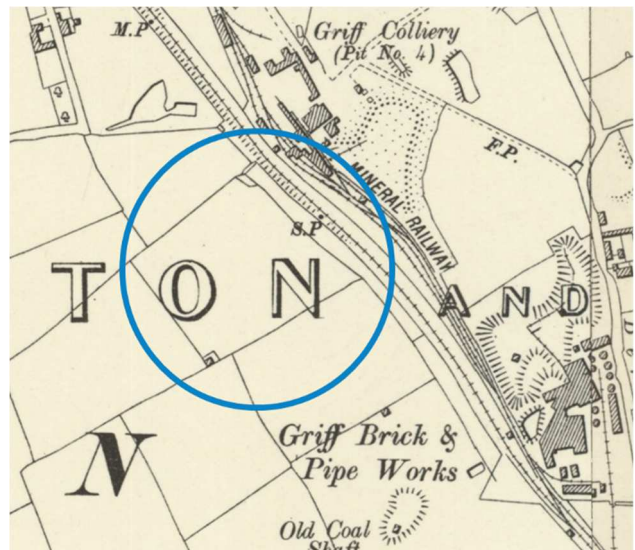
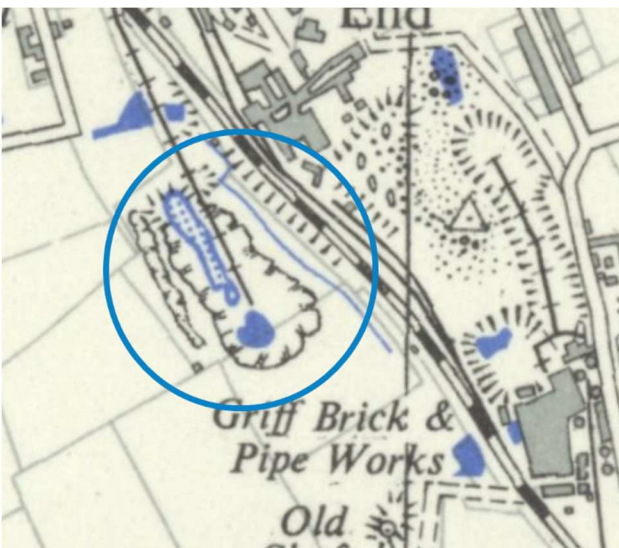
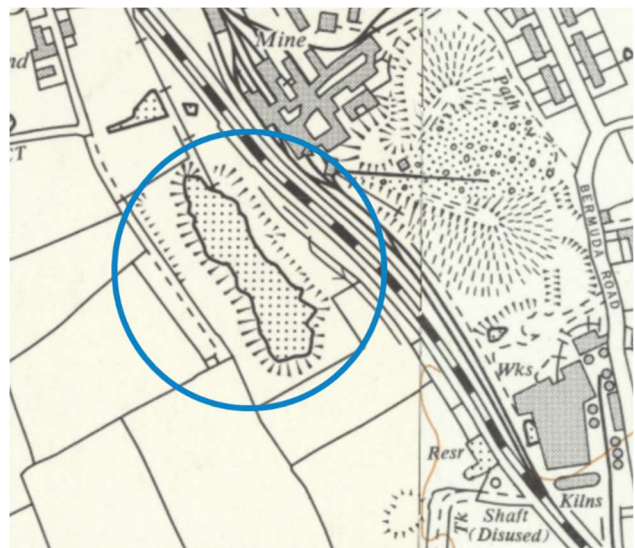
Maps (Figure 4 to Figure 7) show the evolution of the clay pit from its creation to partial flooding in the 1937–1961 map, to complete flooding in the 1949–1969 one. The blue circles are scaled and centred on the same point. A tramway can be seen going into the pit during its working life for extracted material. The L&NWR Griff Branch railway line and a mineral line ran close to the pit to the east.

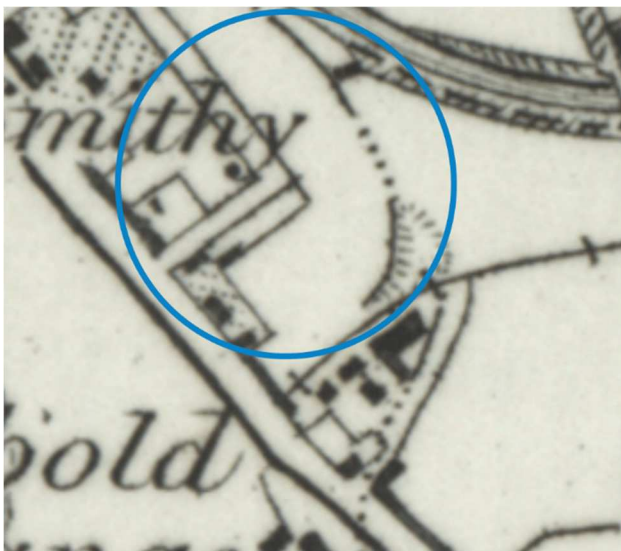
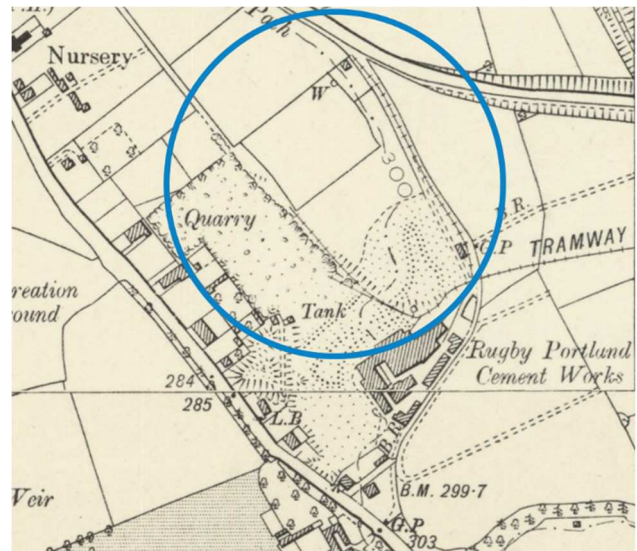
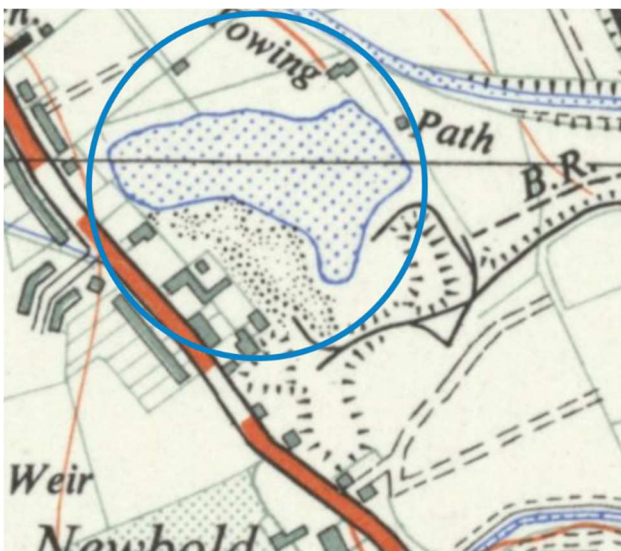
Maps (Figure 8 to Figure 10) show extensive excavation and backfilling of the quarry during its lifetime to its current flooded state. The blue circles are scaled and centred on the same point. Various tramways were in use at different locations during the quarry's working life that would have taken extracted material away to the Rugby Portland Cement Works for processing. A track runs to the north east of the quarry.

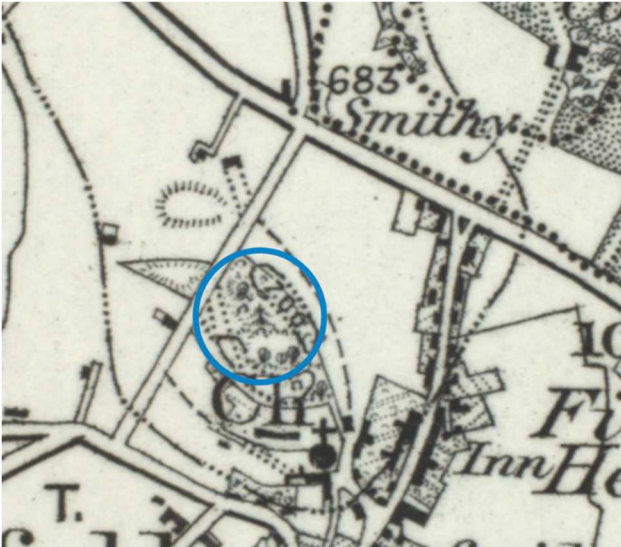
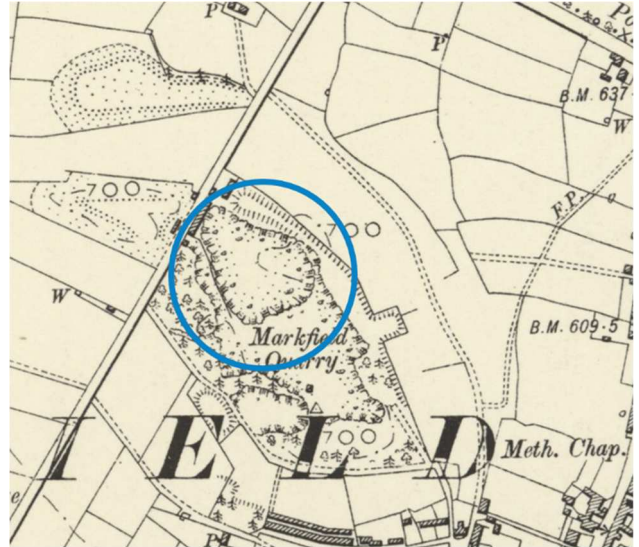
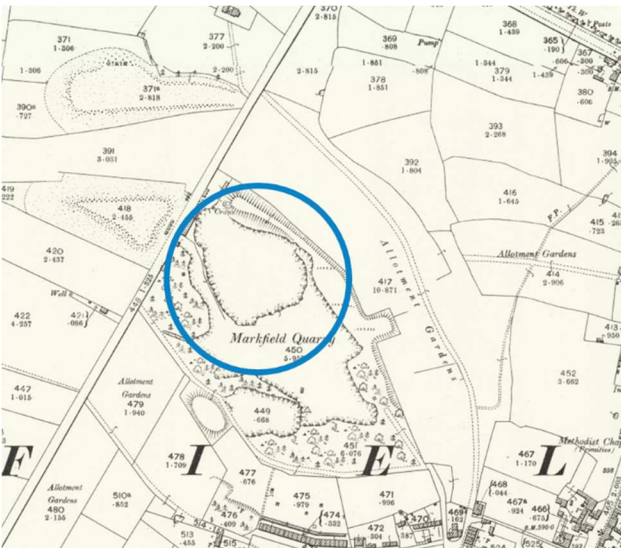
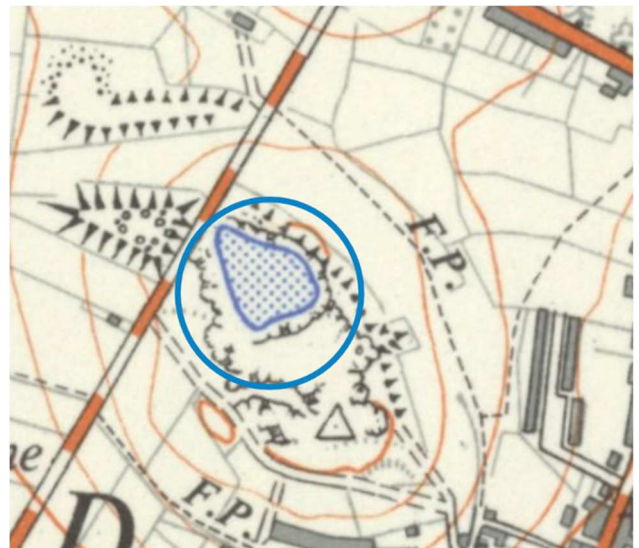
The earliest map from 1885–1900 (Figure 17) shows a wooded area where the quarry is today. In subsequent maps (Figure 18 to Figure 20) the quarry is apparent with a crane being marked to the north of the site in the 1892–1914 map (Figure 19). The 1937–1961 map shows the quarry to be flooded (Figure 20). The blue circles are scaled and centred on the same point.

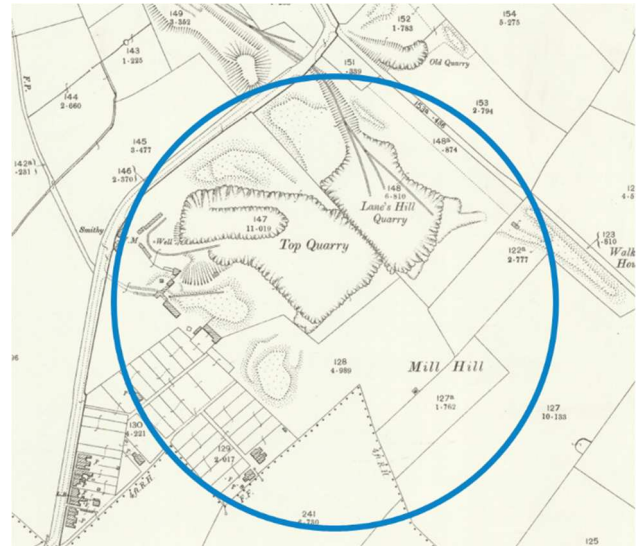
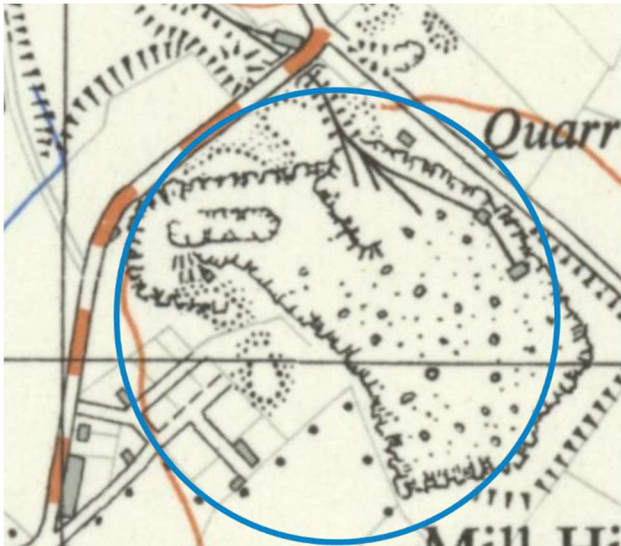
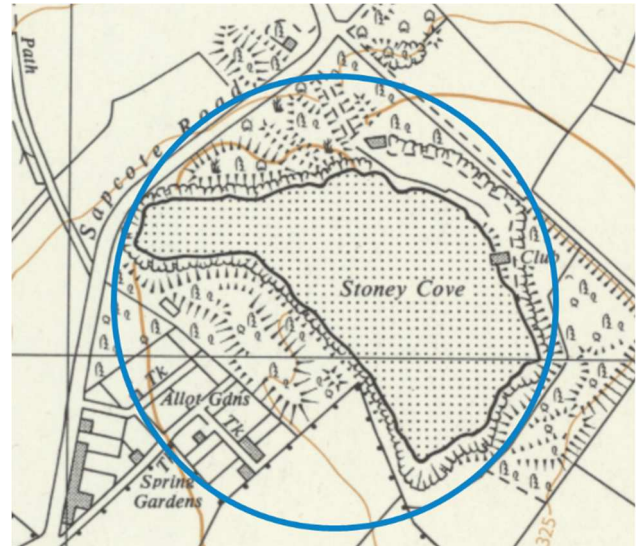
Stoney Cove began life as Top Quarry and Lane's Hill Quarry that remain separate in the 1888–1914 maps (Figure 21 and Figure 22) before merging and expanding to its current size in the 1937–1961 map (Figure 23). The blue circles are scaled and centred on the same point. The site is flooded and named Stoney Cove on the map of 1949–1969 (Figure 24). Tramway rails are visible running under the road to the north-east of the site and down what is now the access road and into to the Lane's Hill Quarry at the north of the site.

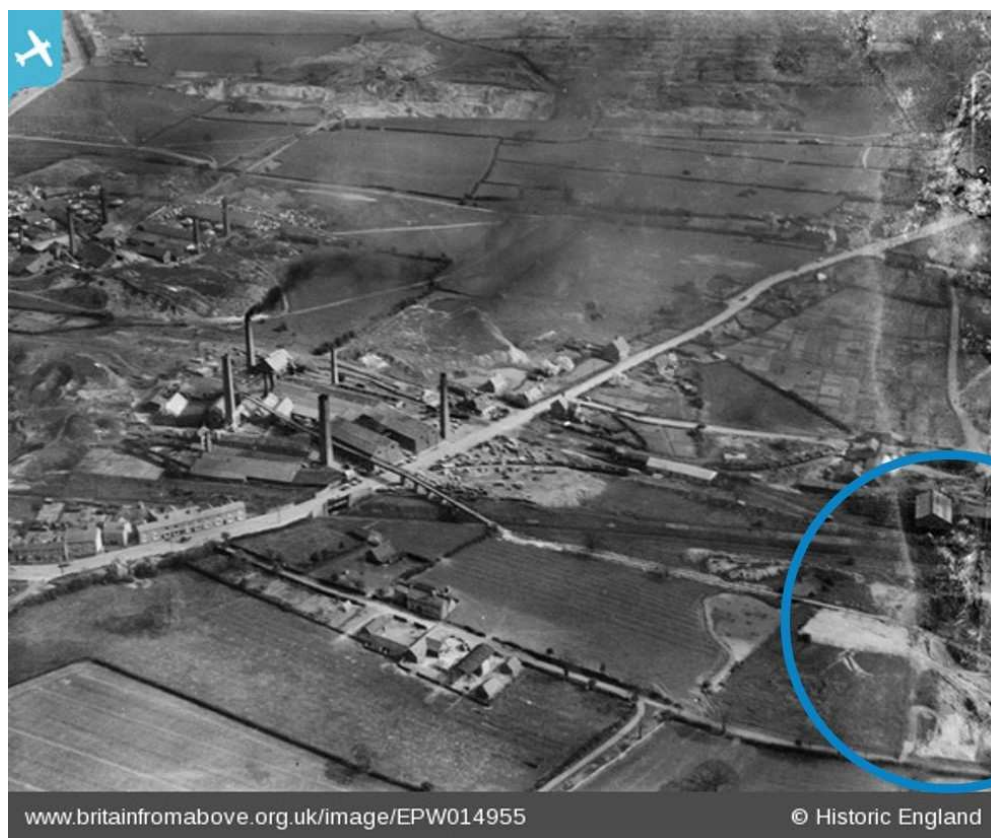
Figure 25 Stanley Brothers Brick and Tile Works showing the clay pit that would become Ensor's Pool, 1926.

- Ensor's Pool (Figure 25) showing the trackway entering the pit.
- Blue Pool (Figure 26) prior to it becoming a reservoir.

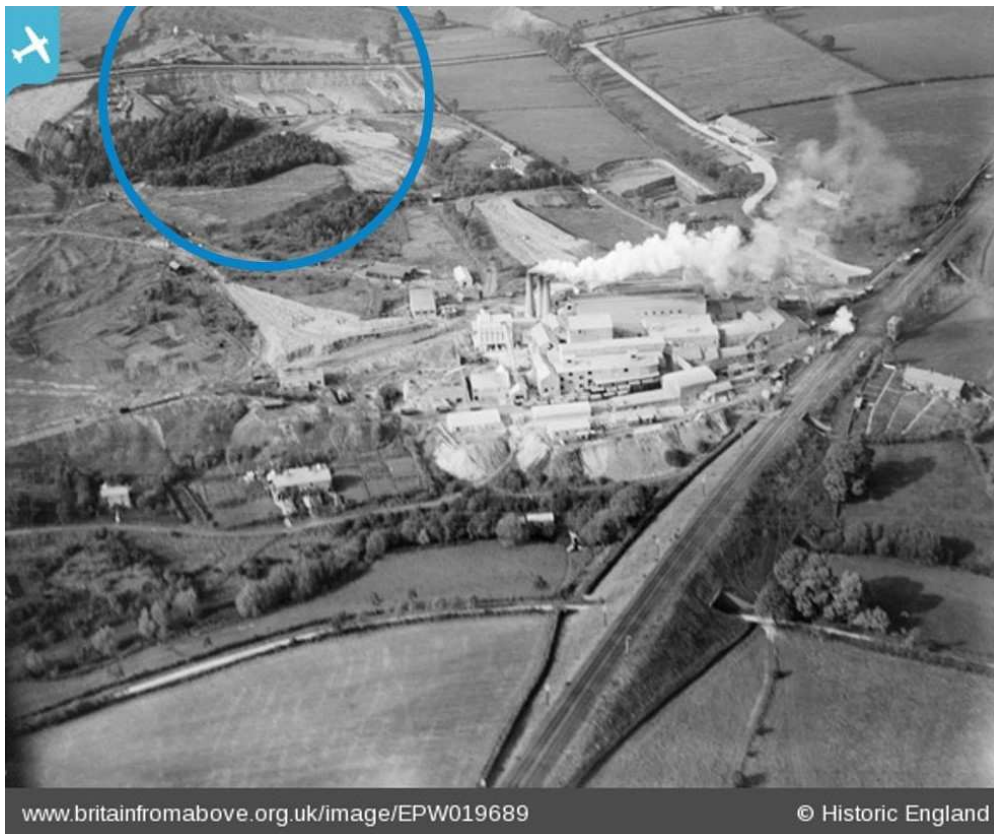
Figure 26 Greaves' Cement Works showing the quarry that would become Blue Pool, 1927.

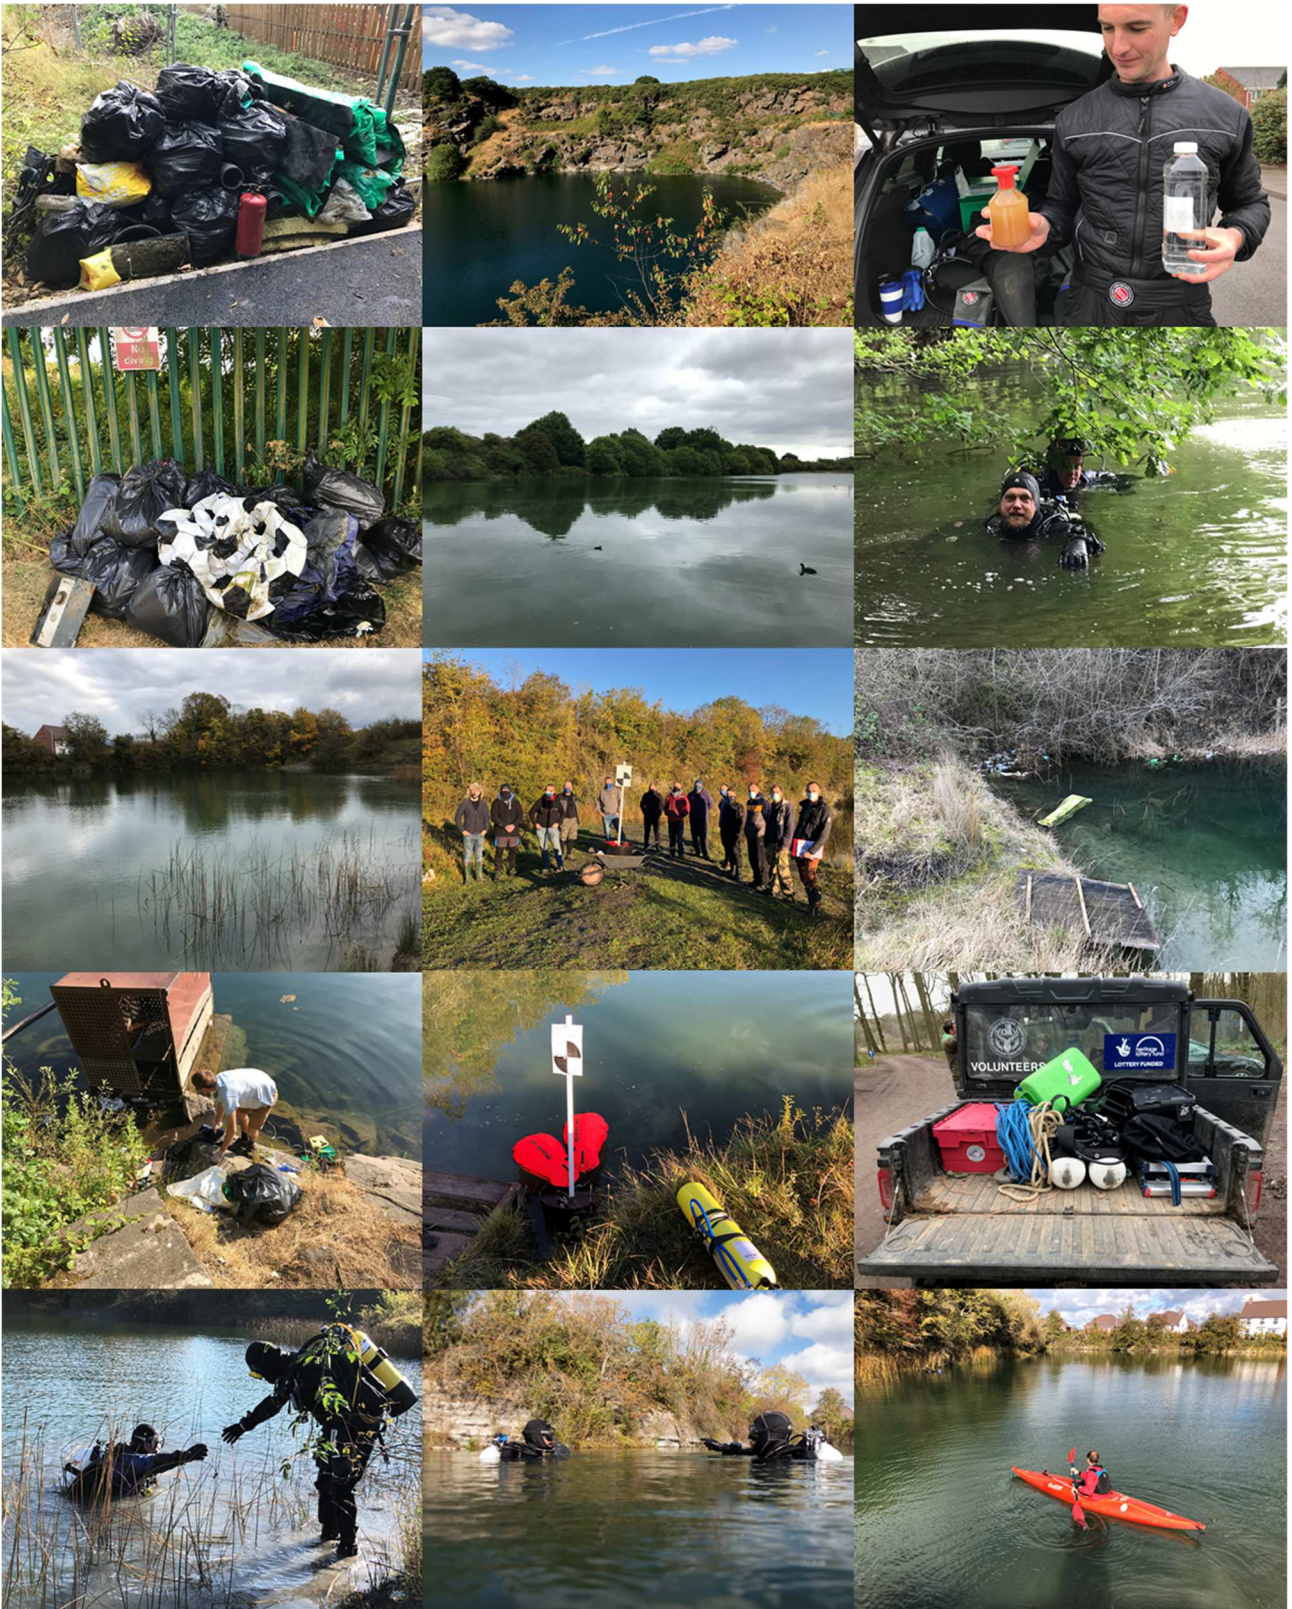
Figure 35 Photographs illustrating the diving activities.

Diving was carried out in accordance with the project risk assessment and method statement (Figure 35). [17] This was agreed with the landowners and other stakeholders. A written dive plan was developed for each day of diving and shared with the project team. For Sites of Special Scientific Interest (SSSIs) consent was obtained from Natural England through the site owners prior to diving.

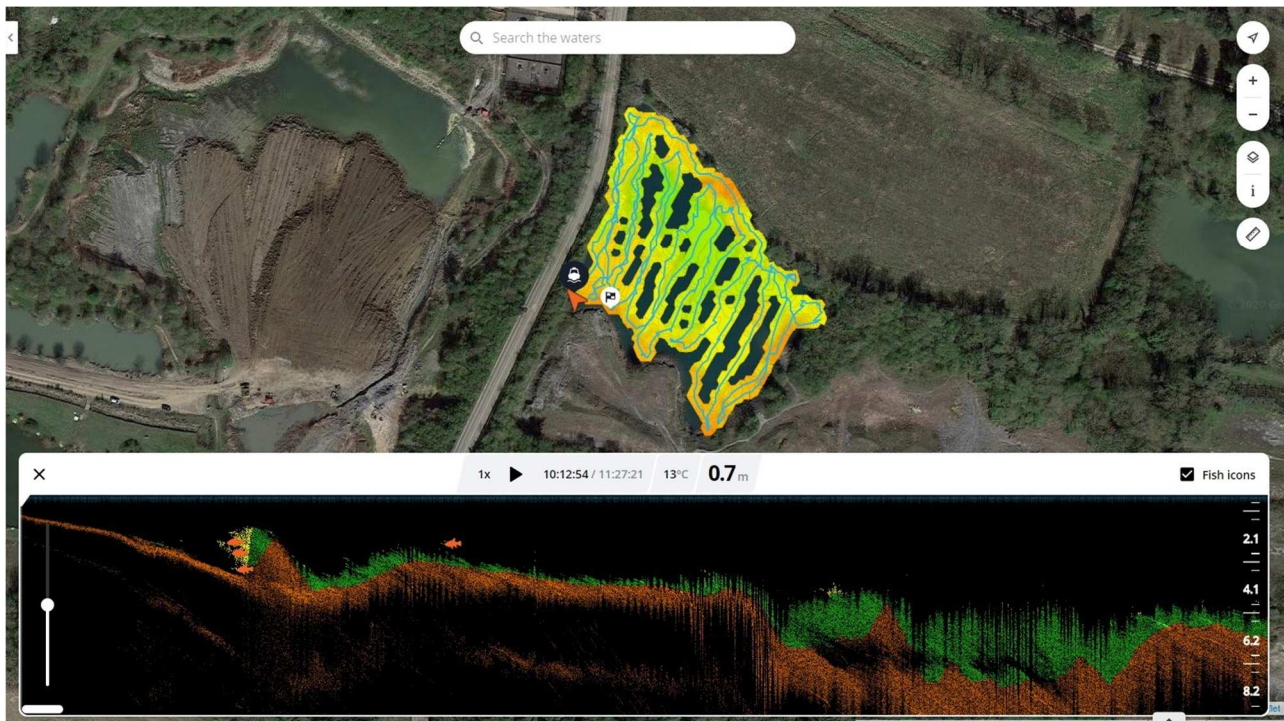
Figure 36 Blue Pool bathymetry data showing the route of the kayak across the water (blue line overlaying the map) and a depth profile (insert below).

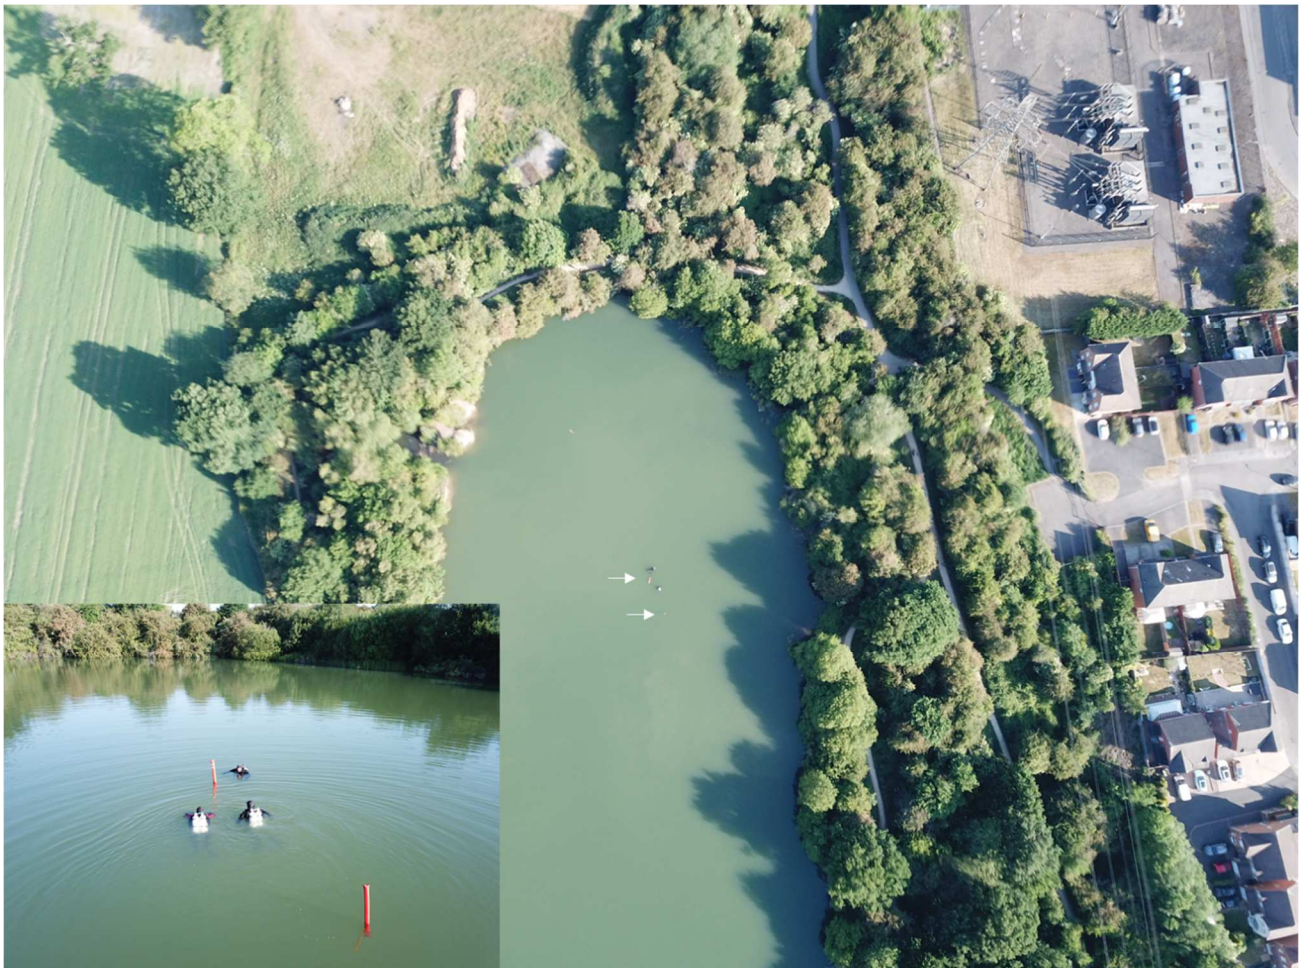
Figure 38 Ensor’s Pool (north-west at top of image) showing its location next to agricultural land, grassland and a housing estate to the east. The location of two submerged standing telegraph poles was temporarily marked by orange buoys (main image, white arrows and insert). The top 1–2 m of water is silty having been stirred up by swimmers over several days prior to the fieldwork.

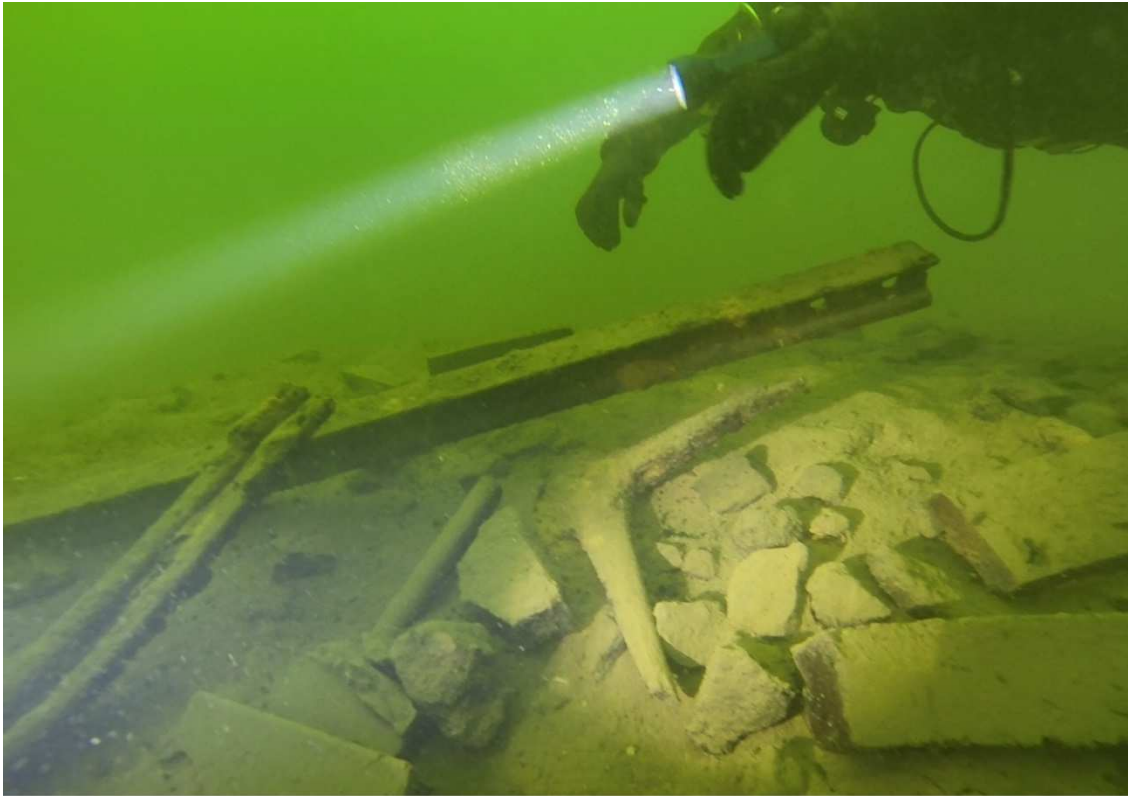
Figure 39 Diver examines artifacts in Ensor's Pool including a pickaxe head and tub rail. Rails may be stamped with a date of manufacture but this was not observed on the rails examined.

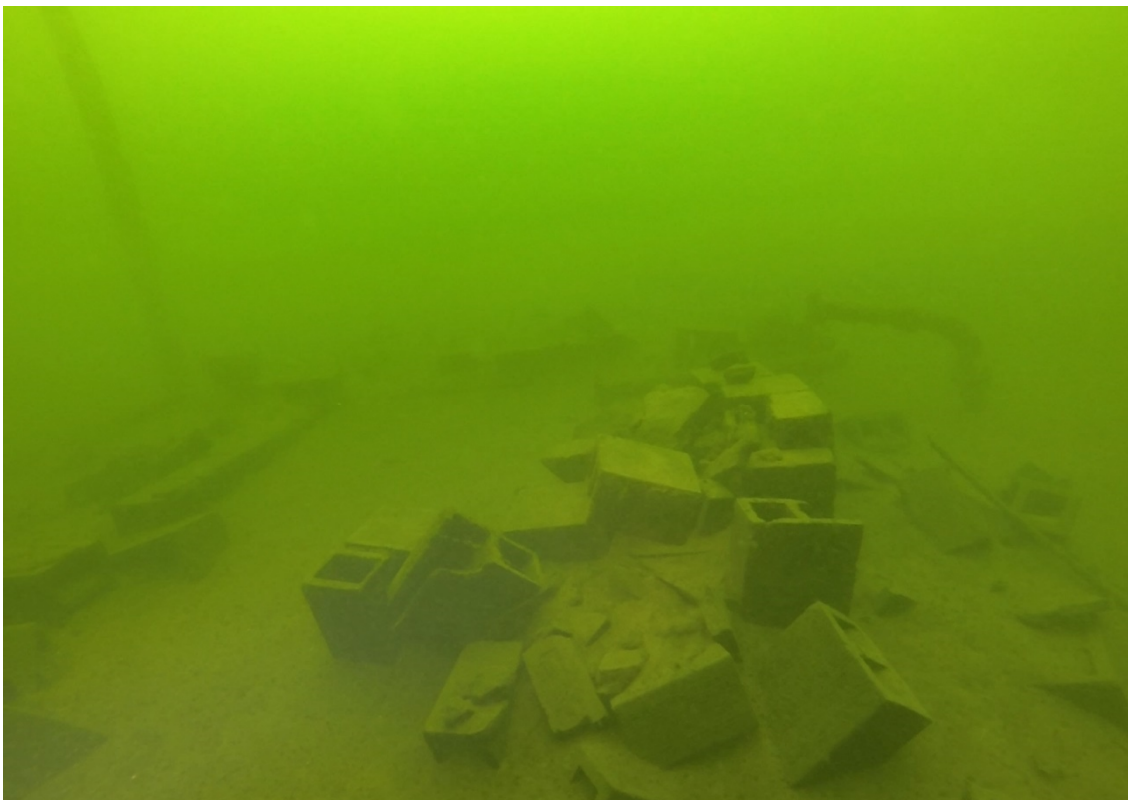
Figure 40 Telegraph pole, building blocks and pipework in Ensor's Pool.

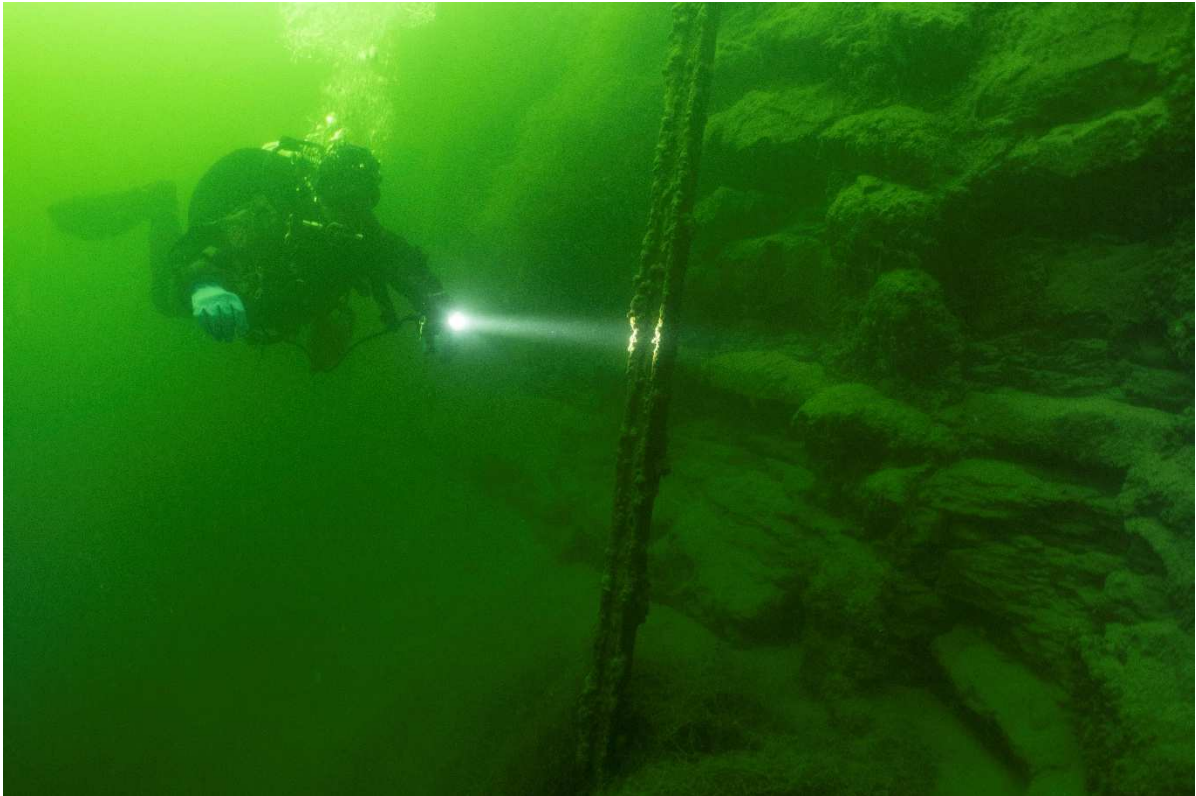
Figure 42 Diver examines the remains of one of a pair of rails at Newbold Quarry with layers of blue lias in the background.

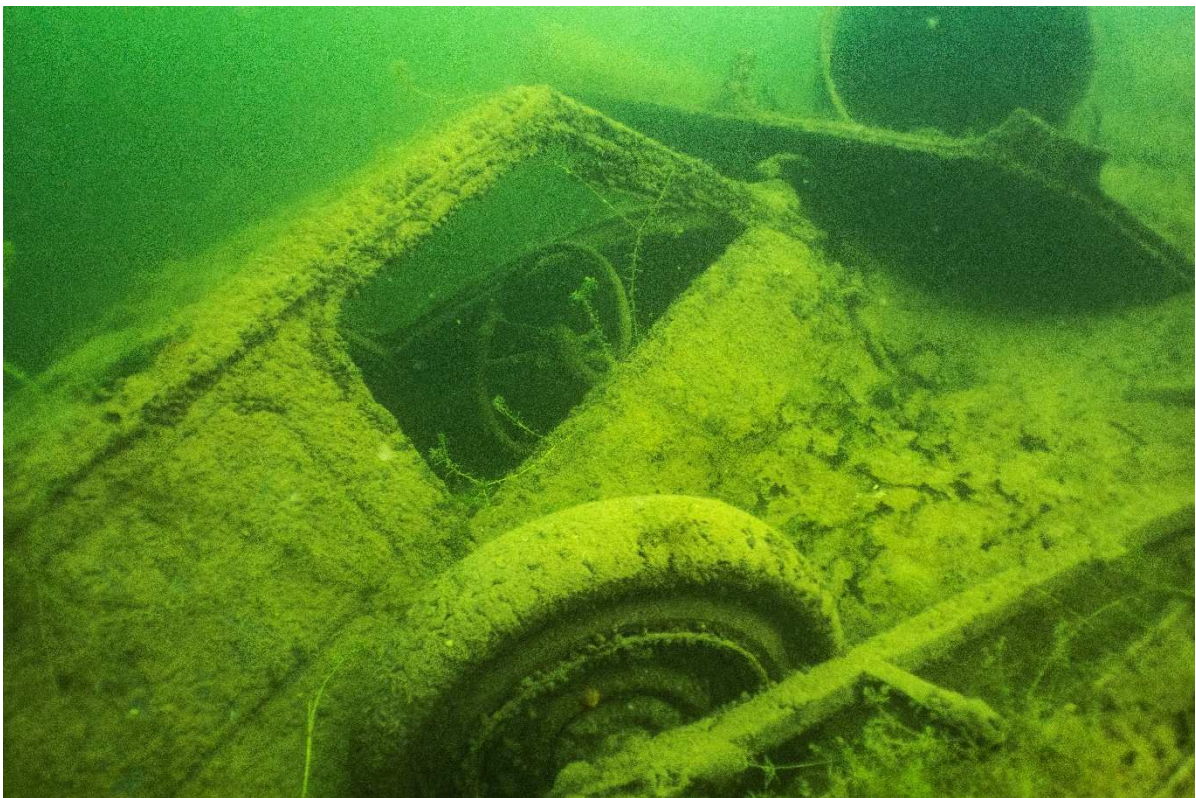
Figure 43 Remains of a car at Newbold Quarry.

Newbold Quarry contained the remains of a pumping barge and a small quarry building now mostly buried in silt. The quarry had high terraces providing variable depths. There was little litter but several vehicles that had presumably been pushed into the quarry from the path, formerly a road, above the east side of the quarry. The site was much improved during the project by the local residents' efforts with frequent litter-picks and the borough council's replacement of fencing. Hydraulic connections to other water bodies were apparent due to flooding over the winter months.

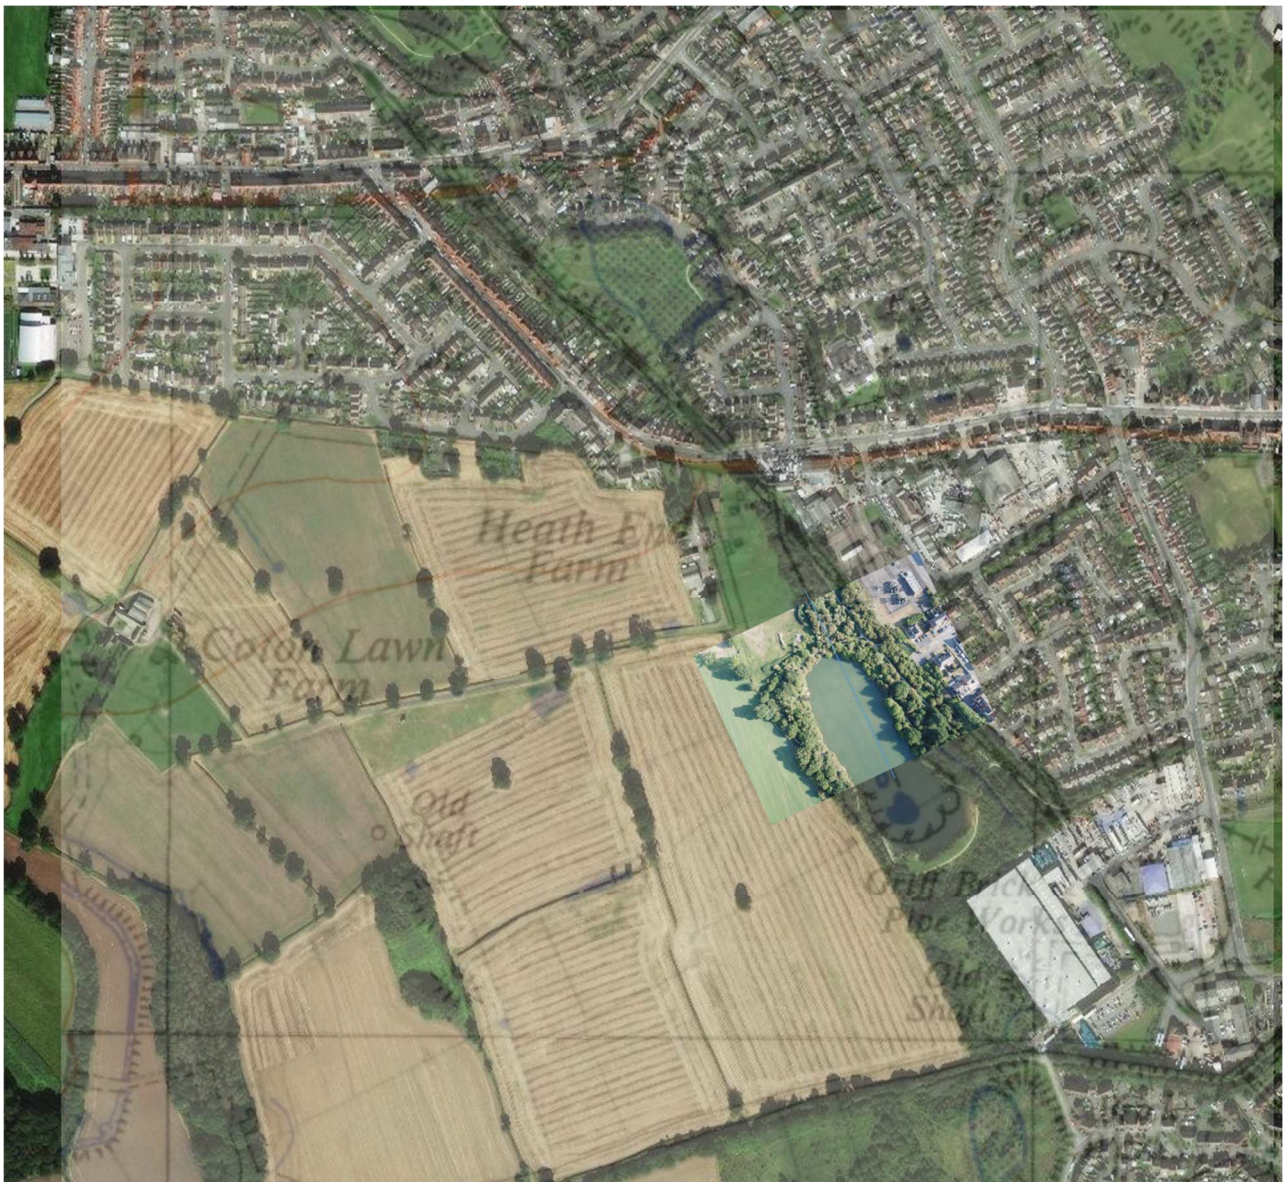
Figure 47 Combining the map of Ensor’s Pool from Figure 6, the drone image from Figure 38, and a modern satellite image helps identify the trackway (blue line) that remains within the water close to the two telegraph poles.

Combining a historical map, satellite and drone photographs revealed the likely location of a trackway, which was subsequently confirmed on the lakebed (Figure 47).

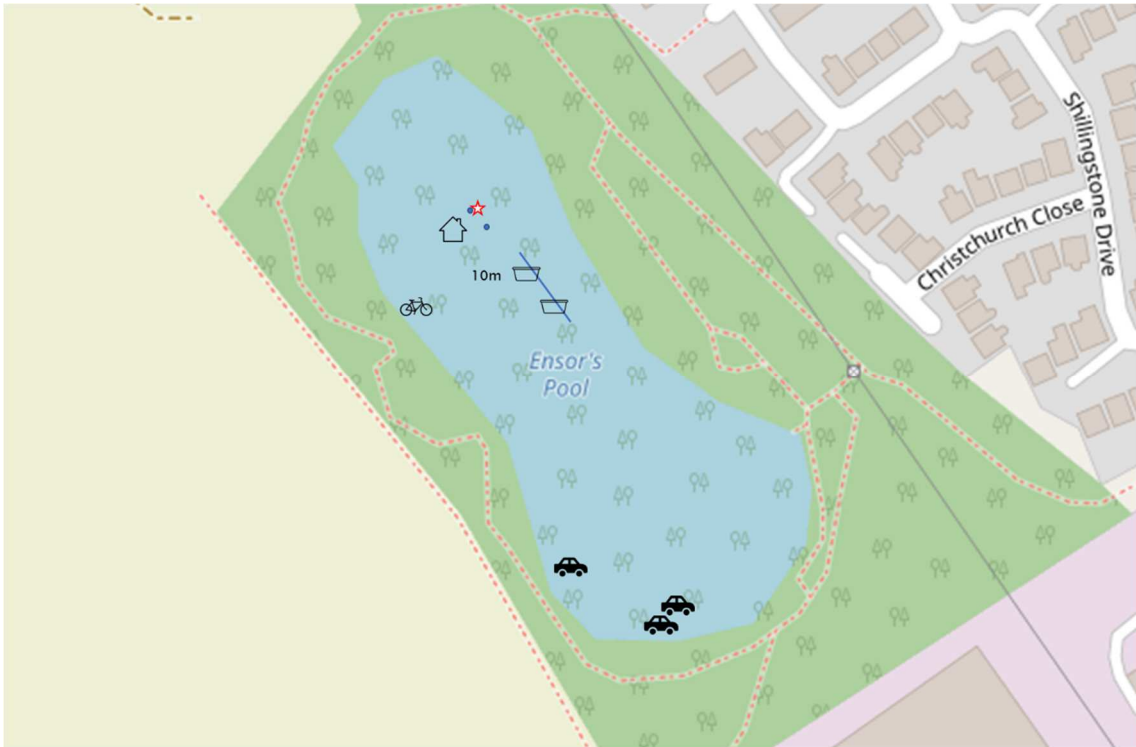
Figure 48 Sketch map of Ensor's Pool based on diver observations showing cars, and the remains of telegraph poles (blue circles), a building, and two tubs and rails. The location of the monitoring station is marked by a red star. [31]

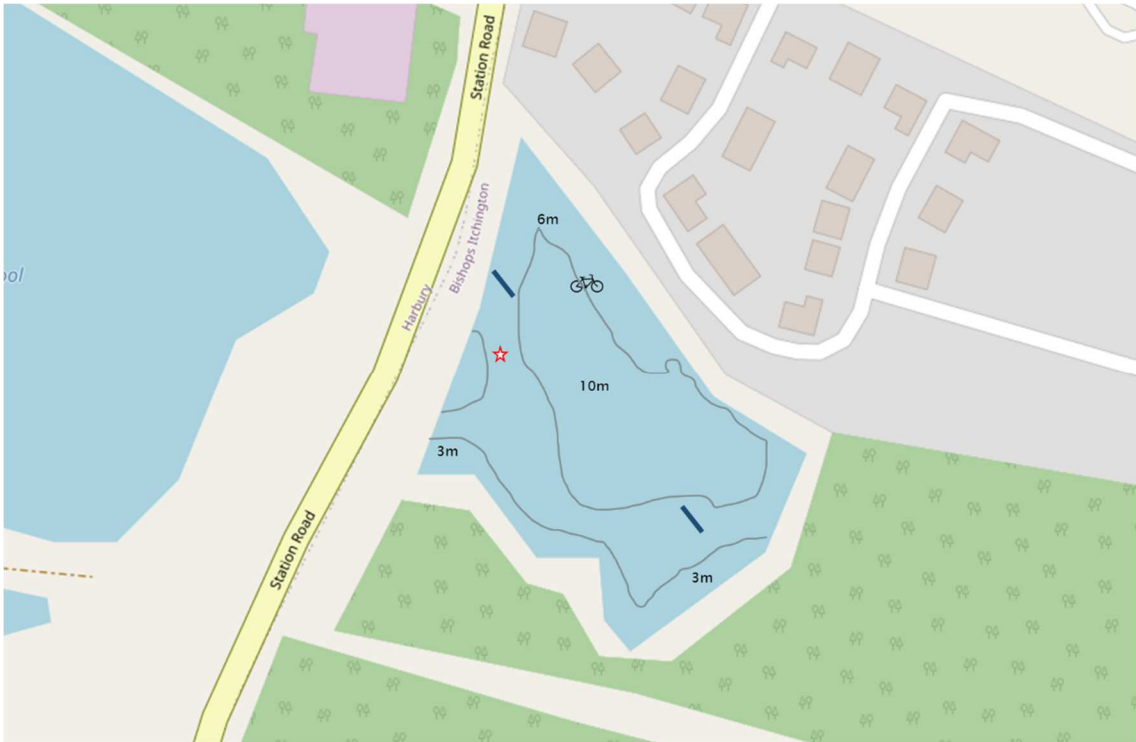
Figure 50 Sketch map of Blue Pool based on diver observations and bathymetry showing the remains of iron rails (blue lines). The location of the monitoring station is marked by a red star. [31]

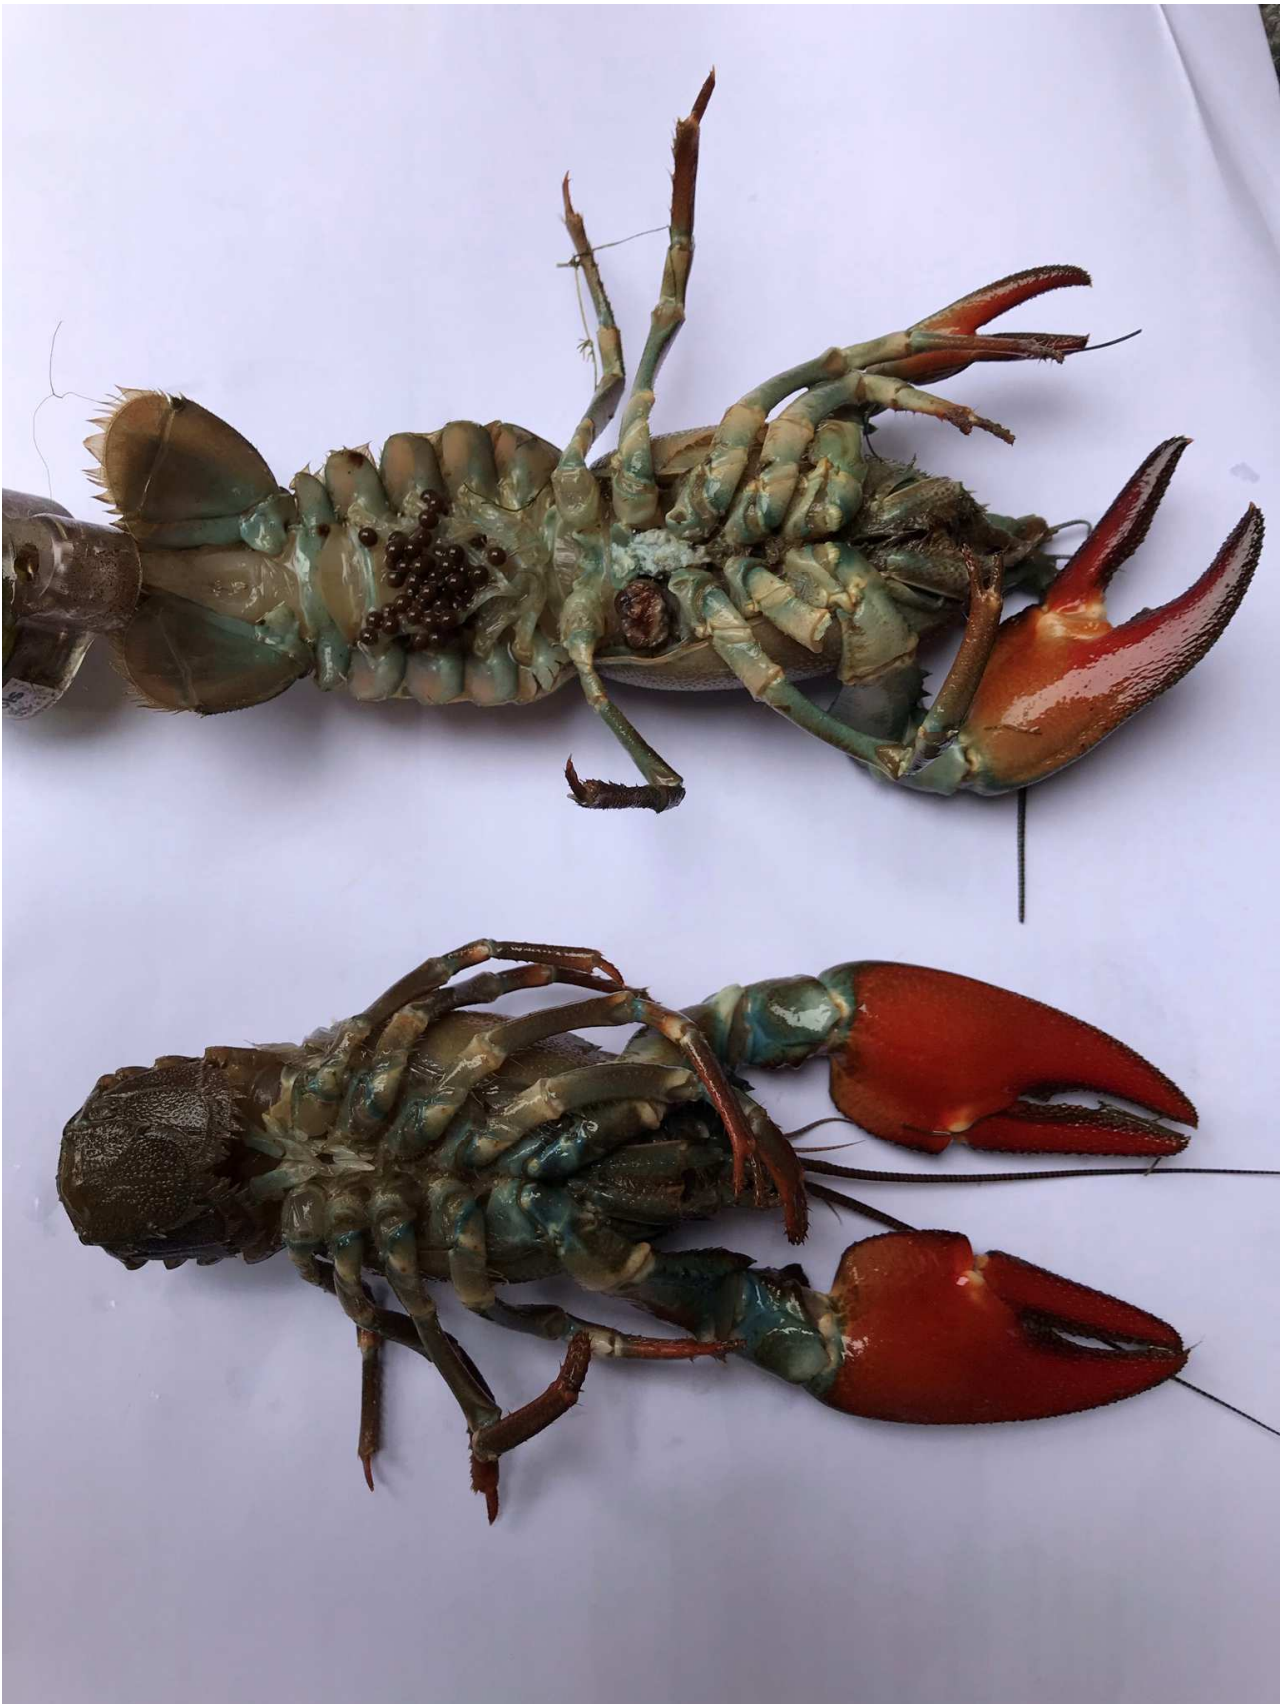
Figure 56 Signal crayfish (berried female, top, and male, bottom) from the water at Newbold Quarry (6<sup>th</sup> November 2021). The female's missing leg and adjacent white patch may indicate crayfish plague infection.

In October 2020 a dead signal crayfish was found on the bank at Blue Pool, however this species was not seen alive in the water. In November 2021 three signal crayfish were seen in Newbold Quarry for the first time. They were noticeably larger than the white-clawed crayfish that were also recorded on the same dive. Two signal crayfish were caught and so a positive identification was made (Figure 56). This is extremely bad news for the native crayfish population as these are never found living alongside signal crayfish for long. Further monitoring will be carried out to determine if the population survives. Although Newbold Quarry is close to the Oxford canal and signal crayfish are known to be able to migrate across land, [29] they have not previously been recorded in the canal.

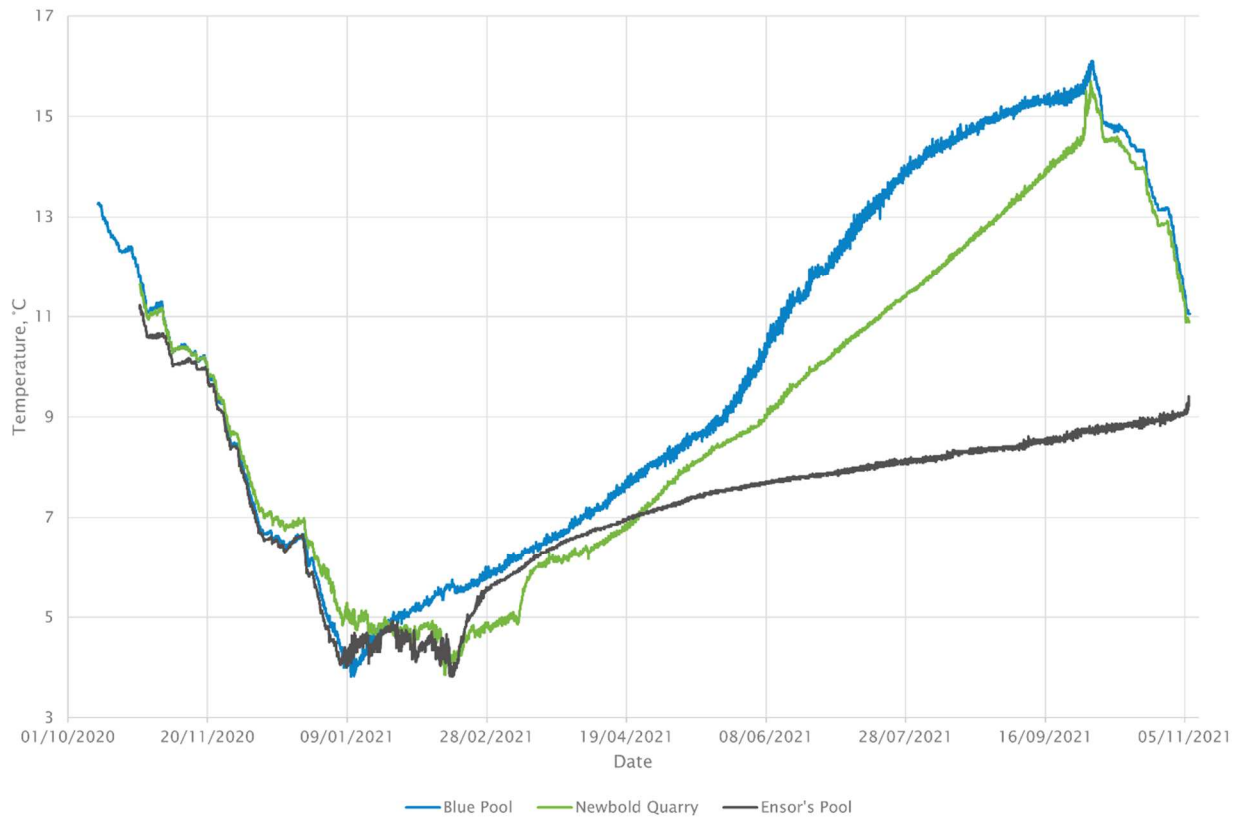
Figure 63 Plot of water temperature versus time over a twelve-month period at Ensor’s Pool, Newbold Quarry, and Blue Pool. The logger at Ensor’s Pool is ~2 m deeper than the other sites, which may explain the difference in maximum temperature given the size and volume of this quarry lies between the other two.
