# PROJECT CATO

A Southsea Sub-Aqua Club project

Martin Davies

November 2018

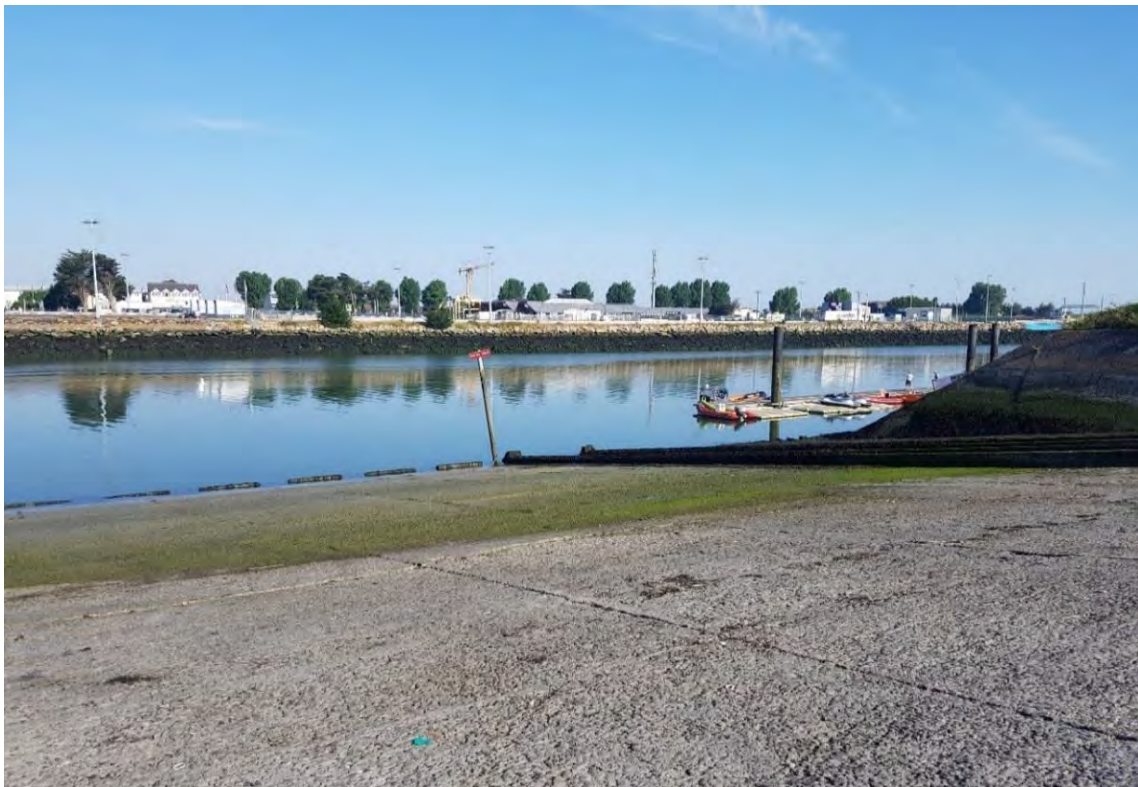
Figure 2 the slipway at Ouistreham ©Martin Davies

A large area of very slippery weed associated with the high water mark. The images shows the edge of the slipway marked by blocks of concrete to prevent trailers and launch vehicles from slipping into the sea when the water is below the edge of the slipway. This was the primary reason for not conducting a second dive each day. The slipway is not usable at all states of the tide. Observations suggested that a period two hours before and after high water gave good access to the water. Times outside of these limits would probably mean that the team could not launch or recover the boat successfully.

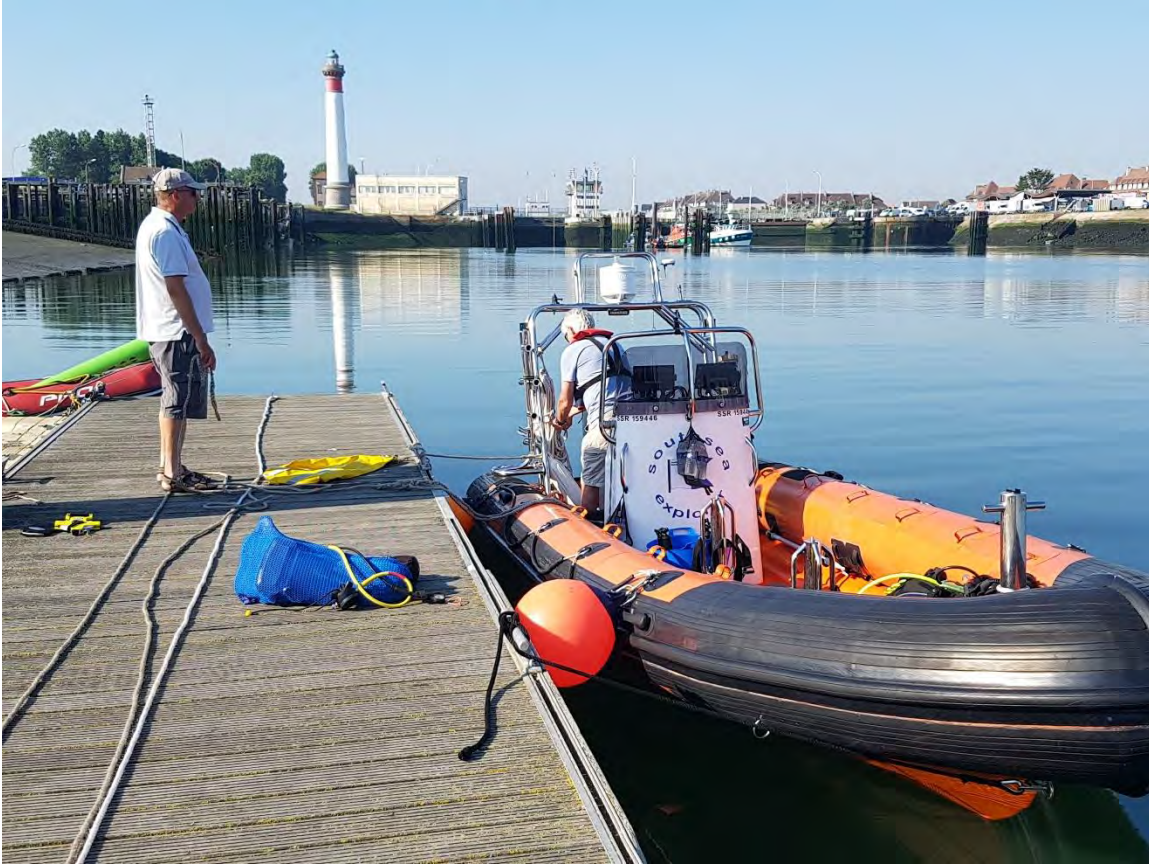
Figure 3 the holding pontoon at Ouistreham ©Martin Davies

is usable at all states of the tide. This meant we could unload gear (especially diving cylinders) and get them ready for filling whilst making plans and readying ourselves for dive number two at low water.

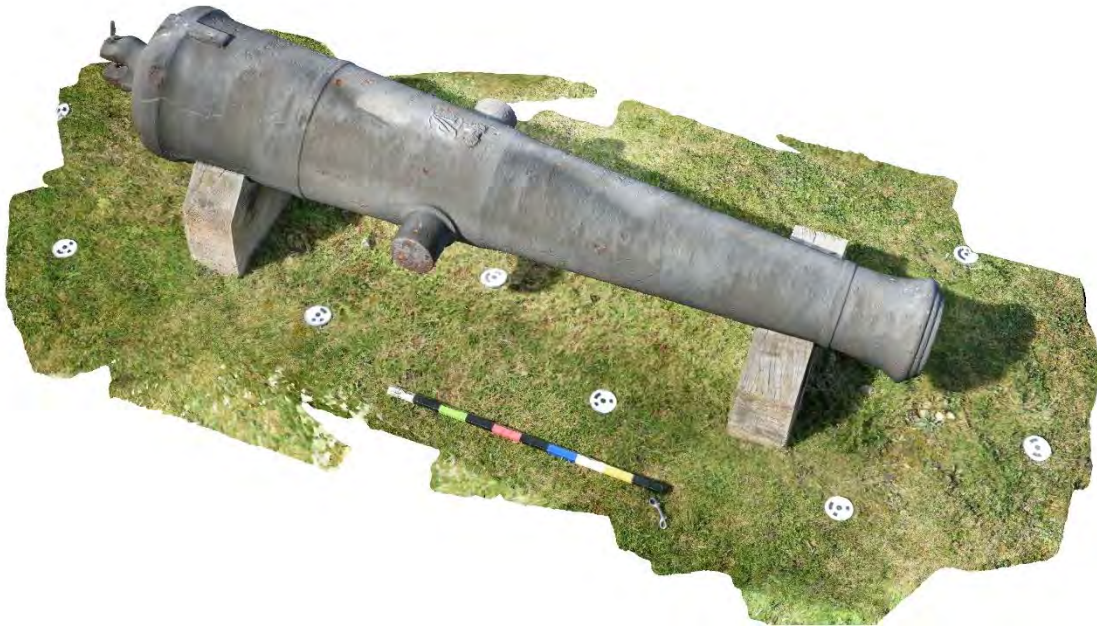
Figure 5 use of photogrammetry targets and scale (©Martin Davies)

When visibility was poor, the collecting of large amounts of imagery was not possible and so more traditional survey methods were used alongside the digital techniques. To assist the digital techniques the use of survey markers would be used if it was felt appropriate, these markers or targets would be placed around an object and then a normal series of images could be taken. The theory is to try to get at least two markers into each image with an overlap, this then allows the software to align the images more accurately.

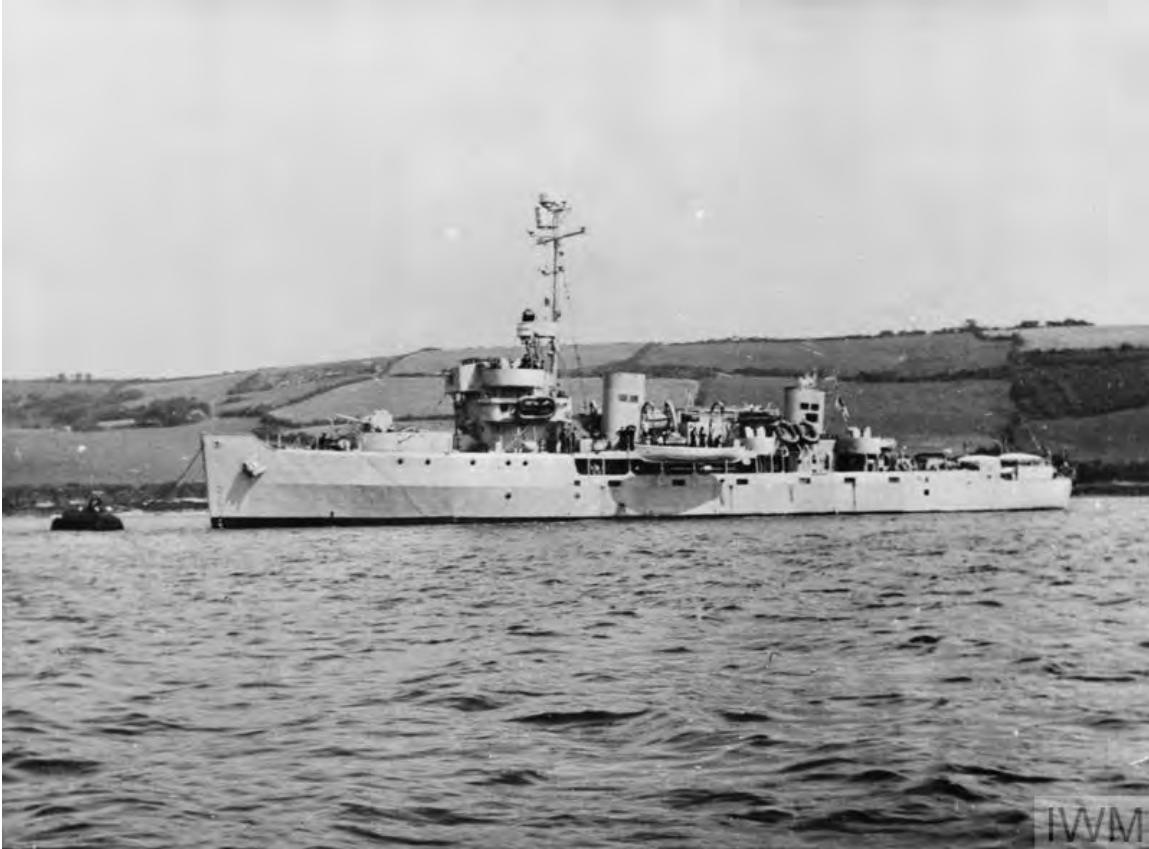
Figure 7 HMS Fairy, a British Catherine Class minesweeper. © IWM (A 30790)

The British Catherine Class of minesweeper as used in WW2 was an American-built *Auk* class minesweeper transferred to the British Royal Navy under a lend-lease agreement. A total of 22 ships were transferred and renamed under the 'Catherine Class'. HMS MAGIC, CATO and PYLADES were all British Catherine class minesweepers.

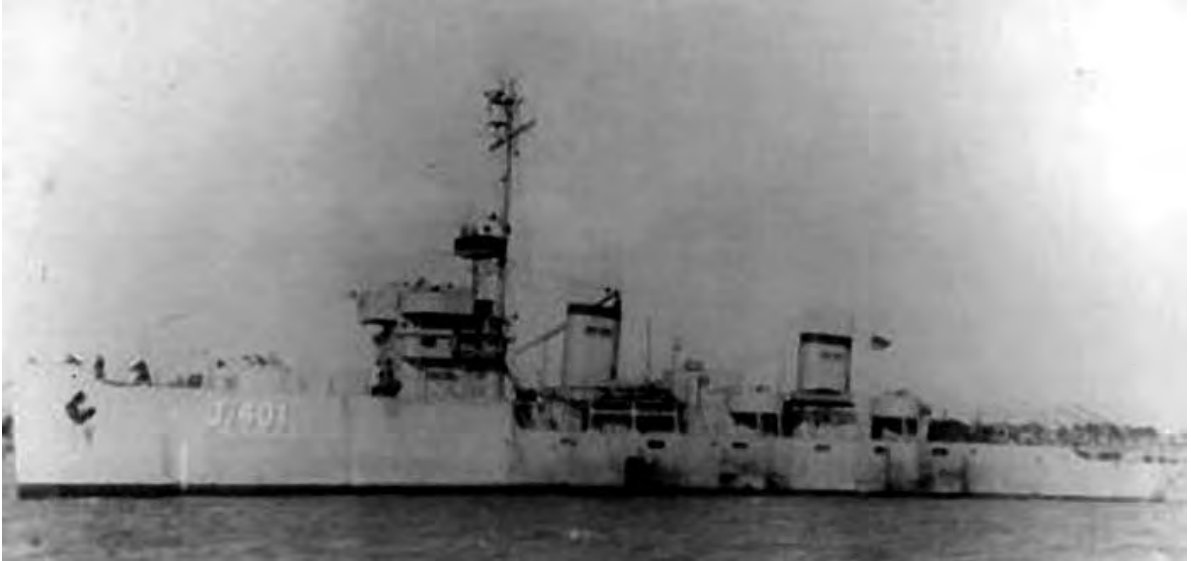
Figure 13 HMS PYLADES (J401)

Built by	Savannah Machinery and Foundry Co. (Savannah, Georgia, U.S.A.)
Ordered	2 Dec 1941
Laid down	30 Jan 1943
Launched	27 Jun 1943
Commissioned	24 Nov 1943
Lost	7 Jul 1944

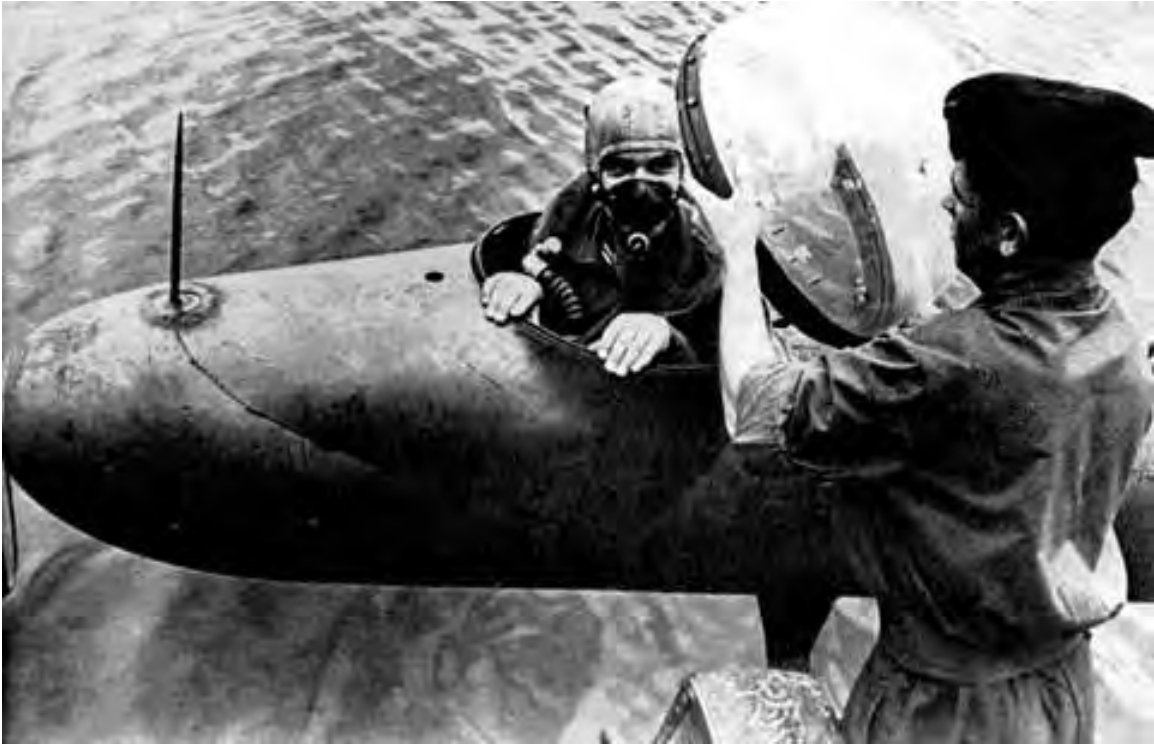
Figure 20 German Neger pilot preparing for launch ©unknown

As the Neger pilot approached the target, he would take aim on his target by aligning a spike at the front of the craft with some markings in the Perspex dome. Once his target was acquired he would arm the lower torpedo and launch it at the target before disengaging. The Neger "craft" was not able to dive, and as a result was very vulnerable to enemy attack. If the transparent dome was damaged, the pilot had almost no chance of escaping from the sinking craft.

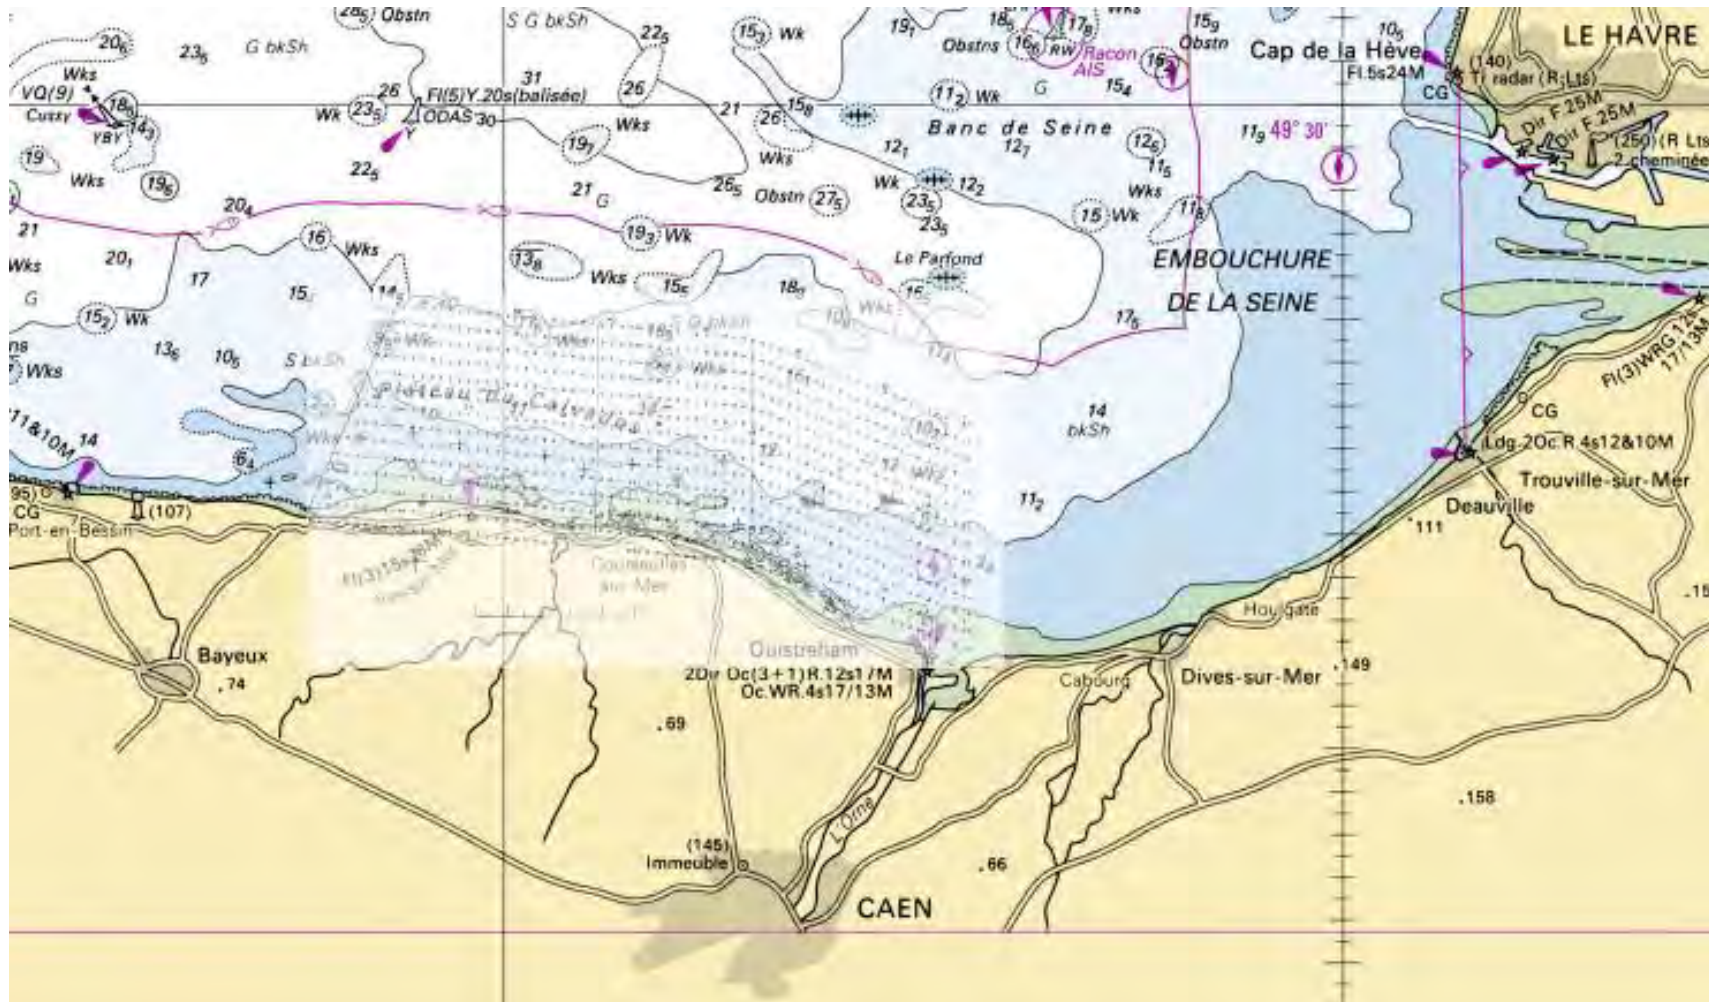
Figure 23 plan of the general area, with the berthing plan overlaid. (Courtesy Jim Fuller)

The following image shows the berthing plan overlaid on a current chart of the area. This illustrates the berthing in relation to the ports of Le Havre and Ouistreham.

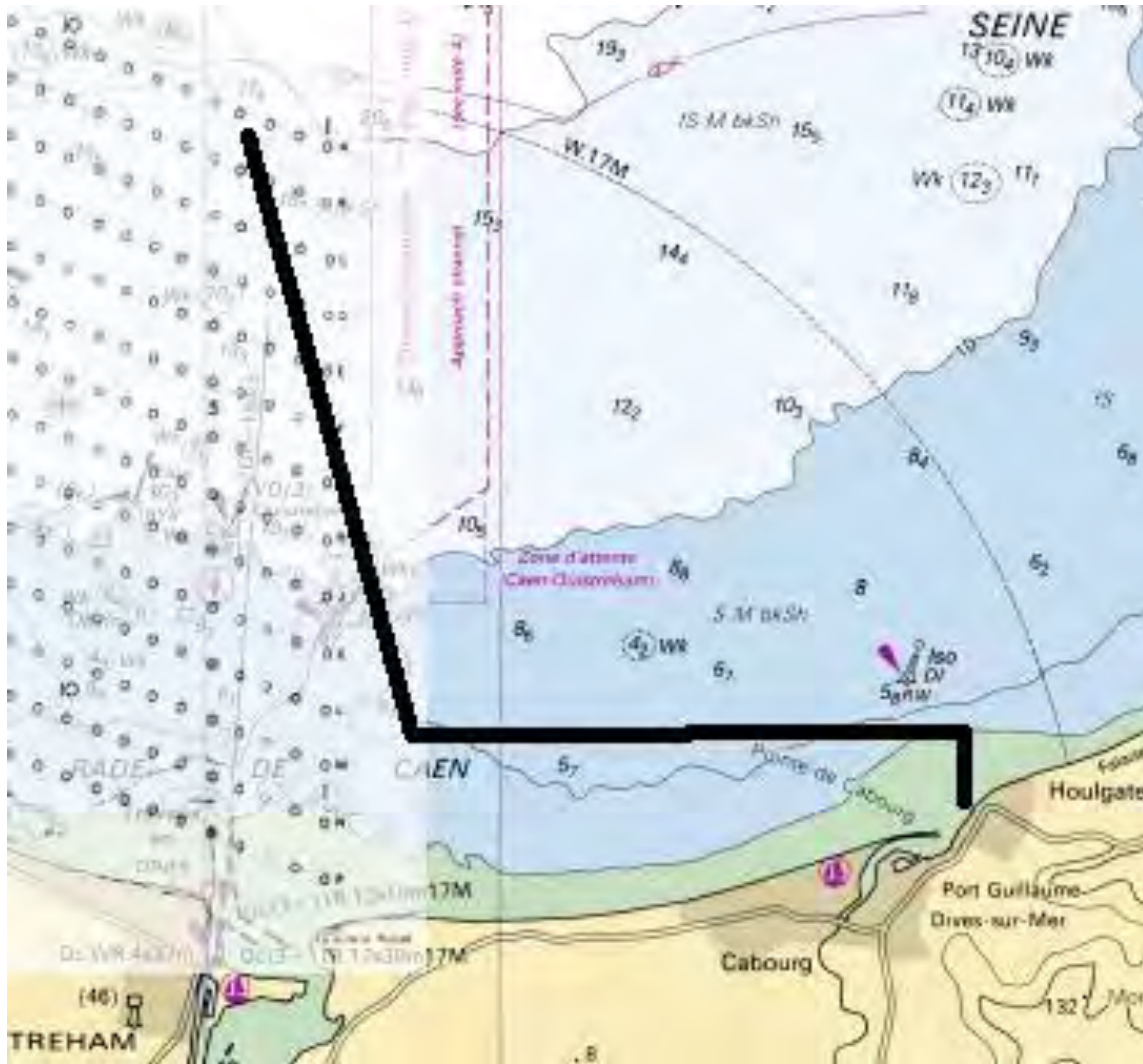
Figure 27 the route taken by the Neger human torpedoes (Courtesy of Jim Fuller)

German Neger boats had orders to follow a course that would take them into the anchoring area with orders to attack any Allied ships at anchor in the area. Failing that they were to attack the harbour works at Ouistreham. The Neger pilots were given detailed instructions on how to get back to their base. The craft had the endurance for a return trip however of the twenty four launched that night only nine returned.

The approximate route taken by the human torpedoes is shown below.

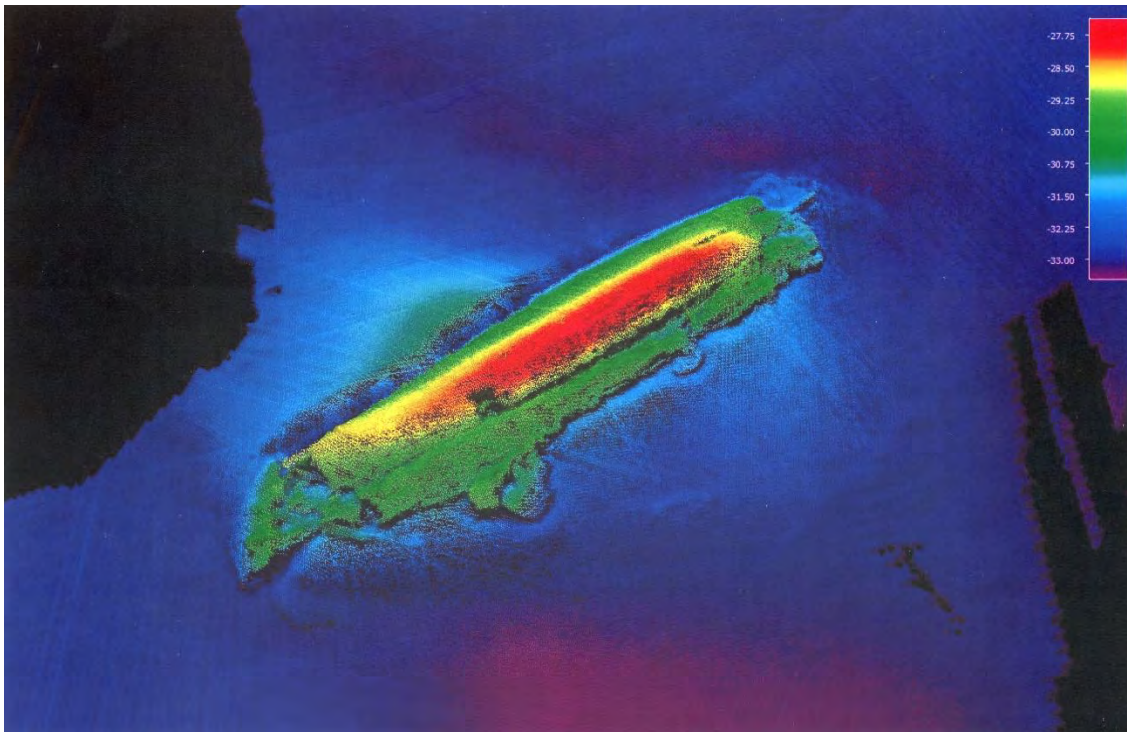
Figure 36 PYLADES multi-beam image courtesy of DRASSM (EA3118).

The wreck is orientated at 45°/ 315°. The wreck is recorded to be 67m long by 9.8m wide.

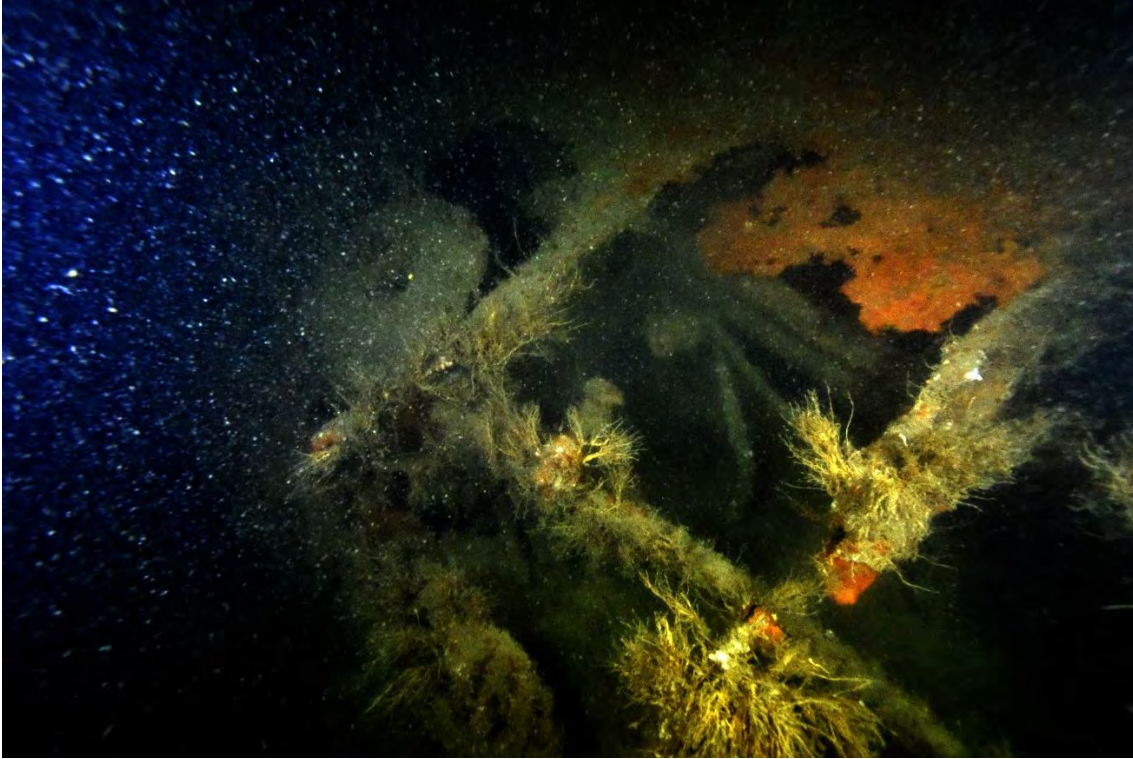
Figure 37 the outer hull plating has begun to erode away ©Martin Davies

The image above shows the extent of the weakening of the outer hull plates, a lot of the plating is very thin and dissolving quickly without the protection of being heavily concreted. The exposed red rusted steel is visible in many places.

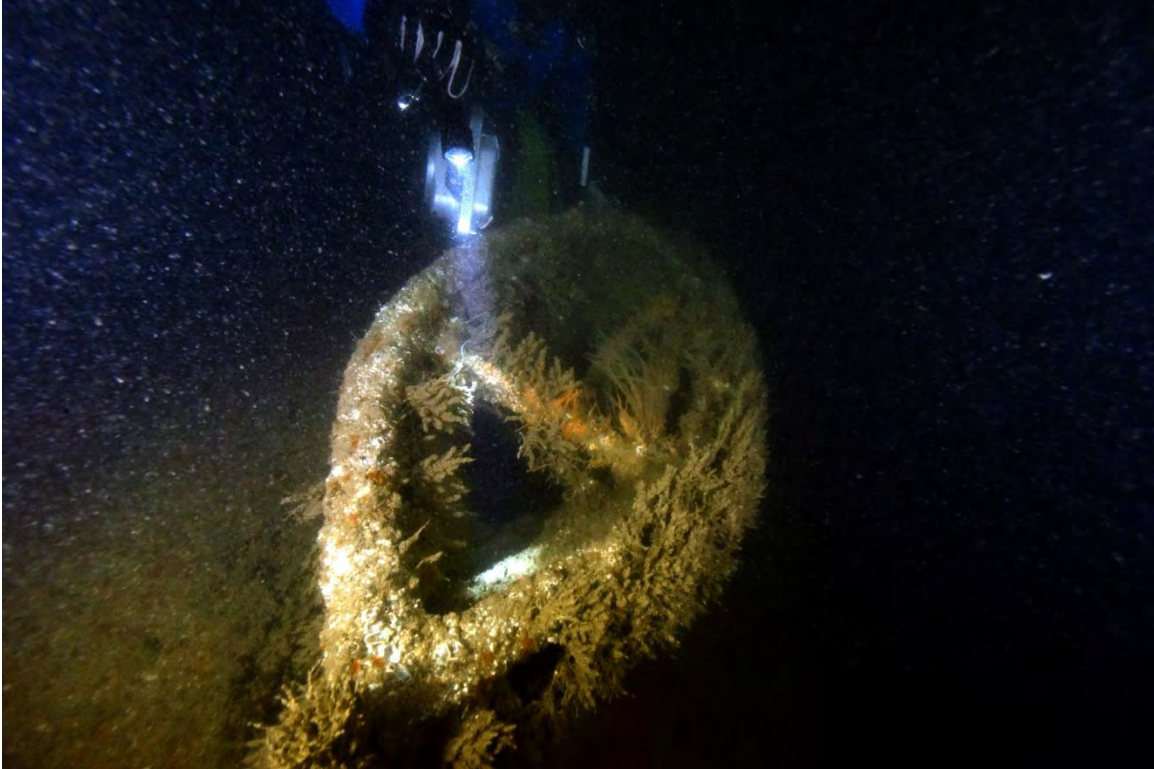
Figure 38 the elliptical metal shape on the hull (ASDIC) ©Martin Davies

Measurements were taken it was 1.3m long and 0.58m at the widest point. The elliptical shape stood 0.45m high from the hull. See image below.

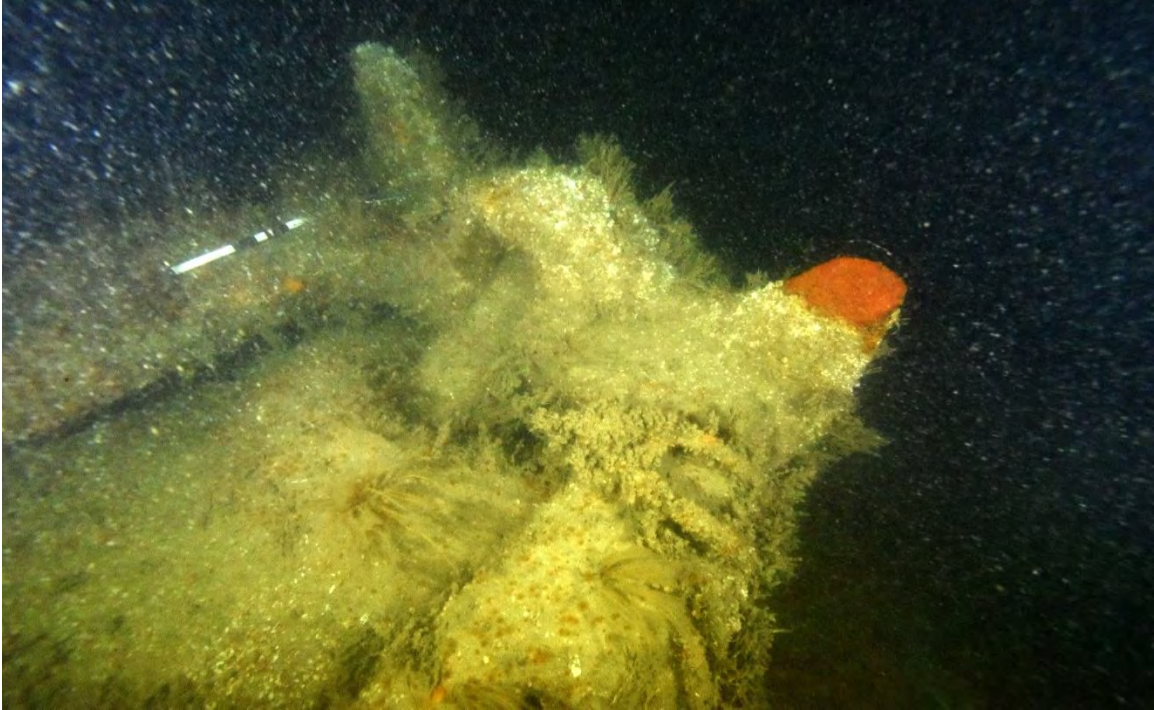
Figure 40 starboard anchor still in place ©Martin Davies

The other notable observation was one of the ship's anchors which was still stowed in place on the starboard side of the hull as seen in the image below.

Wreck hull was the highest point some 5m above sandy sea bed. The Asdic mounting was visible as we moved forward towards the bow. There was damage to the side of the ship just above the anchor which was consistent with an explosion from within, ie metal bent outwards and almost completely folded back.

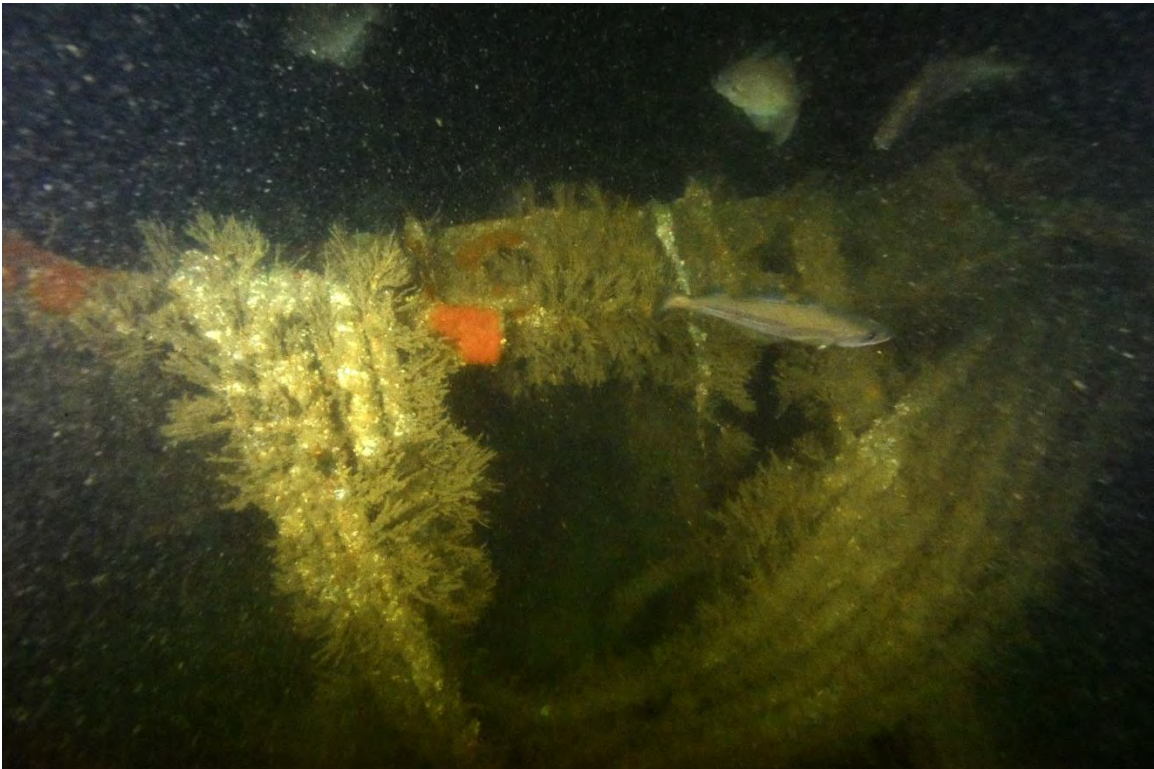
Figure 41 HMS PYLADES, degaussing cables. (Martin Davies)

Returning along the outer hull there were breaks in the fabric of the ship and some of the ship degaussing wire was observed, unsupported and hanging down (see above).

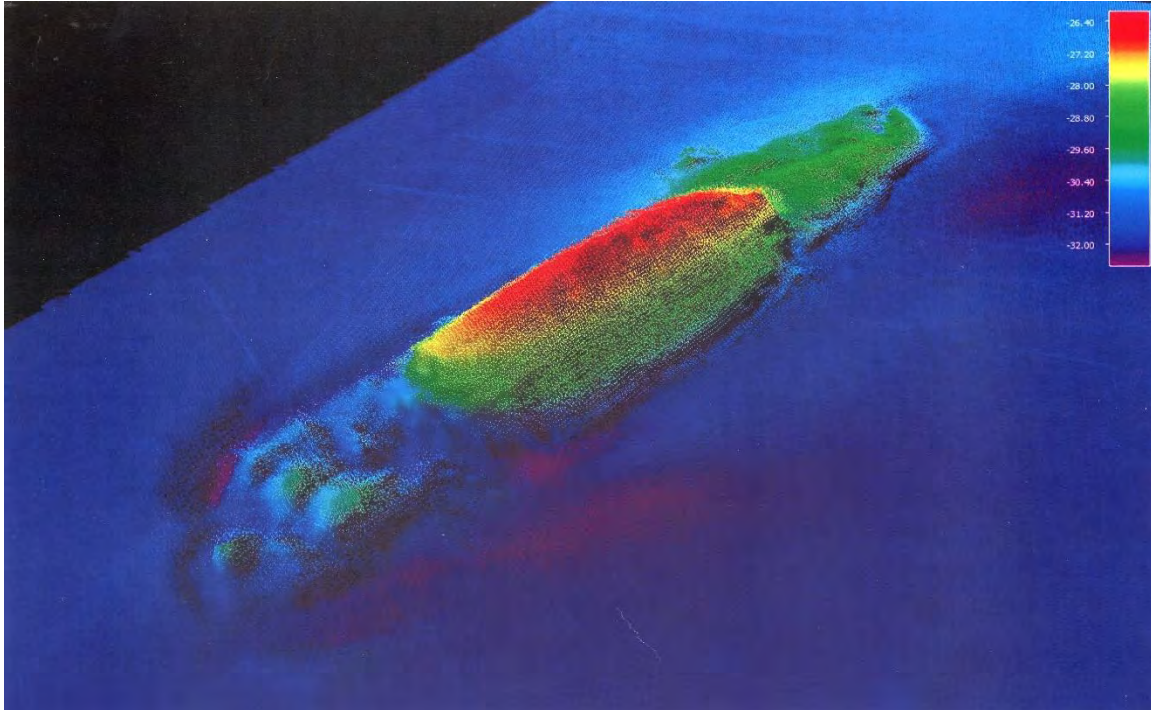
Figure 43 multi-beam image of MAGIC (EA3236). Courtesy of DRASSM

The overall impression of the wreck of MAGIC can be seen from the multi-beam image below. The wreck is not as complete as that of PYLADES with significant damage to the stern area. The bow has broken from the main hull structure.

The wreck site is 66m long by 14m wide and lies east / west, with the bow to the east.

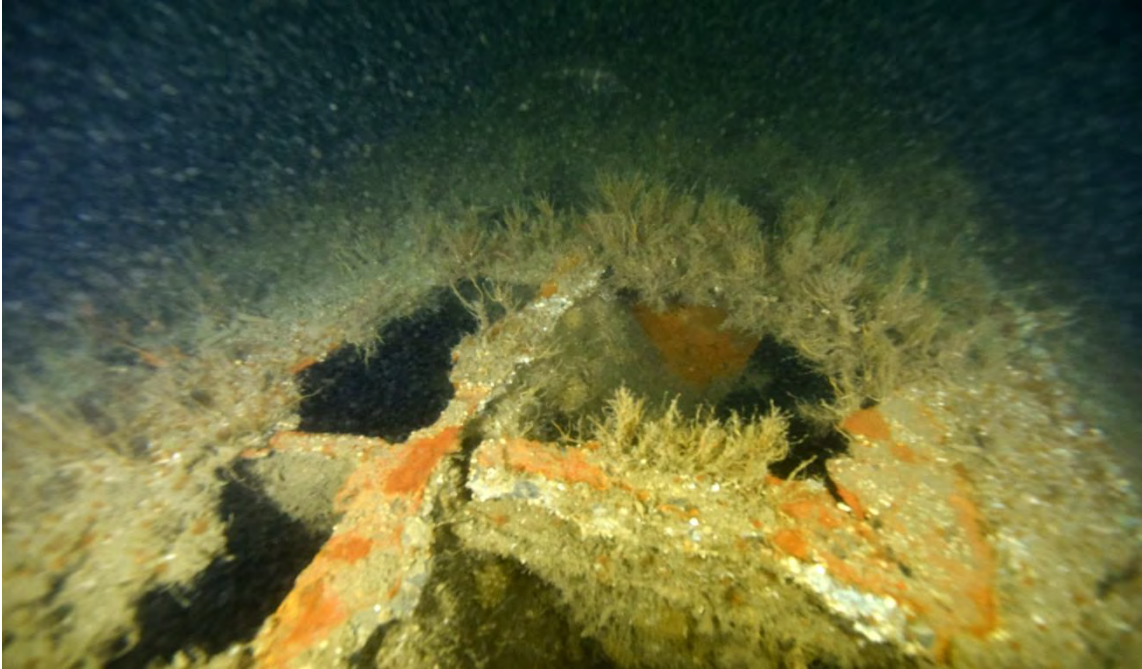
Figure 44. Numerous holes in the plating are visible along the length of the upturned hull ©Martin Davies

The top of the upturned hull being the highest point at 26m. The condition of the upturned hull is similar to that of PYLADES in that there are many access holes in the hull due to erosion of steel plating.

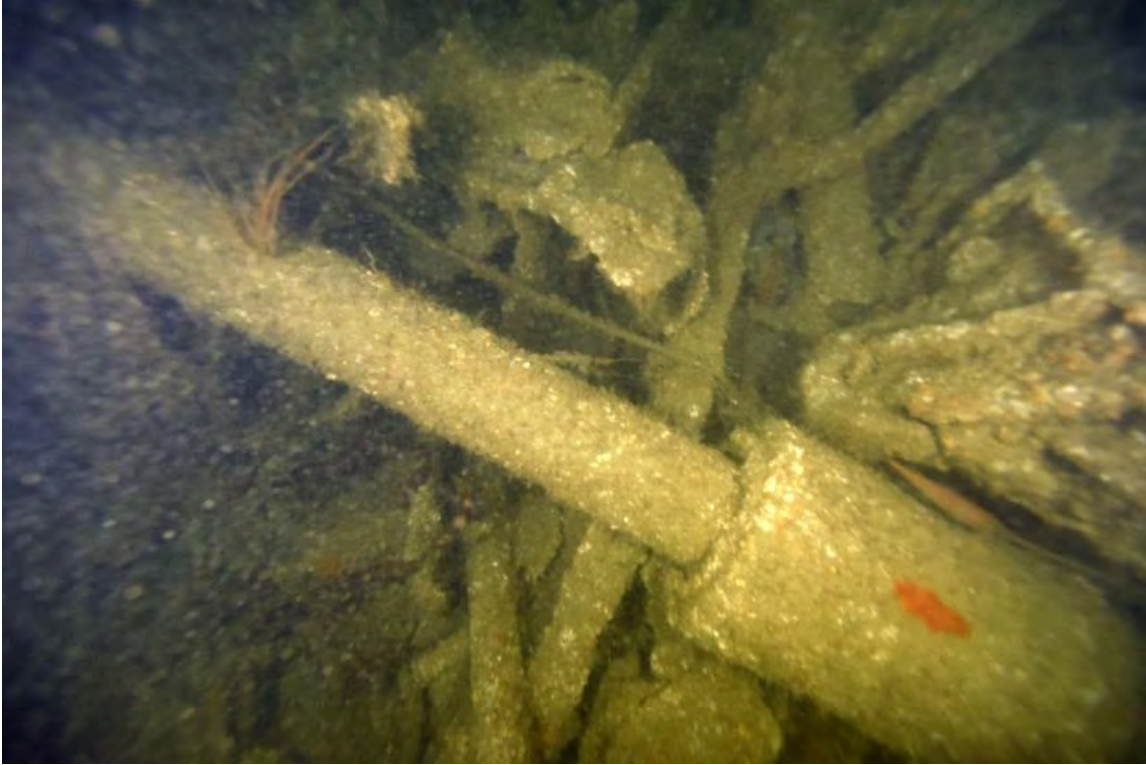
Figure 45 Possible a section of one of the propeller shafts ©Martin Davies

There is some evidence of the propeller shafts or part of them in this area and the main recognizable feature at the end of the wreck is one of the rudder posts still upright with the remains of a rudder visible.

The vessel according to historical records was only hit by one human torpedo 'just aft amidships' towards the stern. The wreck is broken in this area and this is consistent with the accounts of the torpedo hitting MAGIC towards the stern and of her sinking stern first. There were no obvious signs that significant commercial salvage had taken place and it is assumed the engines remain in the main hull structure.

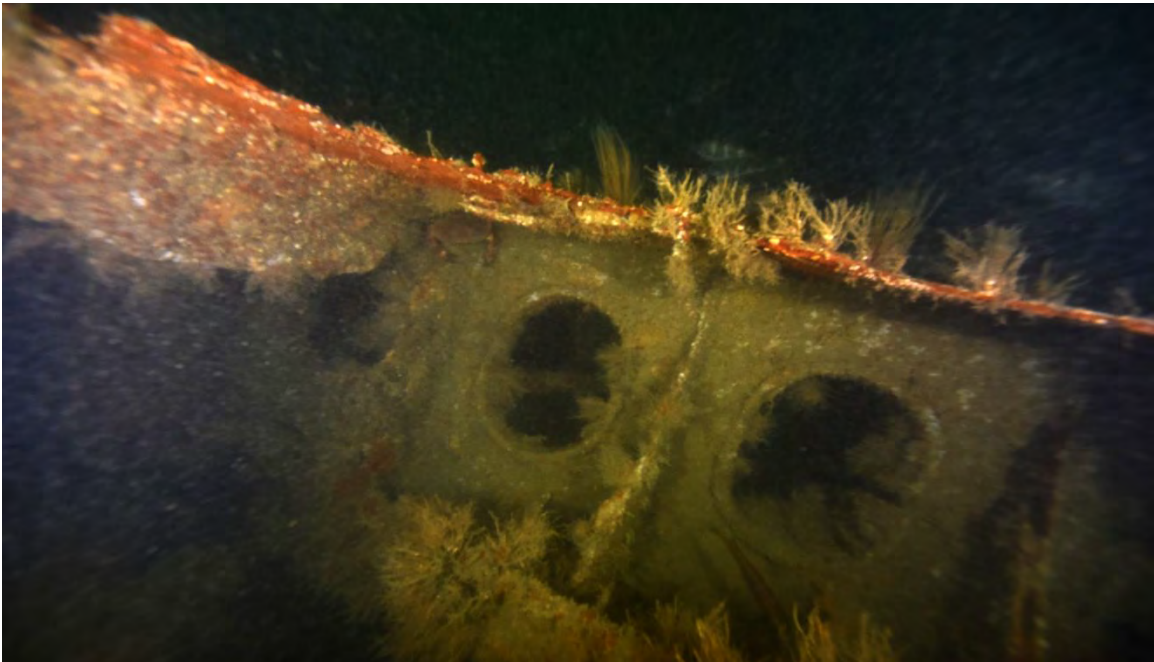
Figure 46 one of the internal frames now exposed ©Martin Davies

Moving forward over the hull some of the internal frames and bulkheads of the ship were still clearly recognizable. Some internal machinery was visible.

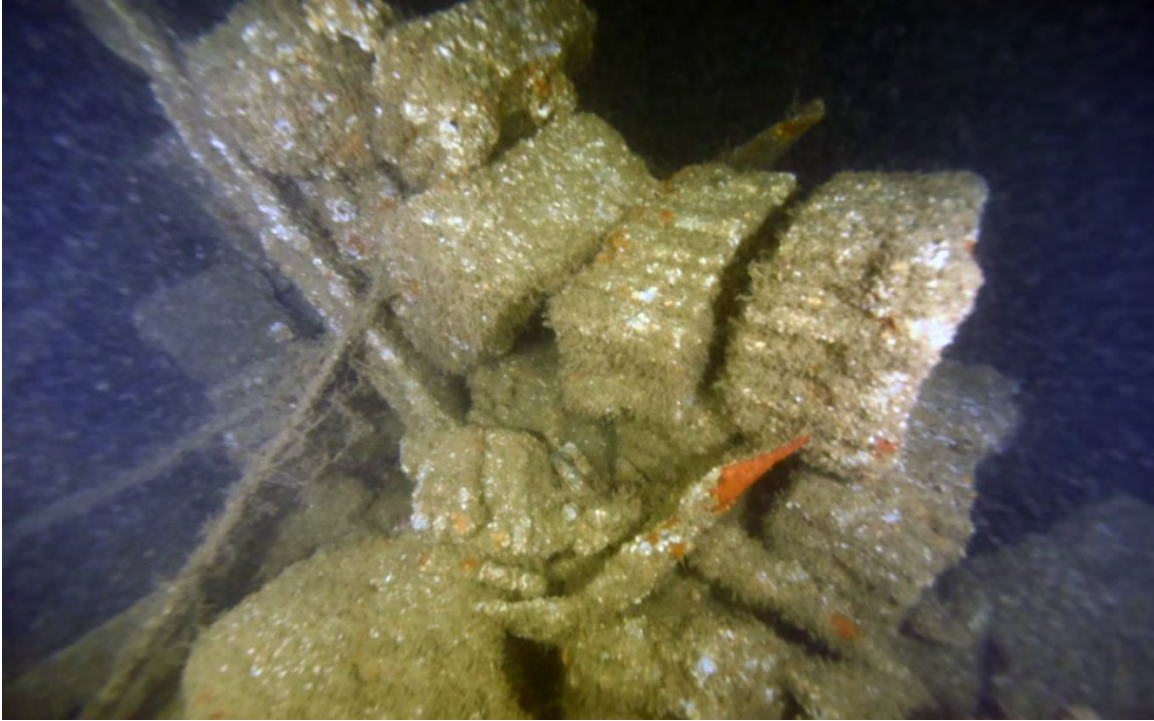
Figure 47 forward magazine with racks of 20mm ammunition ©Martin Davies

Moving forward towards the bow there is another area where there is a distinct break in the main hull and this area is exposed. It is unlikely the damage was caused by a torpedo as this would have triggered a large explosion and the damage would have been much worse. The fact that there are many boxes of 20mm ammunition neatly stacked suggests an alternate theory for the damage.

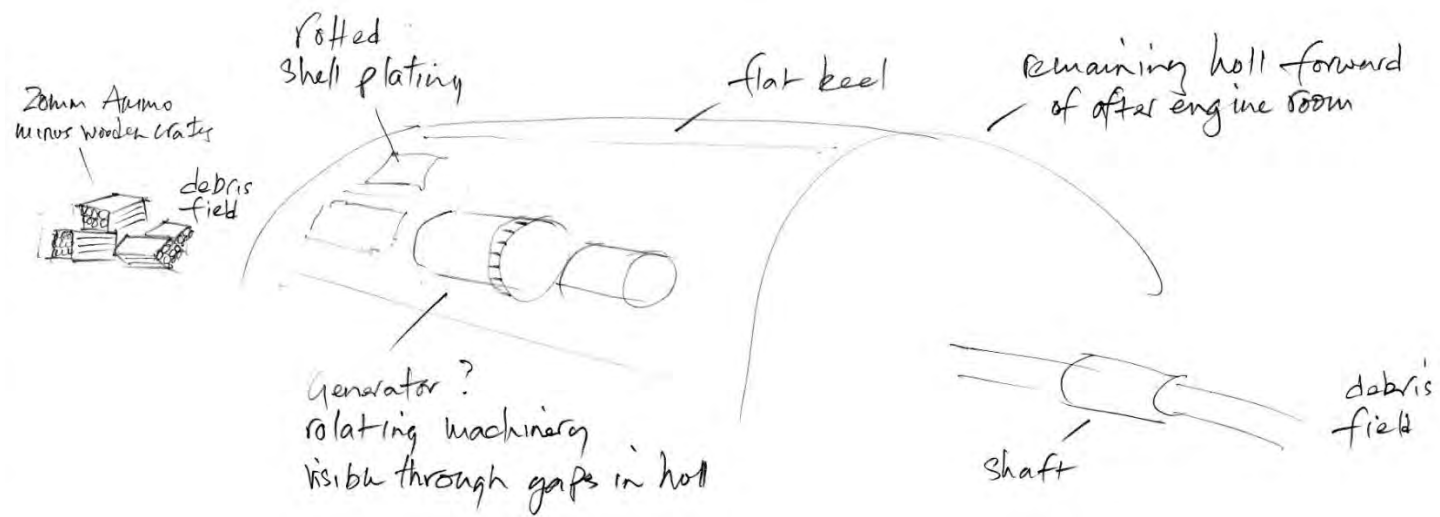
Figure 52 Sketch of the general lay out of the wreck of HMS MAGIC. (Tom Templeton)

WRECK WAS AN UPTURNED HULL WITH BREAKS AHEAD OF THE STERN AND BOW. THROUGH THE GAPS IN THE HULL MACHINERY WAS EVIDENT. JUST AHEAD OF THE STERN THERE IS A GAP OF APPROX 6-7 METRES BEFORE THE RUDDER ASSEMBLY IS FOUND. IN THIS AREA WE FOUND WHAT LOOKED TO BE THE PROPELLER SHAFT.

TOWARDS THE BOW THERE WAS ANOTHER AREA WHERE THE HULL HAD COLLAPSED/WAS MISSING. IN THIS AREA WE OBSERVED A NUMBER OF RECTANGULAR BOXES. (? AMMUNITION?).

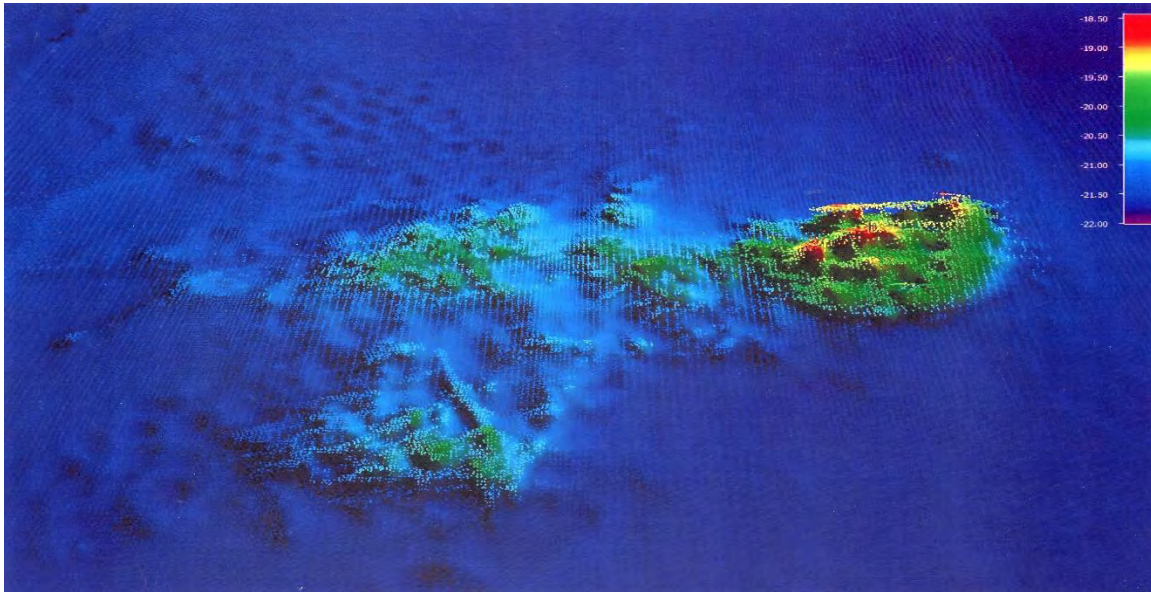
Figure 53 multi-beam image of CATO (EA3235) courtesy of DRASSM

The wreck of CATO lies in a general seabed depth of 20m of water. The wreck is very degraded, possibly as a result of commercial salvage. Other than the distinctive bow, which rests on the port side, there was little to identify the wreck from the significant debris field.

The site was visited twice by the dive team. The wreck is very broken and the majority of the site is not recognizable. See below.

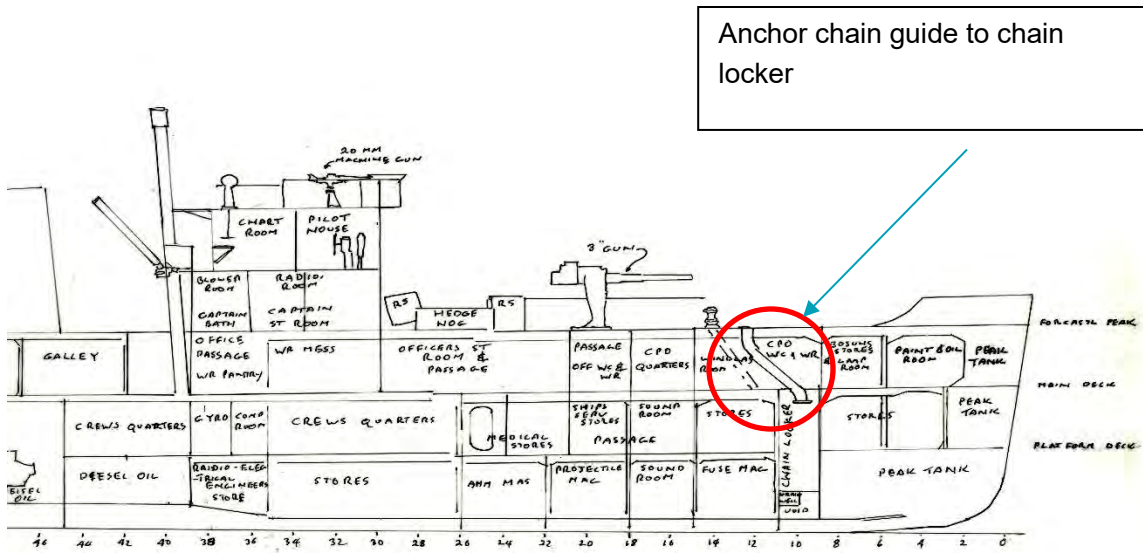
Figure 54 line drawing of the bow of an Auk class minesweeper (Robert Watkins)

We discovered that this highest point was the bow area and this was still relatively intact on its port side. From this piece alone we can conclude that this was an Auk/Catherine class minesweeper as it is very distinctive. The drawing below created from ship's plans was used to confirm this.

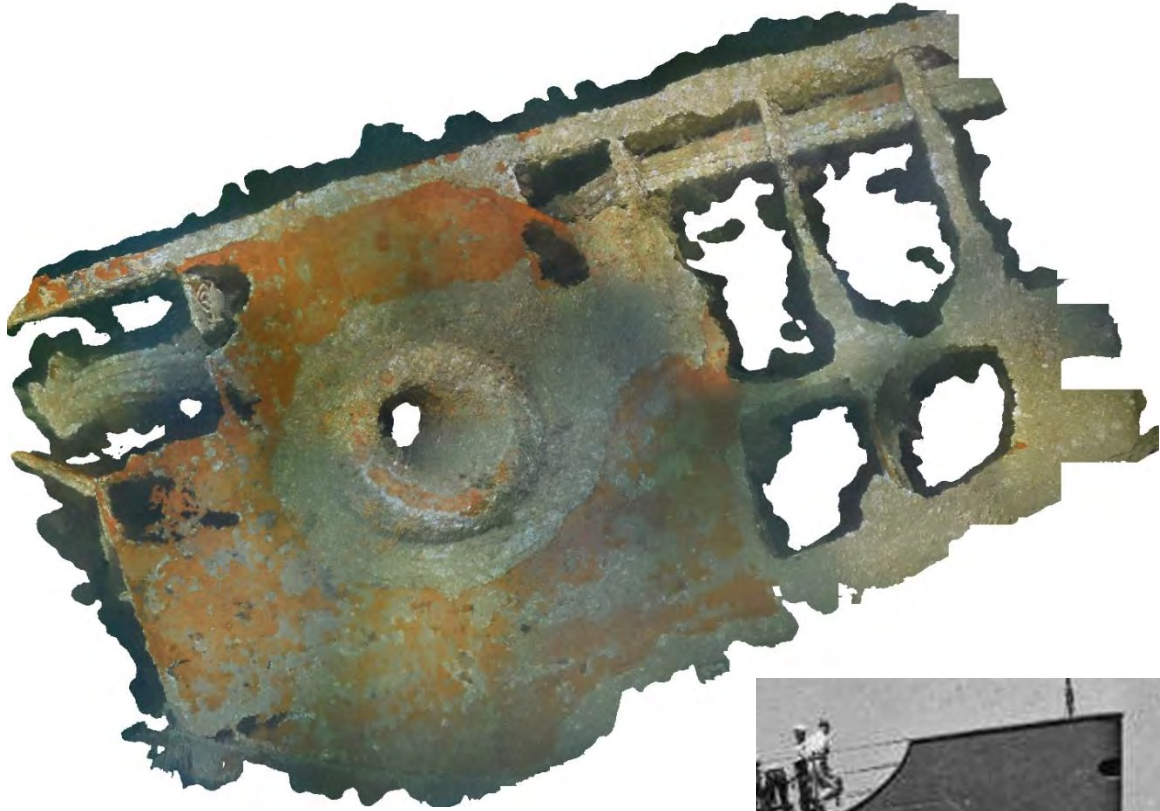
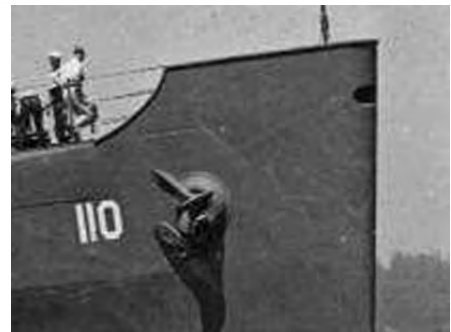
Figure 56 Photogrammetry - Starboard view of the bow ©Martin Davies Inset image of hawser and anchor at the bow of an Awk class minesweeper.

The above image clearly shows the remains and condition of the starboard side of the bow. Some exposed metal is red with rust where there is no concretion. Large holes have appeared in the hull plating where the hull material has degraded.

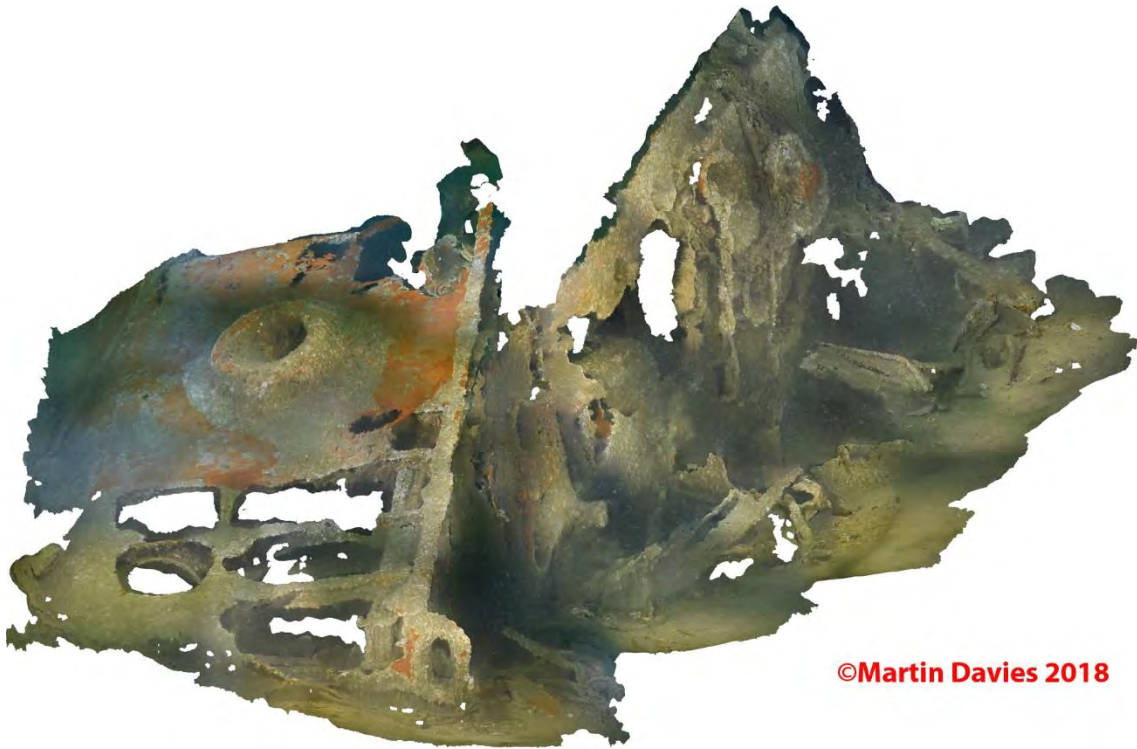
Figure 57 Photogrammetry image showing bow, 'bull nose' and foredeck (©Martin Davies)

A second view of the bow can be seen below, this side view shows the true shape of the bow and many distinguishing features. A 3D model has been made of the remains and can be seen by following the link below.
