# PROJECT CATO

A Southsea Sub-Aqua Club project

Martin Davies

November 2018

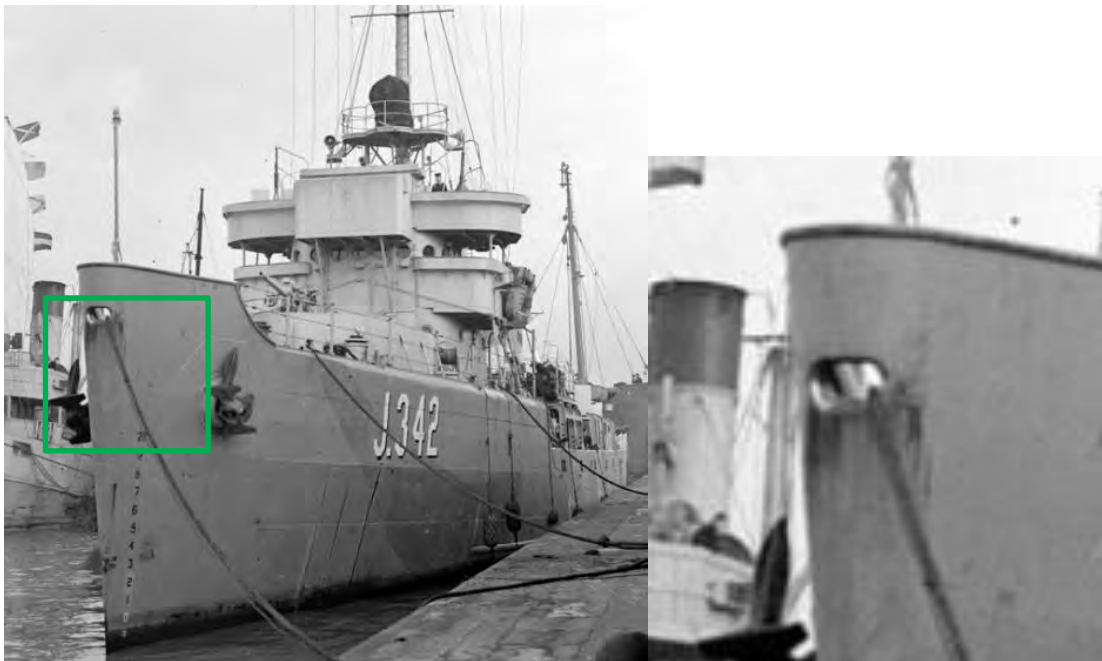
Figure 58 The Auk class 'Bullnose' - for mooring ropes.

At the very front of the bow there is a large, distinctive oval shaped structure known as a 'Bullnose'. This would have been used as a guide for mooring ropes.

In the images above the 'bullnose' of the ship can be clearly identified when compared to the historical image and also seen in the historical photograph of the bow of an Auk / Catherine class minesweeper.

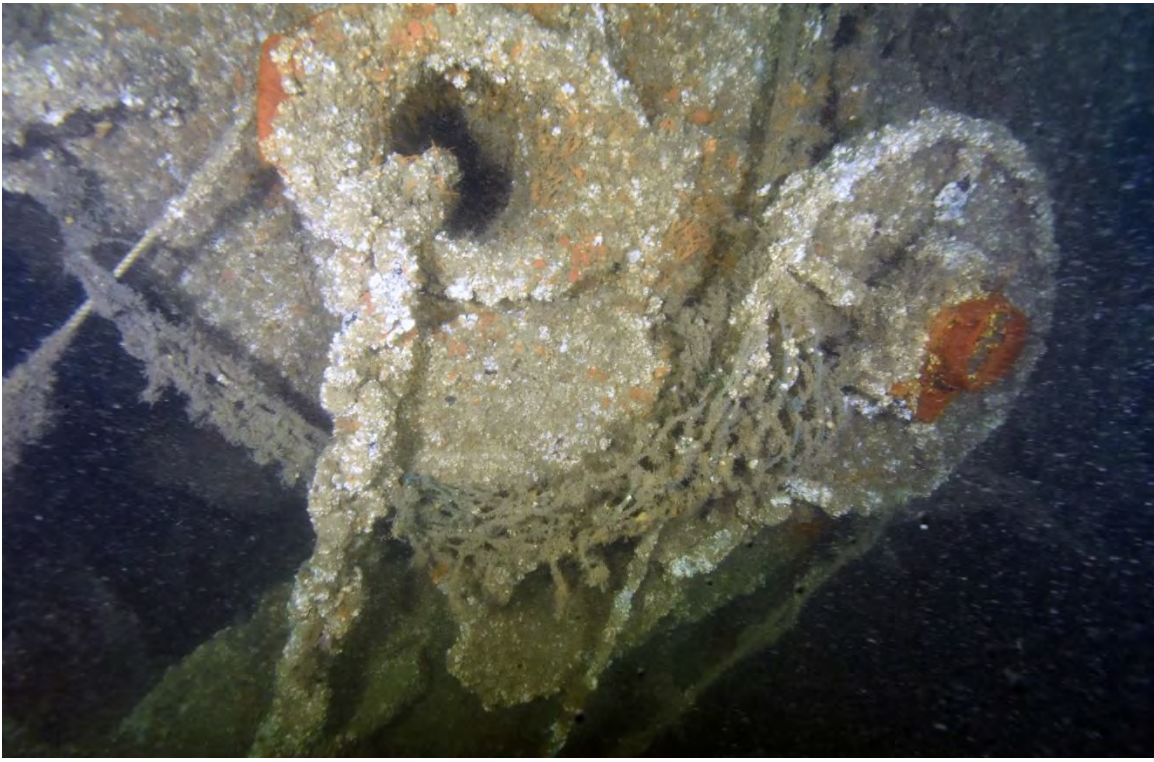
Figure 62 starboard anchor chain from the chain locker ©Martin Davies

We observed the starboard anchor chain coming out of the chain locker but there appears to be no anchor connected to it. The chain disappears into the seabed. This would suggest that the anchor may have been recovered at some point in time as the ship was at anchor when the sinking occurred.

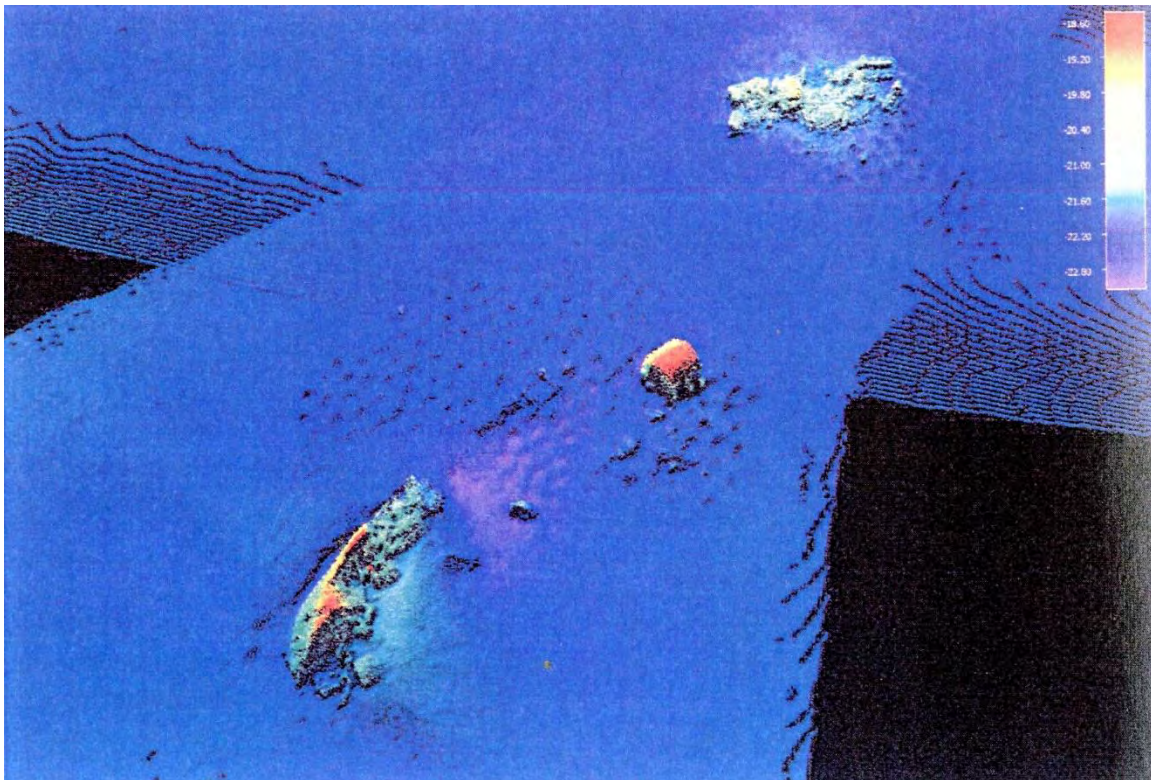
Figure 67 the wreck site known as Lord Austin, multi-beam courtesy DRASSM

A single dive was done on this site known as HMT Lord Austin, this consisted of a wreck site in 3 parts, as seen below.

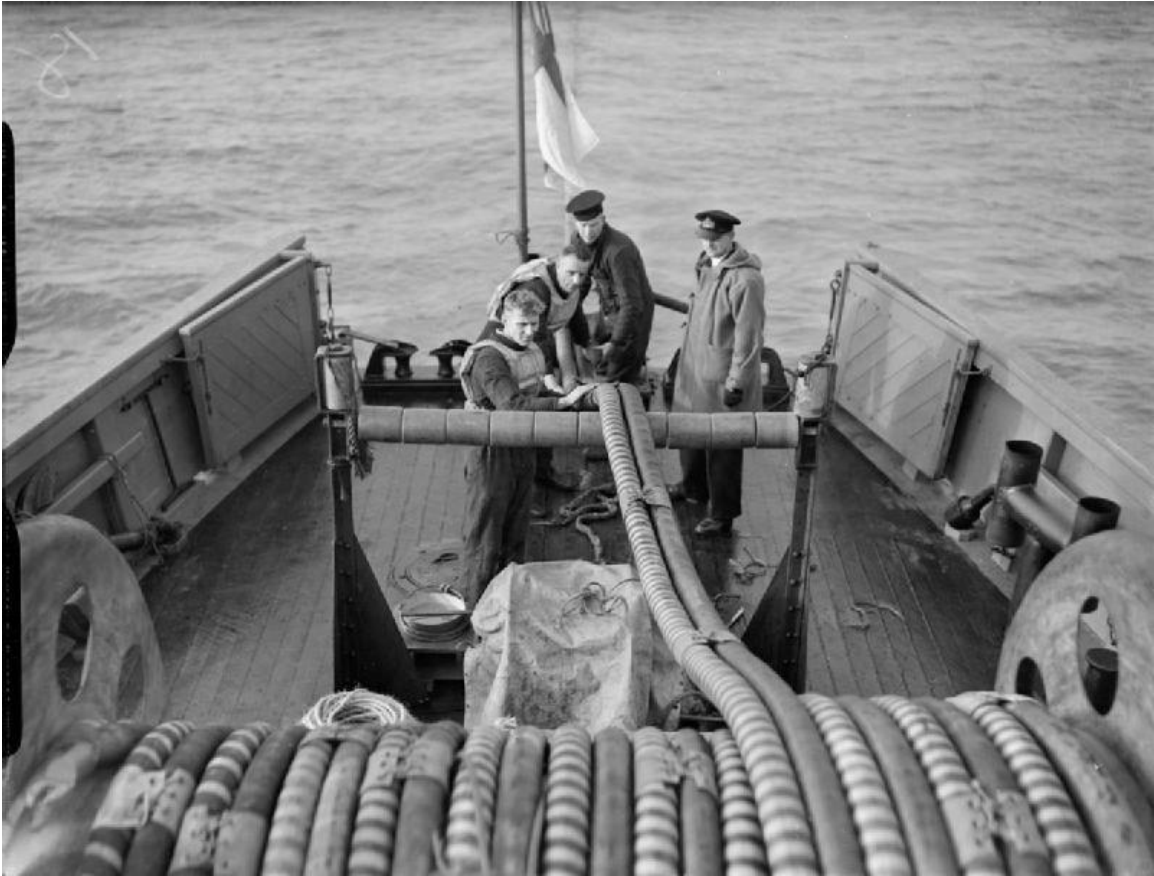
Figure 72 Archive image of buoyant electric minesweeping cable in use ©unknown

The image above shows a large diameter winch carrying the buoyant electric cable that was used in minesweeping operations by vessels such as Lord Austin. From the information we have so far this vessel looks more like a minesweeper than an ASW trawler. - Although research to date has shed little light on ASW and Anti-Submarine vessels so this could be the basis for a more detailed investigation and a future project.
