Project Solent Warships

Prepared for The British Sub-Aqua Jubilee Trust

April 2024

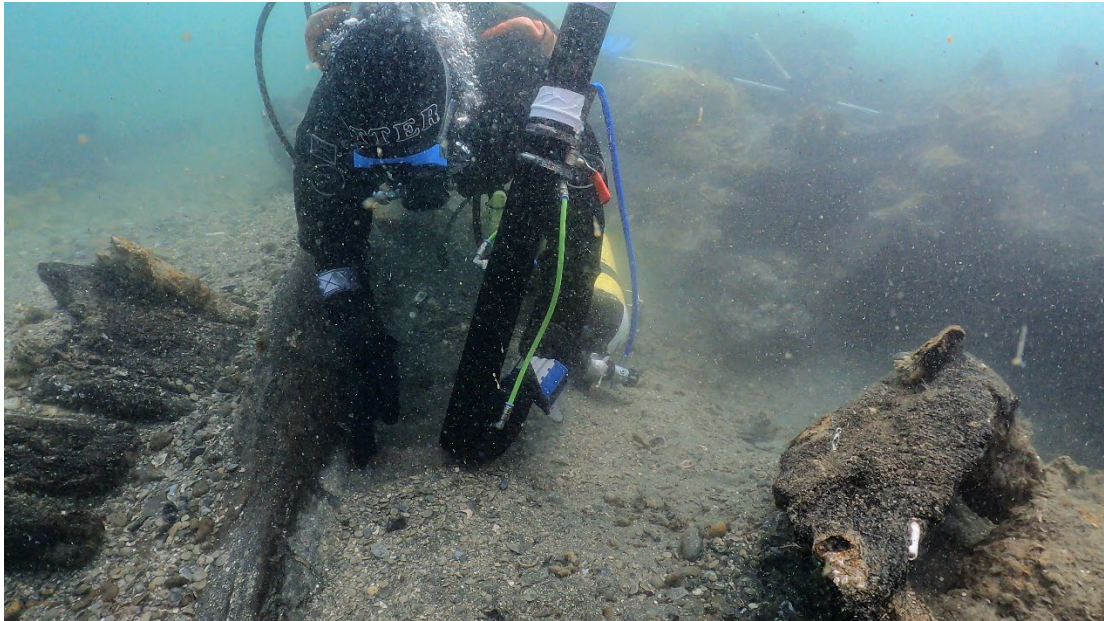
Figure 3: Diver using the portable airlift on the wreck of Hazardous in Bracklesham Bay, May 2023 (Photo by Dan Pascoe)

- 2.3.1. Two small portable in-water airlifts were borrowed for the project to assist with the excavation of small test pits. These airlifts have been designed to be easily transported by a diver to the site and run off an independent diving cylinder. They have been used previously on the protected wrecks of *London* and *Hazardous* (Figure 3).

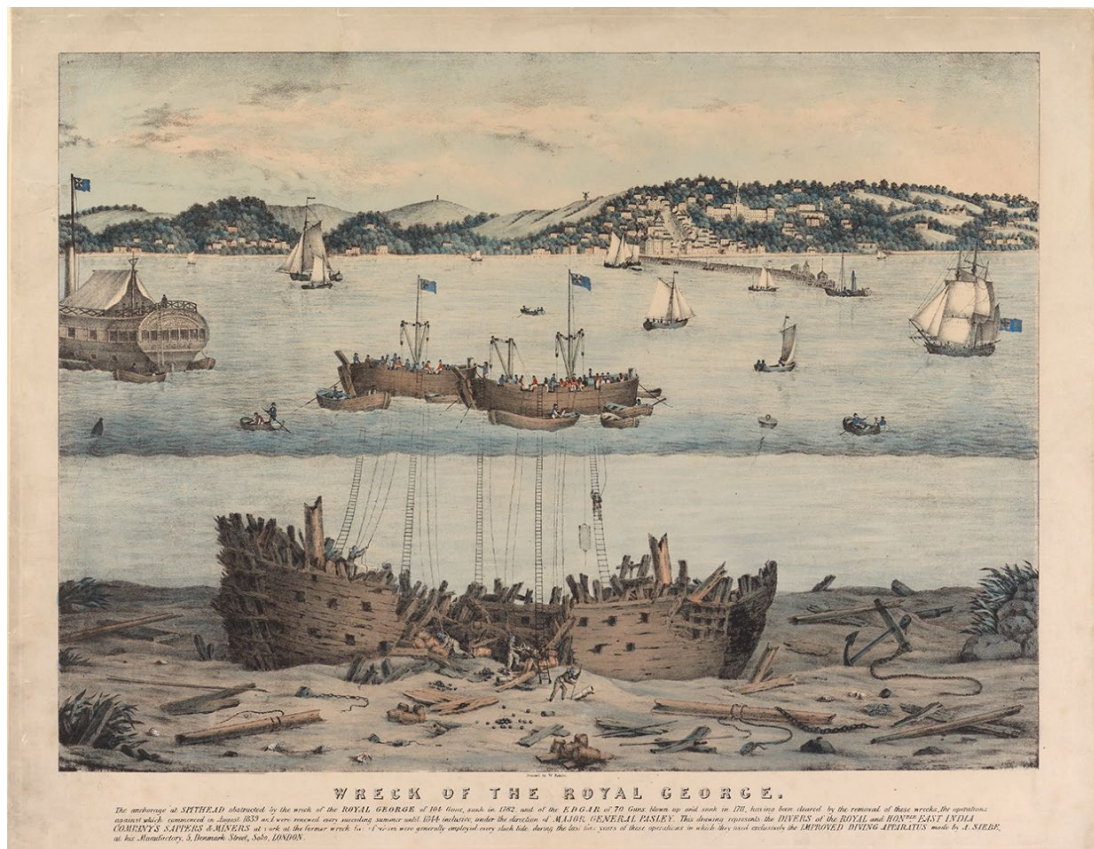
Figure 4: Shows two slave vessels over the wreck of *Royal George* with lifting gear. Alongside these vessels are two smaller boats which could represent the lighters carrying the dive pumps and explosives. These vessels match those used on *Edgar*. Also note in the background, the town of Ryde and it's pier on the Isle of Wight.

accommodation for the working party. Success was also fitted with derricks and winches for hauling up heavy objects from the wreck site such as the rudder. These vessels, or similar, are illustrated in operation over the wreck of *Royal George* (Figure 4).

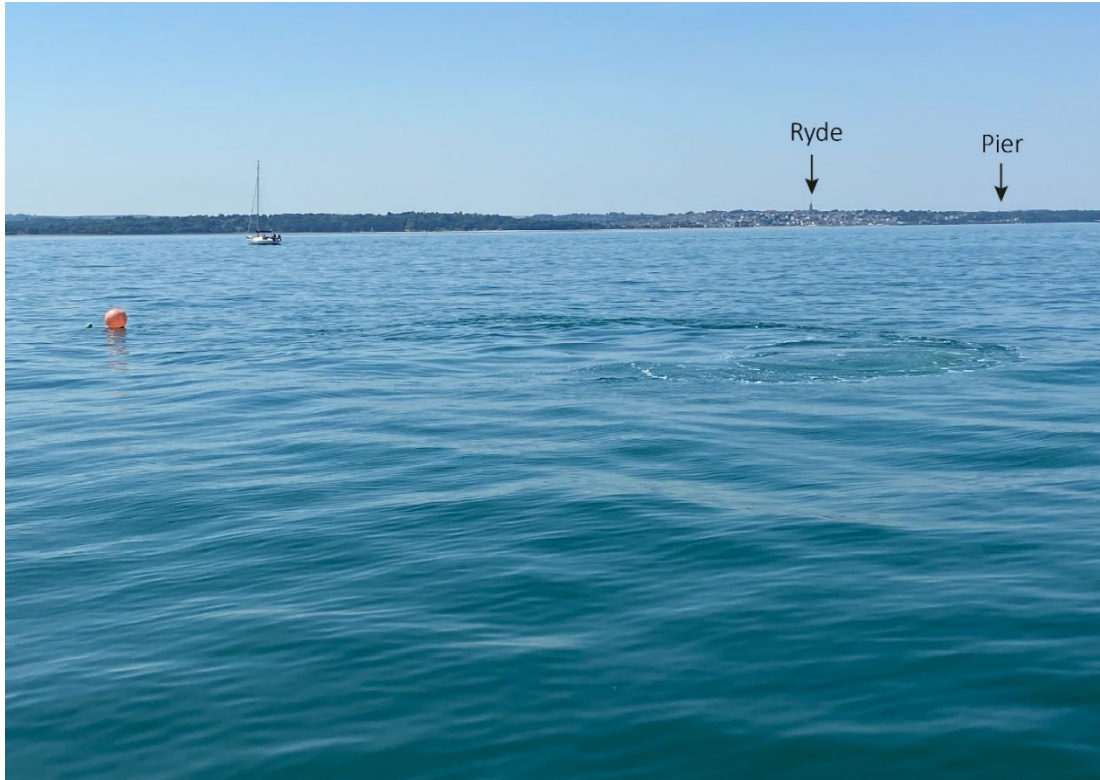
Figure 5: Photograph showing the shot on the site of Edgar with divers bubbles on the surface. The Isle of Wight town of Ryde and it's pier in the background.

3.1.15. In the background of the illustration, the Isle of Wight town of Ryde can be seen, along with the town's pier, extending out into the Solent. 183 years later and the Solent warships project dive team were exploring in the footsteps of those Royal Engineer standard dress divers on *Edgar*, which was located 700m to the Southeast of *Royal George* (Figure 5).

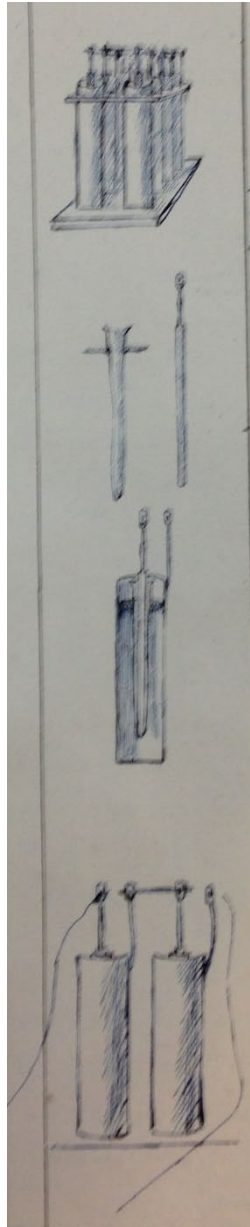
Figure 6: Showing the illustrations of the batteries of galvanic cells and the electric detonators employed in firing the charges sketched by the medical surgeon in his journal (TNA ADM 106/121/1/2).

rope was secured along its length, which was also waterproofed. The conducting wires were then attached to the two priming connectors, “...by two fine platina threads” which were separated by a piece of wood. The platina threads were placed in a waterproof heavy cotton bag which held a small charge. These were then inserted into an airtight container containing ‘cylinders of gunpowder’. The explosive was detonated by, “...connecting the opposing poles of the batteries and making the platina treads red hot” (TNA ADM 106/121/1/2) (Figure 6).

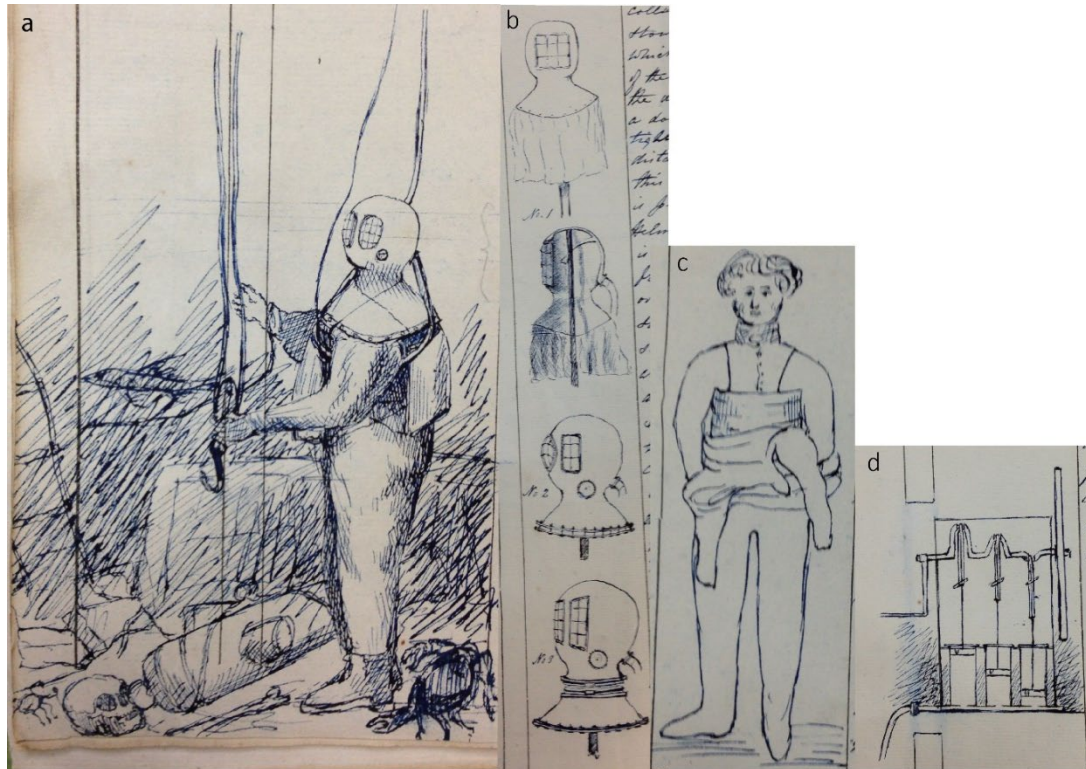
Figure 7: Illustrations inside a medical journal. Illustration a) shows a diver receiving the lifting hook from the surface, to possibly recover a gun from the wreck of Royal George. Illustration a and b identifies that the divers were using Deans open helmet. Illustration c shows the diver suit and d illustrates the air pump with cranks, gears, flywheel and water reservoir (TNA ADM 101/121/1/4).

3.1.18. After detonation the divers would then descend to the wreck and attach lifting gear to items on the wreck including guns, anchors and structure (Figure 7). This is illustrated in a medical journal of a surgeon who was observing and recording the effects of these diving operations on the team of divers (Figure 7).

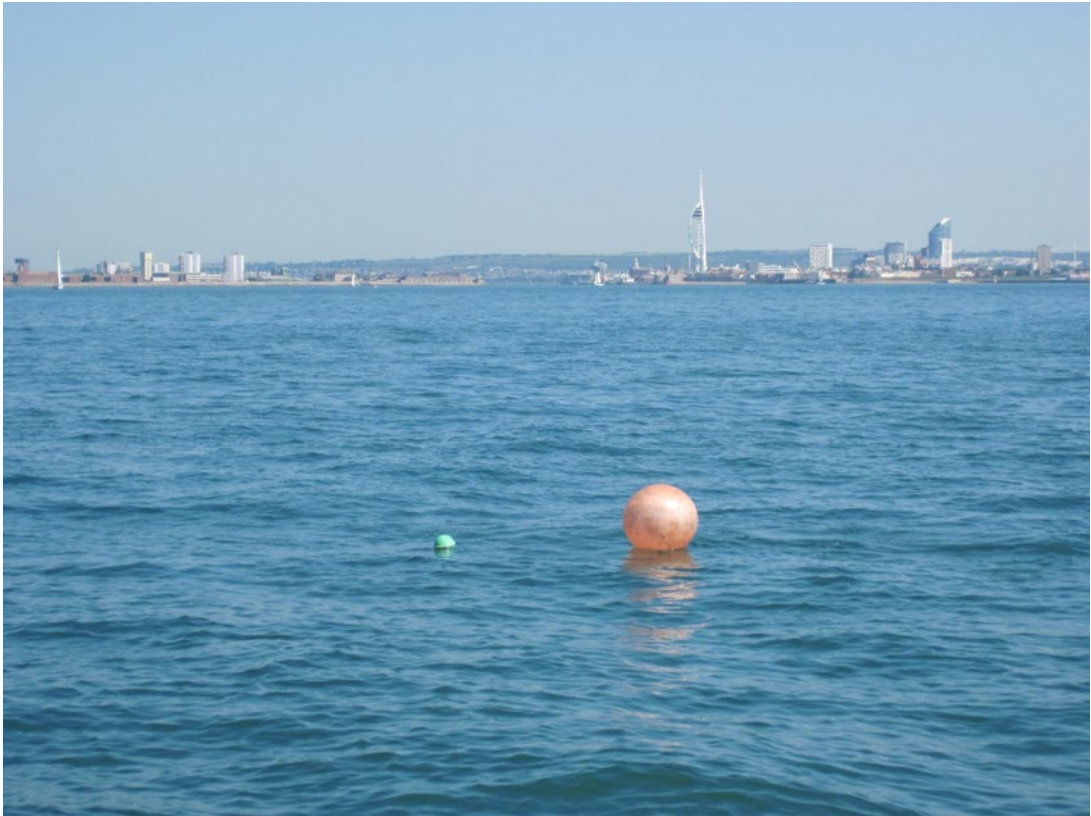
Figure 10: Showing the shot on the site of Edgar with Portsmouth Harbour in the background.

3.1.23. To maximise time on site and to conduct multiple tasks simultaneously, two shots were initially deployed. The first shot was deployed on the centre of the mound in Area 2 (Figure 10), and the second on a large mag target northeast of Area 2. One pair of divers were tasked with locating either exposed archaeological features or hard contacts below the surface of the seabed on the mound, using metal probes. The second pair were given a metal detector and a metal probe for locating potential guns or other large ferrous objects.

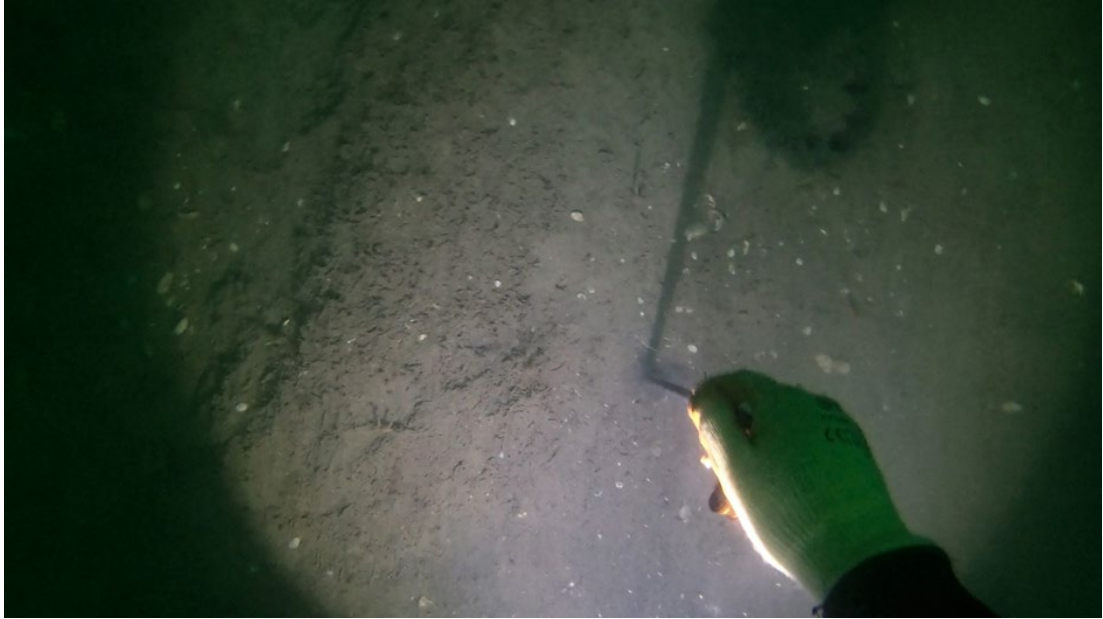
Figure 11: Diver probing into soft silty seabed with head torch on.

- 3.1.24. On reaching the bottom of the shot, at the centre of the Area 2 mound, the divers attached a reel and conducted a circular search, while probing into the seabed and visually inspecting for exposed wreck (Figure 11). At 25m deep there was just enough ambient light to see without the use of a torch. With torches on, vision was restricted to what was immediately in the torch light. With torches off, however, it was possible to make out subtle shapes and undulations in the distance. As such, torches remained off while searching but when potential features were spotted torches were switched on to inspect.

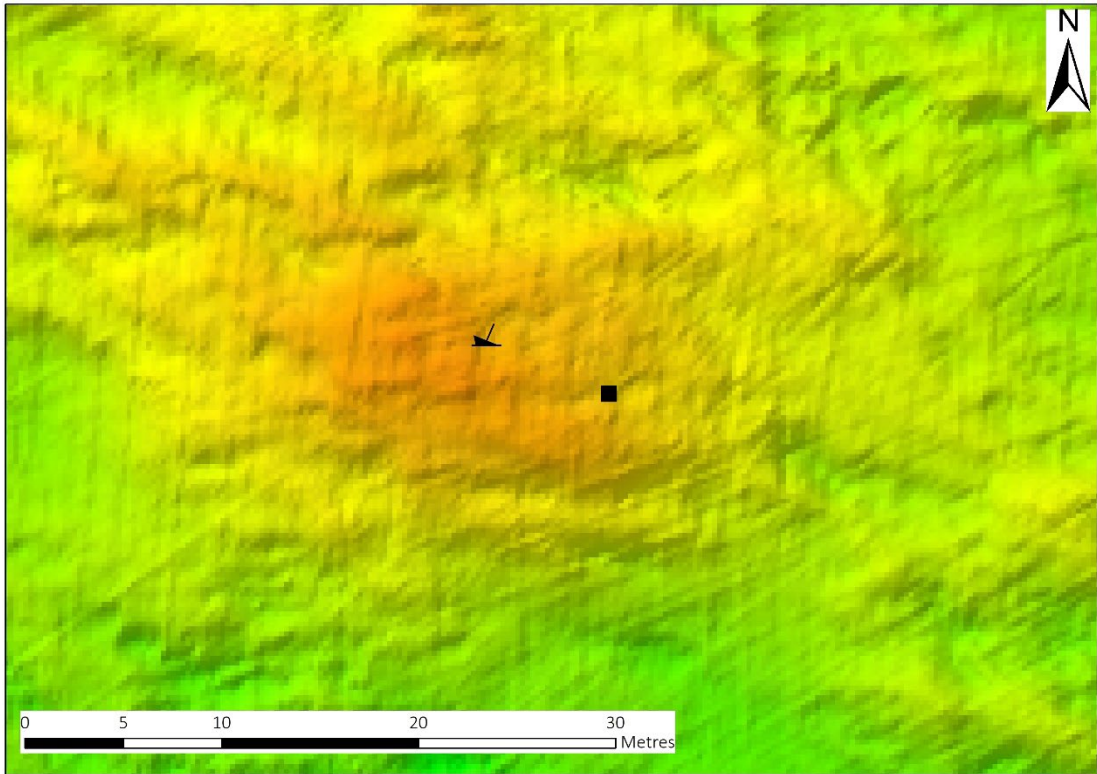
Figure 12: Showing the bathymetry of the mound. The wreck mark identifies the centre of the mound and the black square relates to the hard contact and location of test pit.

- 3.1.26. The surface of the mound was undulating with shallow but obvious peaks and troughs. The bottom of the troughs were approximately 0.3 - 0.5 m deeper than the peaks. When probing during circular searches hard contacts were found all over the mound. The contacts were within c.0.5 m below the surface within the troughs. With bottom time running out, the decision was made to head back and find a contact that was within the bottom of a trough close to the shot (Figure 12).

- 3.1.27. A firm contact was established 5 m from the shot and the probe was placed firmly into the seabed marking the position. The divers then laid a pink ground line from the probe back to the shot to enable the next pair of divers to find it (Figure 12).

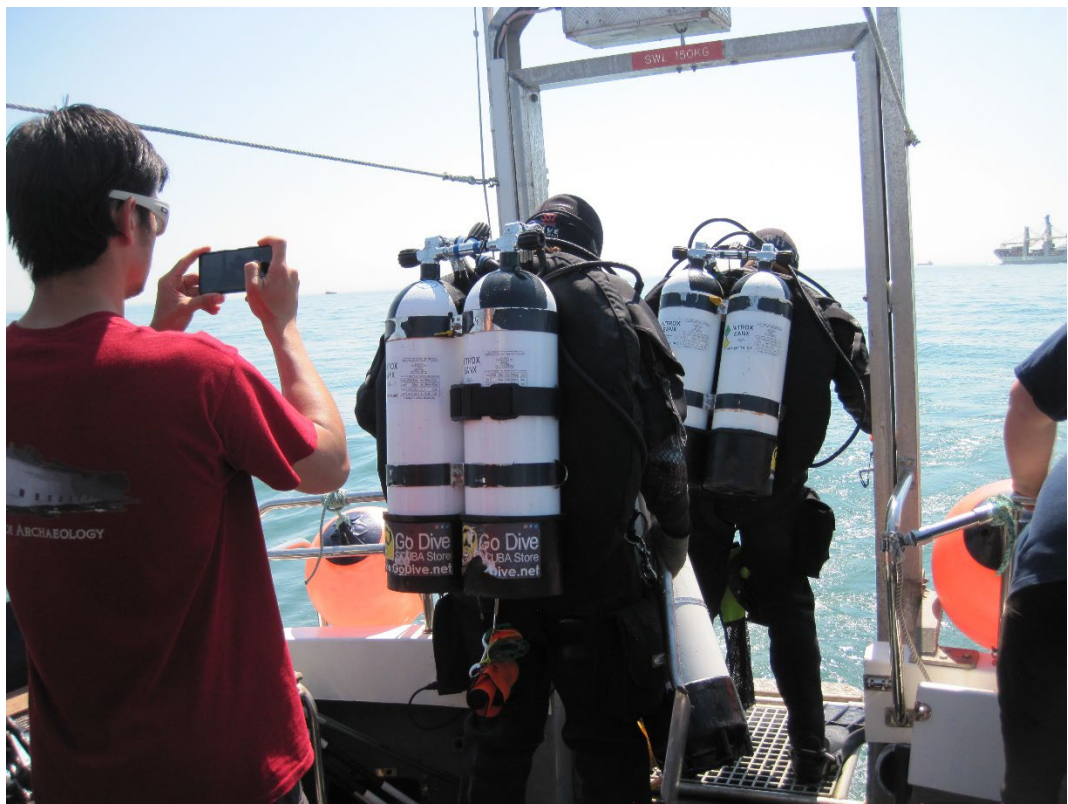
Figure 14: The next pair of divers about to jump in carrying an 18-litre cylinder each to use with the portable airlifts, which had been left on the seabed by the previous divers.

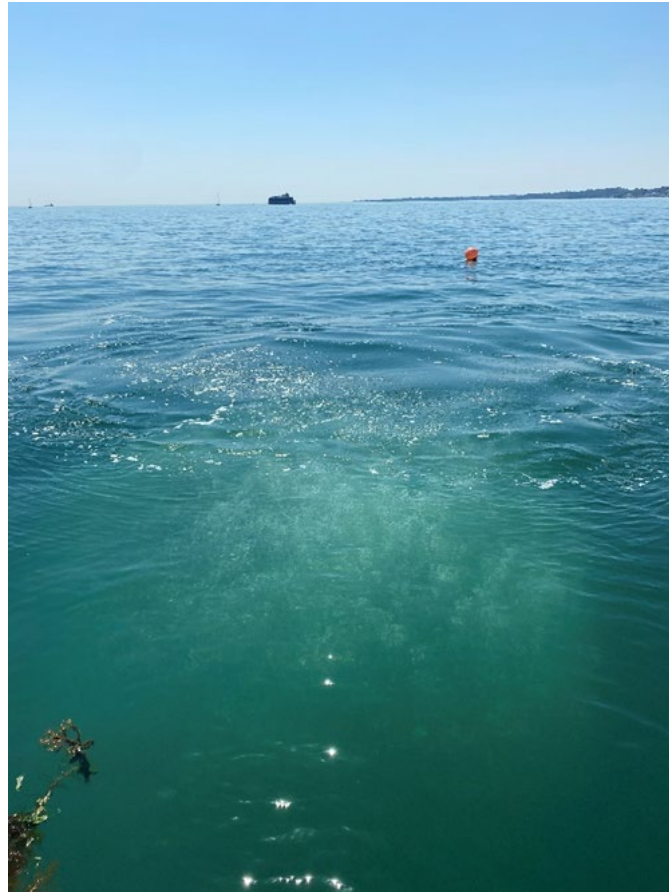
Figure 15: Bubbles from the divers airlifts rising up to the surface from Edgar.

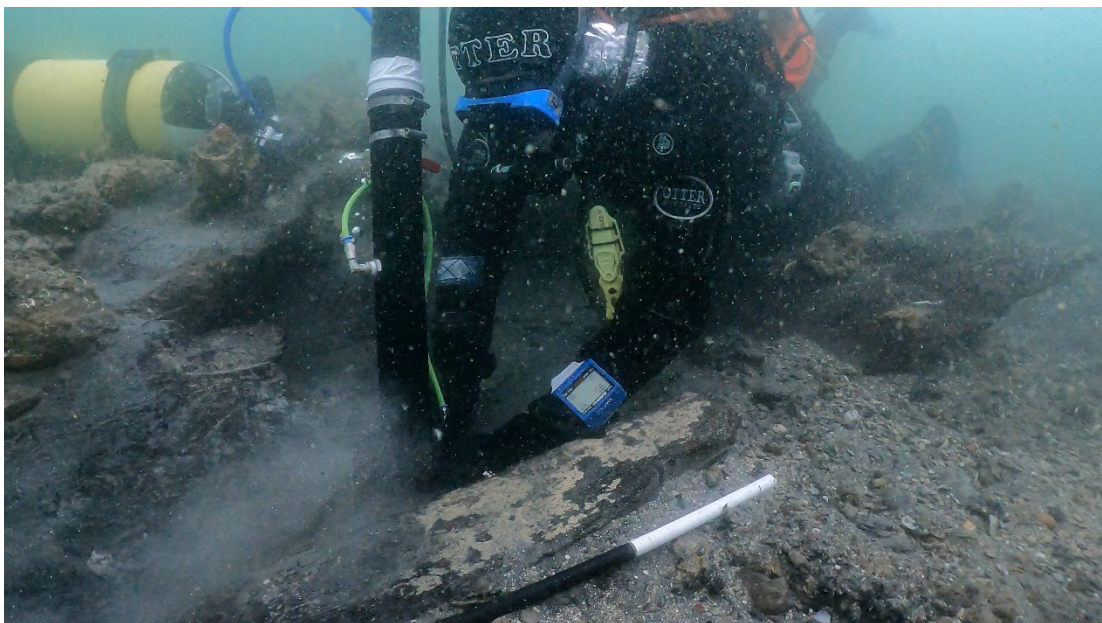
Figure 16: Diver Keith using the portable airlift while excavating the gundeck on the wreck of Hazardous in Bracklesham Bay during May 2023. This image is being used because visibility was too poor on Edgar for taking photographs when the airlifts were in use.

- 3.1.29. Following a quick briefing on the surface by the first pair of divers the next pair of divers were deployed on the centre of Area 2. The new pair of divers were tasked with excavating a small test pit at the location of the probe to identify potential archaeological features. The divers were given a portable airlift with a single 18 litre cylinder to run the airlift (Figures 13-15). Portable airlifts were chosen as the excavation tool because hand fanning, alongside hand trowels, were found to be ineffective on site, due to the fluidity of the surface silts and lack of bottom currents during the dive windows. The airlifts were also a much more controlled method of excavation than hand fanning, which immediately destroyed any visibility. The portable airlift had been trialled with reasonable success on the 2014-2015 excavations of *London* (Cotswold Archaeology 2015). They were also being used to excavate the forward gundeck of *Hazardous* a few miles East in Bracklesham Bay during the 2023 season (Figure 16).

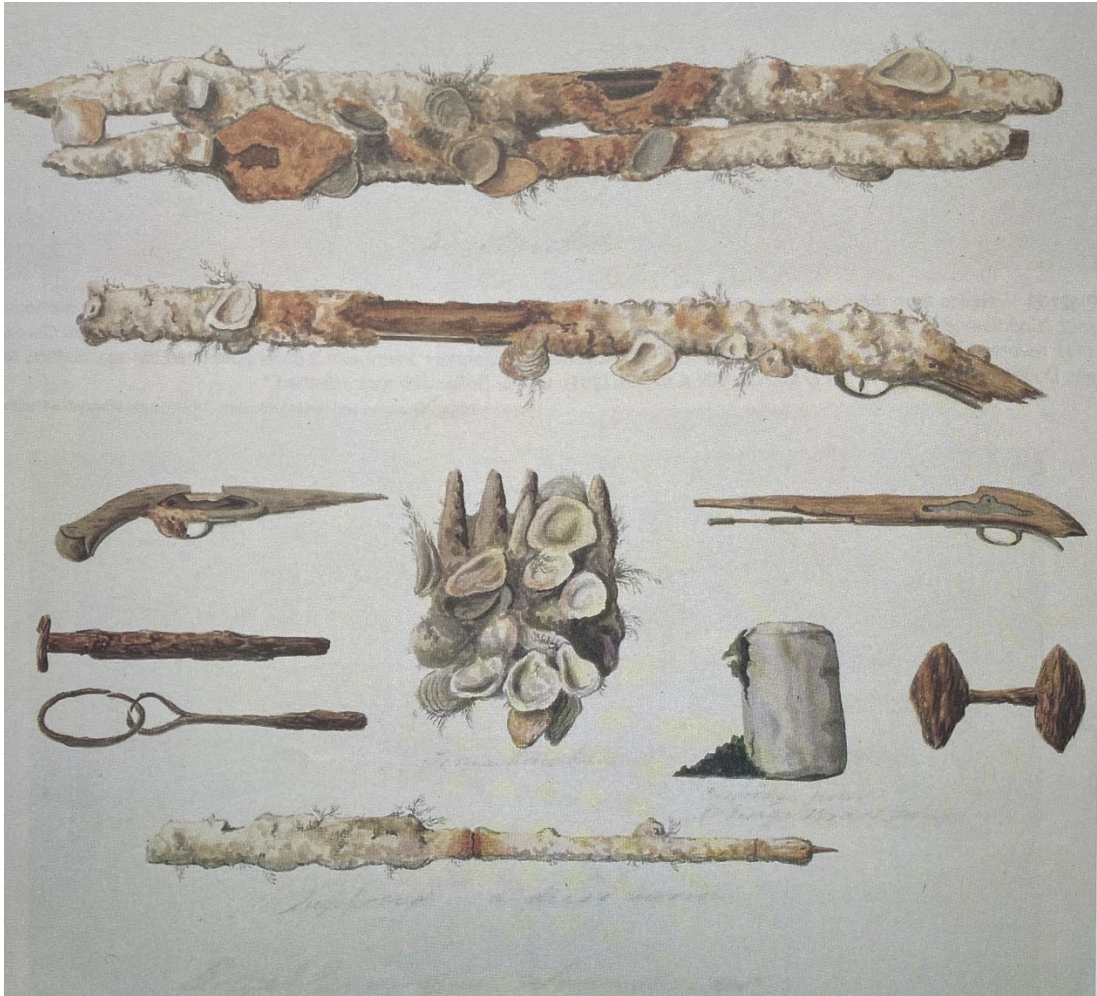
Figure 17: Artefacts recovered from the wreck of Royal George by the diver John Deane. Note how they are covered in oyster shells (Image Portsmouth City Museum and Record Services but copied from John Bevan's book, plate 14, *The infernal Diver* (Bevan 1996)).

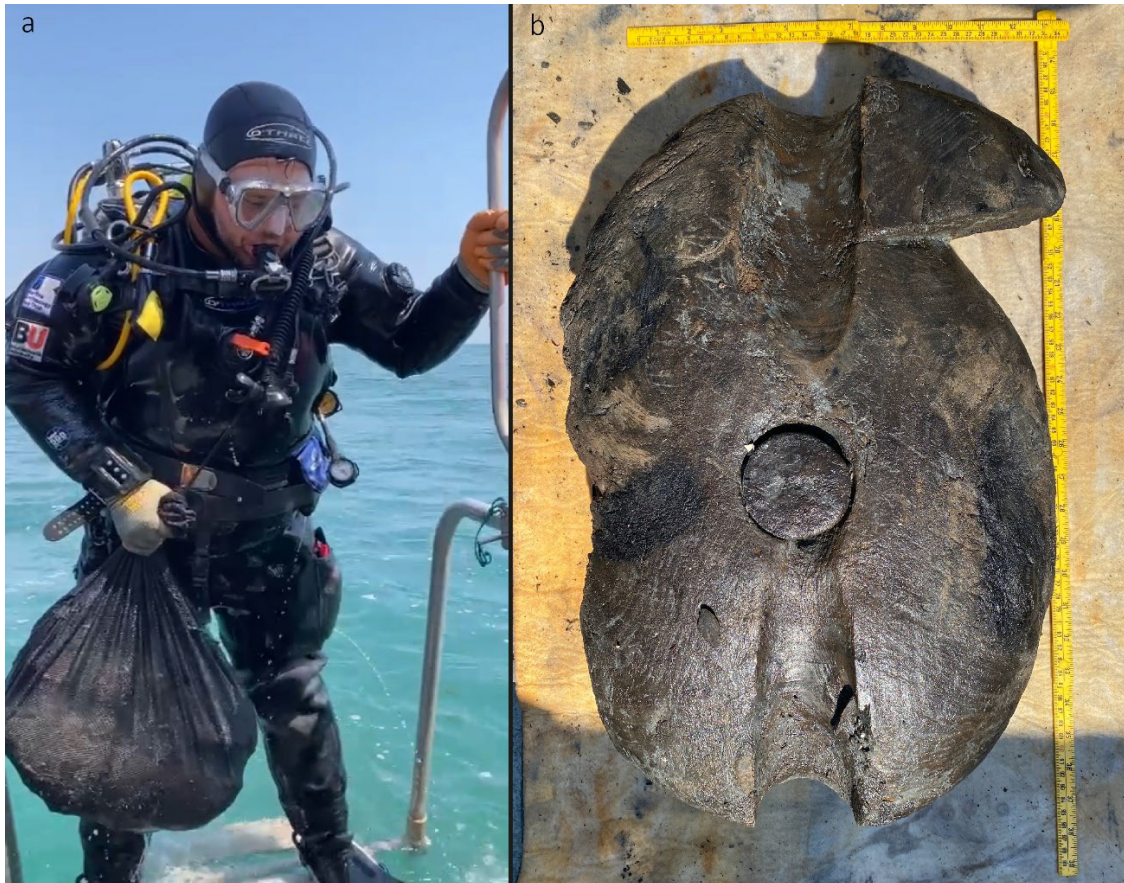
Figure 18: Photograph a showing diver Felix returning to the boat with block in net bag. Image b is the initial photograph of the block taken while still on the boat.

- 3.1.38. Fortunately, the penultimate pair managed to free the block, place the block into a large net bag and recover it by hand to the surface. When on the surface the block was measured and identified as a 19 inch shoulder block. The size and type were consistent with one coming from a large wooden sailing vessel (Figure 18).

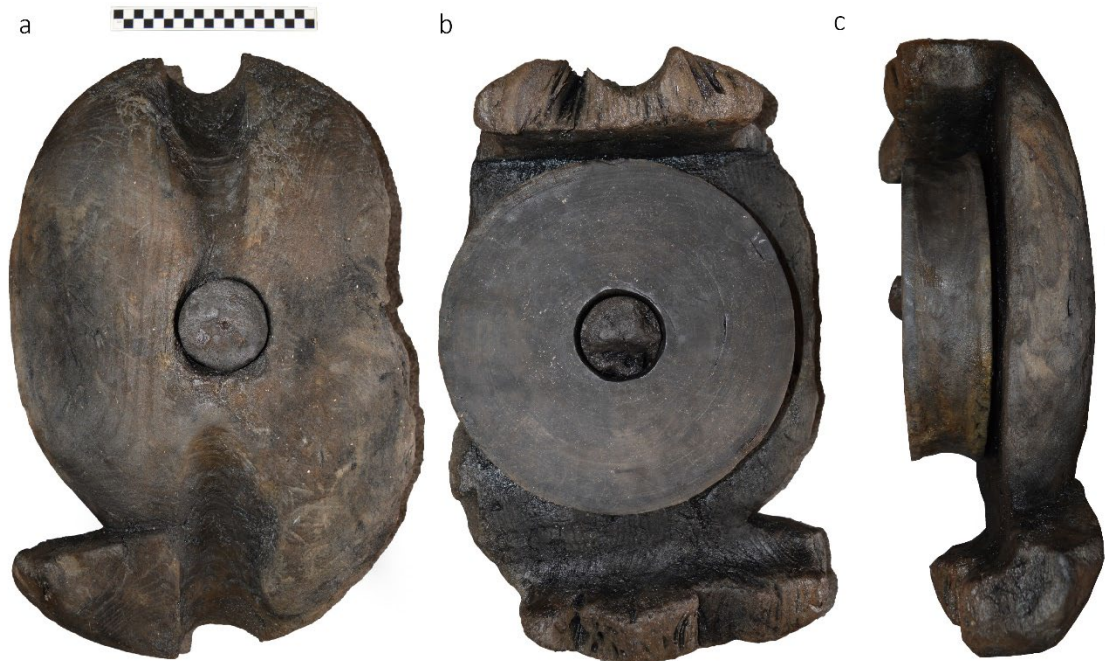
Figure 20: Showing the shoulder block Edgar23A00001. side a shows the the intact side of the shell, side b shows the sheave inside the block due to the other side of the shell missing and side c shows the profile of the block and thickness of the sheave and shell. The scal in the imgae is 20 cm with 1 cm increments.

Edgar23A00001 consists of three parts, the shell, sheave and pin. The shell is unfortunately missing one side but originally would have been turned and cut from a single piece of wood, probably elm. The shell is 490 mm (19.3 in) long and this is the dimension that determines the size of the block. The sheave is made of a hard wood, possibly lignum, and has a diameter of 275 mm (10.8 in) and is 70 mm (2.75 in) thick. The pin has a diameter of 62 mm (2.4 in) and is 160 mm (6.3 in) long. The pin has teredo damage at one end suggesting it is not made of a tropical hardwood such as lignum vitae. At present the wood species is only a

suggestion made from personal experience of recording blocks from Royal Navy ships of the 17 and 18th centuries. Analysis by a wood species specialist will be sought in the future.

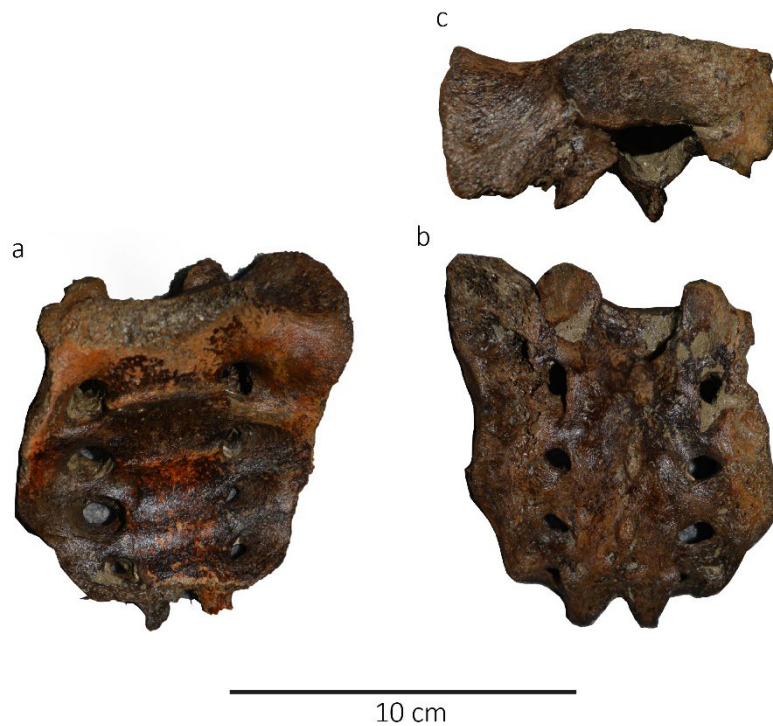
Figure 21: Shows the sacrum recovered from *Edgar*, a is the anterior, b is the posterior and c is the proximal end.

3.1.42. A human remains specialist at Bournemouth University examined the bone **Edgar23A00002**, confirmed it was human and identified it as the sacrum (Figure 21). The sacrum is at the lower end of the spine and, along with the coccyx, is actually variably fused vertebrae. During adolescence the sacral vertebrae fuse into one immobile, wedged shaped bone, known as the sacrum. The coccyx can fuse with the sacrum in later life but it is not present here, suggesting this individual was not elderly; unsurprising on a ship of the line.

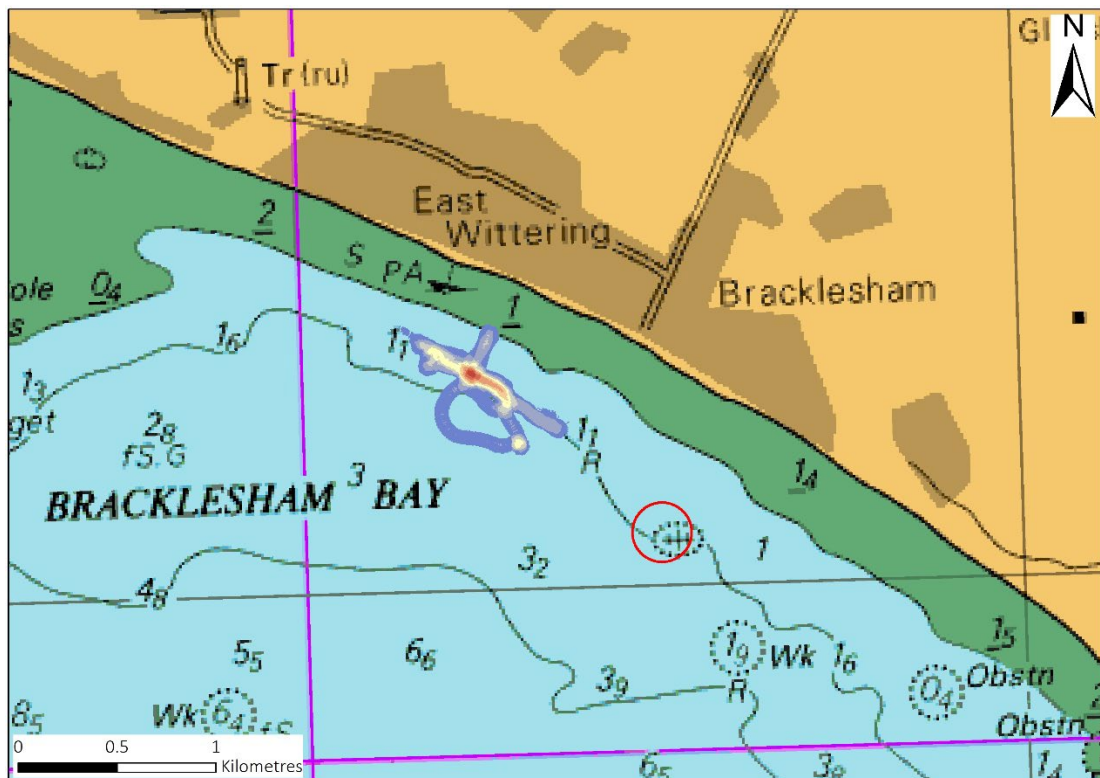
Figure 23: Showing the 2023 magnetometer survey. The red scale represents a large magnetic signature. The red circle is the designated wreck of Hazardous.

As such it was decided to survey an area close in shore from and in line with Bracklesham Lane - 1 km to the west. The width of the survey ranged between 100-200m (Figure 23).

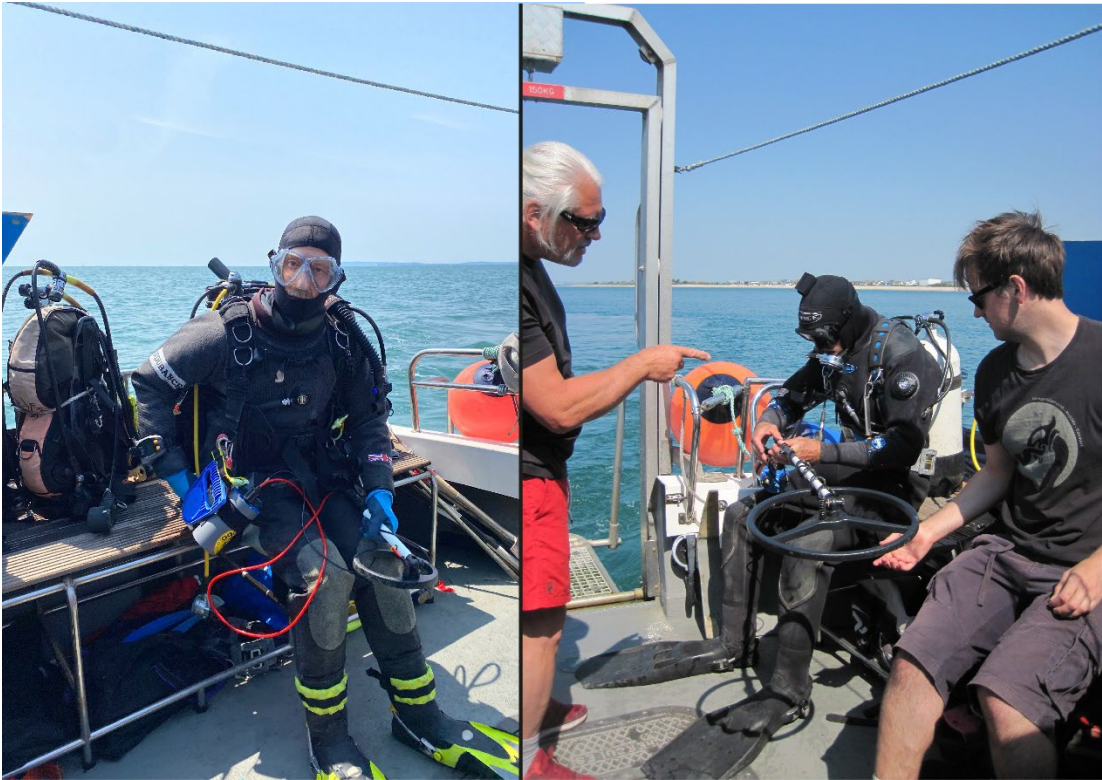
Figure 25: Divers with Aqua Scan metal detectors. Diver on left has the smaller 8 in search loop and the diver on the right has the larger 15 in search loop.

- 3.2.11. Diving was conducted in Bracklesham Bay over a total of three days during the 14-16th June from the dive boat *Wight Spirit*. This time was shared with diving off Hayling Island and Chichester Harbour. For diving in this region of the eastern Solent *Wight Spirit* was based out of Southsea Marina and as such it was only a relatively short steam east towards Hayling and Bracklesham Bay. A total of 27 dives were undertaken by 13 divers, amounting to total dive time of 1,168 mins.
- 3.2.12. Calm seas and bright sunshine during the week of fieldwork led to ideal underwater conditions in the shallow waters of Bracklesham Bay. Underwater visibility was between 3-4 m each day and alongside the shallow depths meant it was ideal for the less experienced members of the team to learn new scientific diving skills, such as circular searches and metal detector searches (Figure 25).

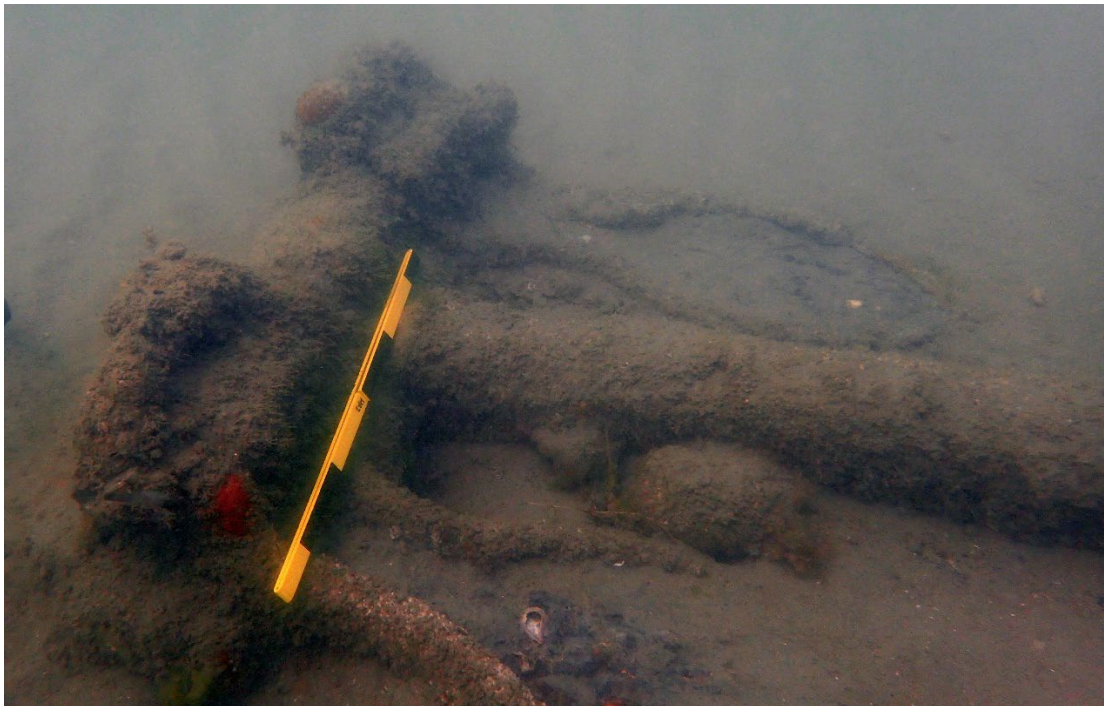
Figure 28: Large stockless anchor, probably a relic from World War II training exercises in Bracklesham Bay associated with Exercise Fabius III.

- 3.2.14. The largest and most promising magnetic target was dived first, and this was identified straight away by the divers. Unfortunately, it was not a cannon, anchor or pile of shot associated with an early 18th century warship, but it did have another military association. The target was in fact a large stockless anchor (Figure 28), with a long, concreted length of stud-link chain attached for several metres, which disappeared into the sandy seabed. Similar anchors and length of chain are found further offshore, which provided moorings for landing craft during the Second World War.
- 3.2.15. The anchor and chain could have been associated with Exercise Fabius III involving the Canadian forces. This was a D-Day invasion exercise where Canadian forces practised beach landings in Bracklesham Bay in preparation for landing on the beaches of Normandy (Figure 29).

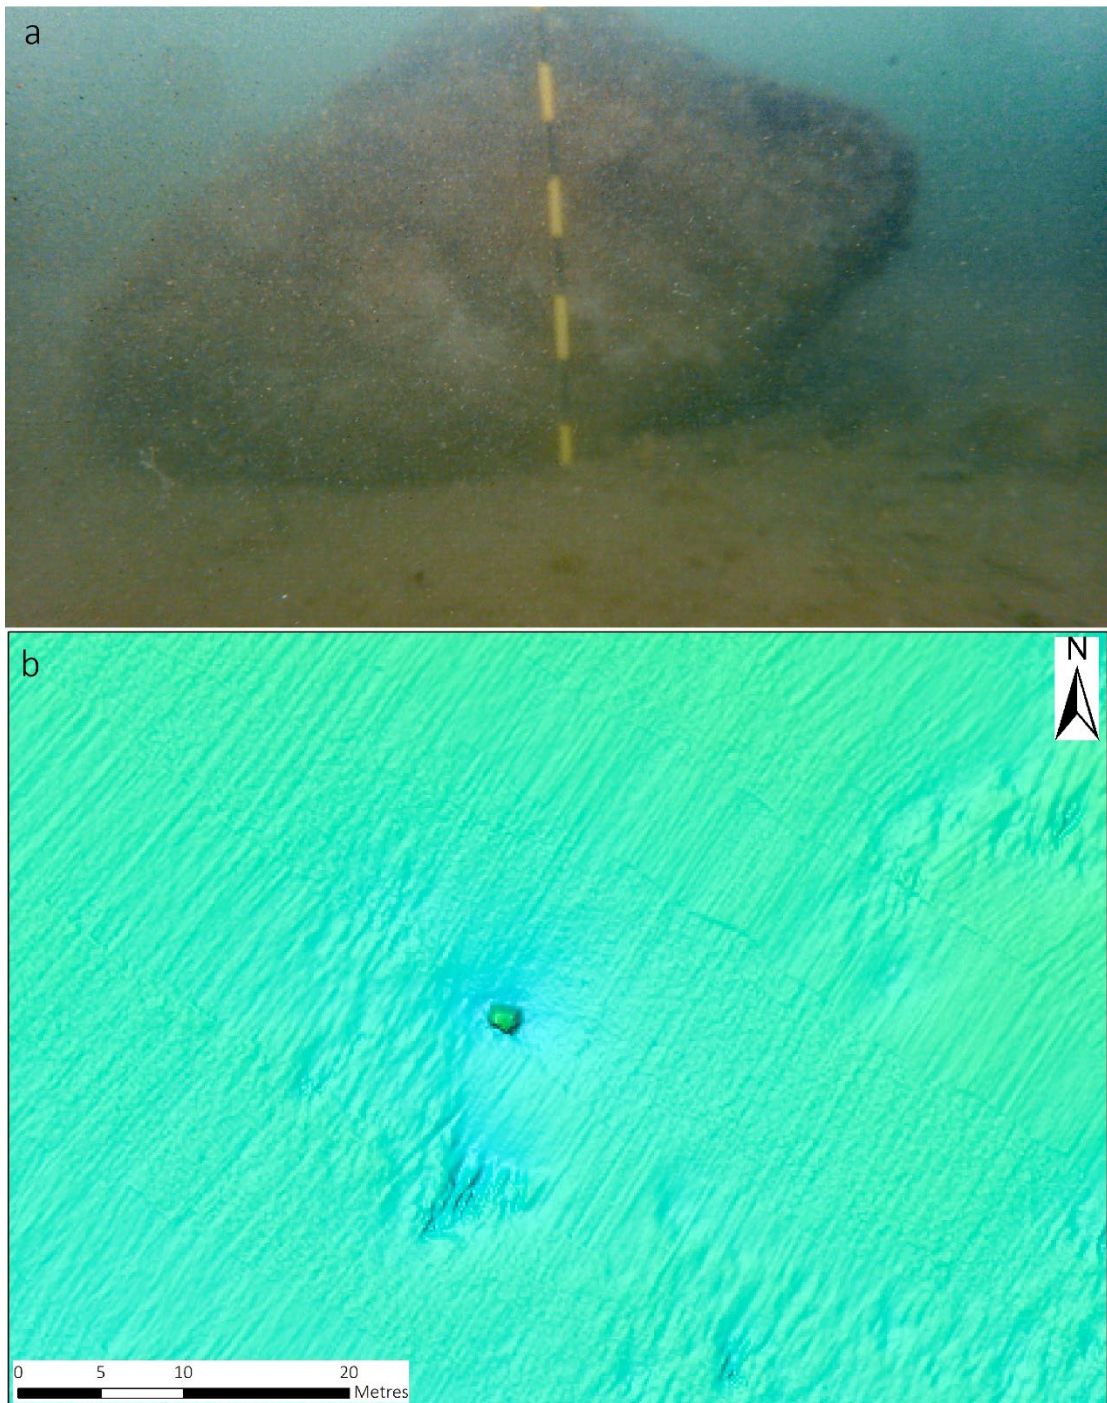
Figure 30; One of the bathymetry anomalies confirmed by diver ground-truthing as a natural boulder.

- 3.2.19. Sadly, none of the anomalies dived turned out to be associated with a site of a shipwreck, although some loose and disarticulated timbers were found, suggesting possible remains somewhere in the vicinity.
- 3.2.20. The most notable anomaly was confirmed as a large boulder, standing 1 m proud of the seabed, and therefore natural (Figure 30). Despite the disappointing results it was a good exercise for those members of the team who were learning new underwater search skills.

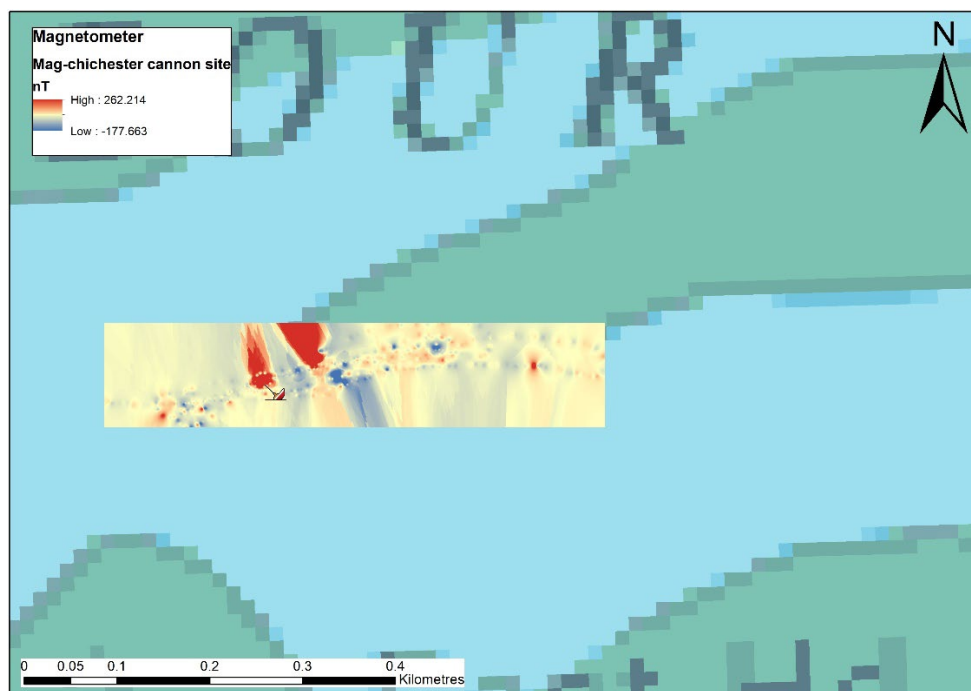
Figure 33: Showing the magnetometer survey inside Chichester Harbour in relation to the position of gun given by the fisherman.

- 3.4.4. In the spring of 2023 the author returned to the position with the Hazardous Project Group to conduct a magnetometer survey. Very close to the position given by the fisherman a large magnetic target was found (Figure 33) and, as such, was added to the list of dive targets.

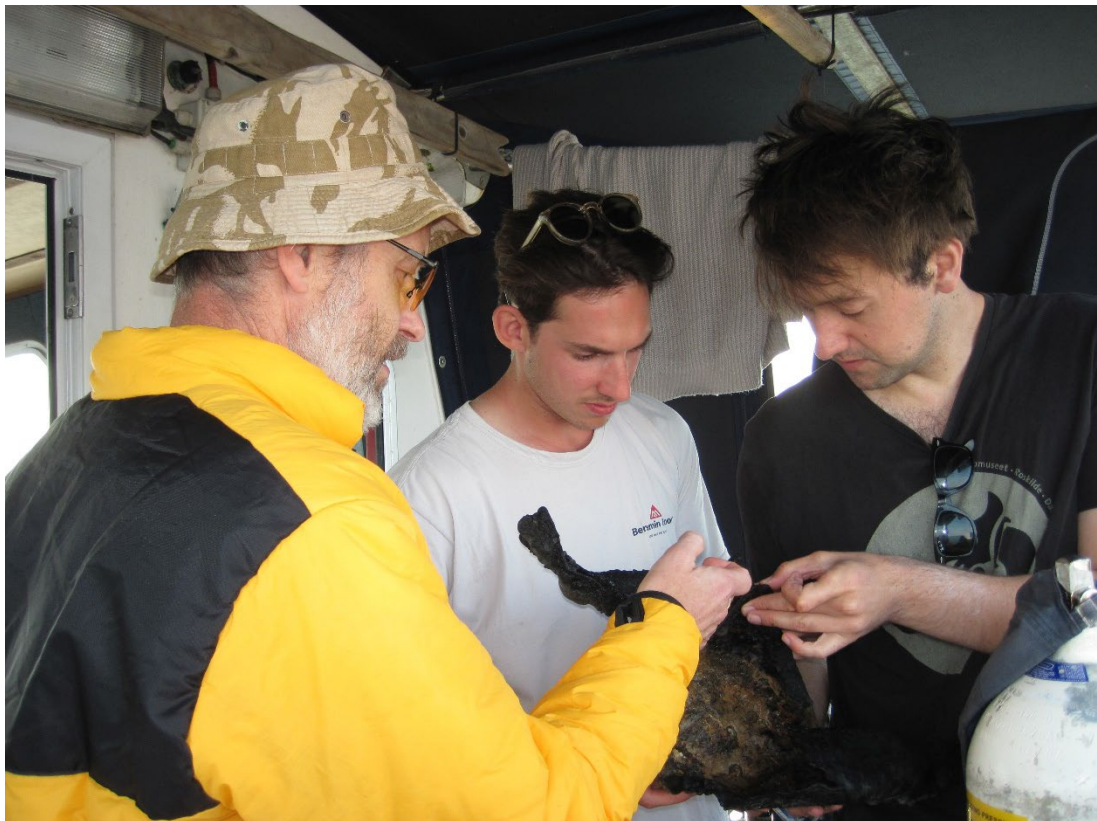
Figure 35: Divers, Dave, Cal and Jack inspecting the piece of fuselage.

- 3.4.9. On the first dive the divers described a clean gravel bottom, sloping up to the north and down to the south representing the north side of the channel. The divers came across a loose piece of aluminium, which they recovered.
- 3.4.10. On inspection of the piece of aluminium it was found to be sheet aluminium with rivets and sections of framing and, as such, it was consistent with a piece of aircraft fuselage (Figure 35). This was quite exciting as it confirmed what the Harbour Master has believed about this being close to a location of an aircraft. However, the divers had not located any more wreckage in the area of seabed that they searched, therefore further searches were necessary to find the actual site of the wreckage. The next pair of divers also returned the piece of fuselage back to the seabed.
