# SS Faith 1852-1855

A report on the investigation by members of the British Sub Aqua Club  
of the remains of an early screw steamship sunk off the Isle of Wight in 1855

**A REPORT TO THE BRITISH SUB-AQUA JUBILEE TRUST, MARCH 2017**

# **SS *FAITH* PROJECT REPORT**

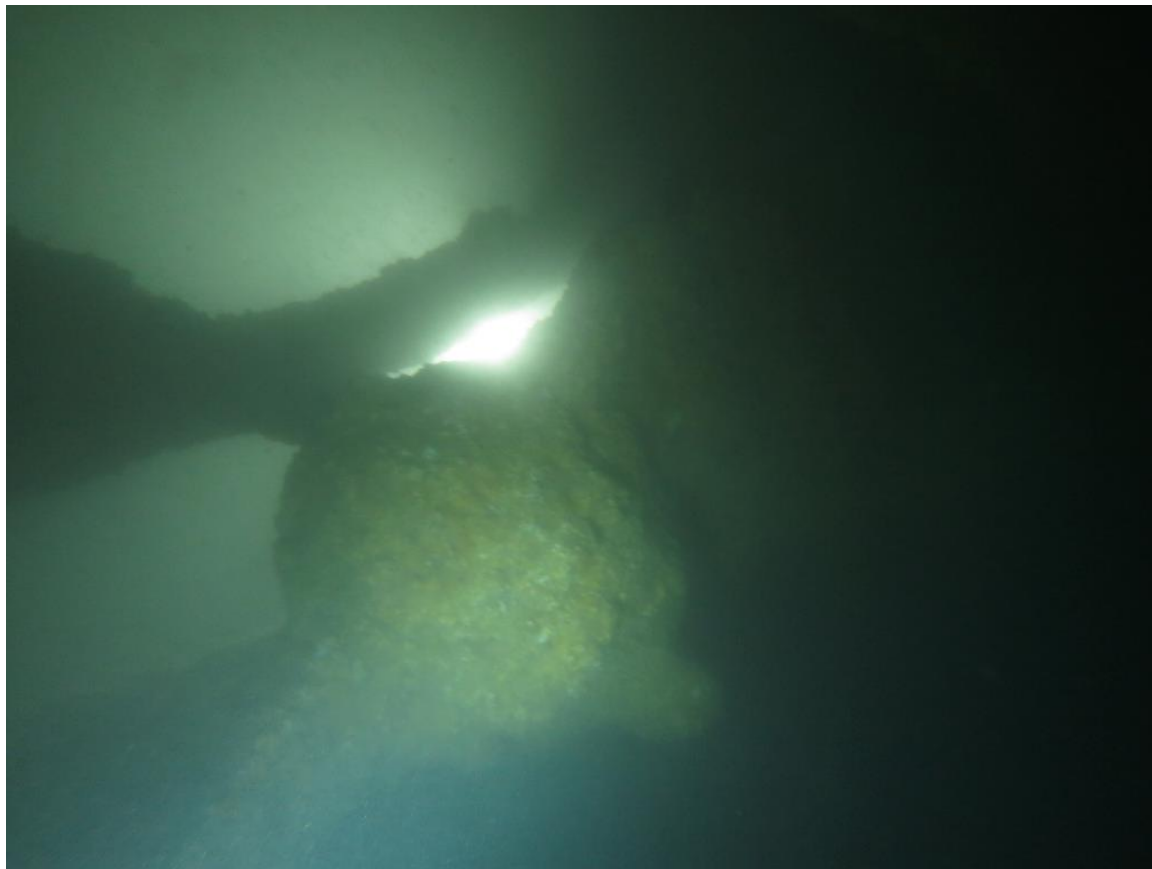
Figure 7. Propeller blades with boss © Dave Robbins 2012. The image shows the generally poor visibility, but the broken propeller blade can be seen to the left of the image.

The blades were probably of cast iron, and this could have been why one shattered if the propeller was still working as the ship hit bottom. We should question how the propeller was immobilized during sailing. The options are by feathering, lifting or fixing vertically.

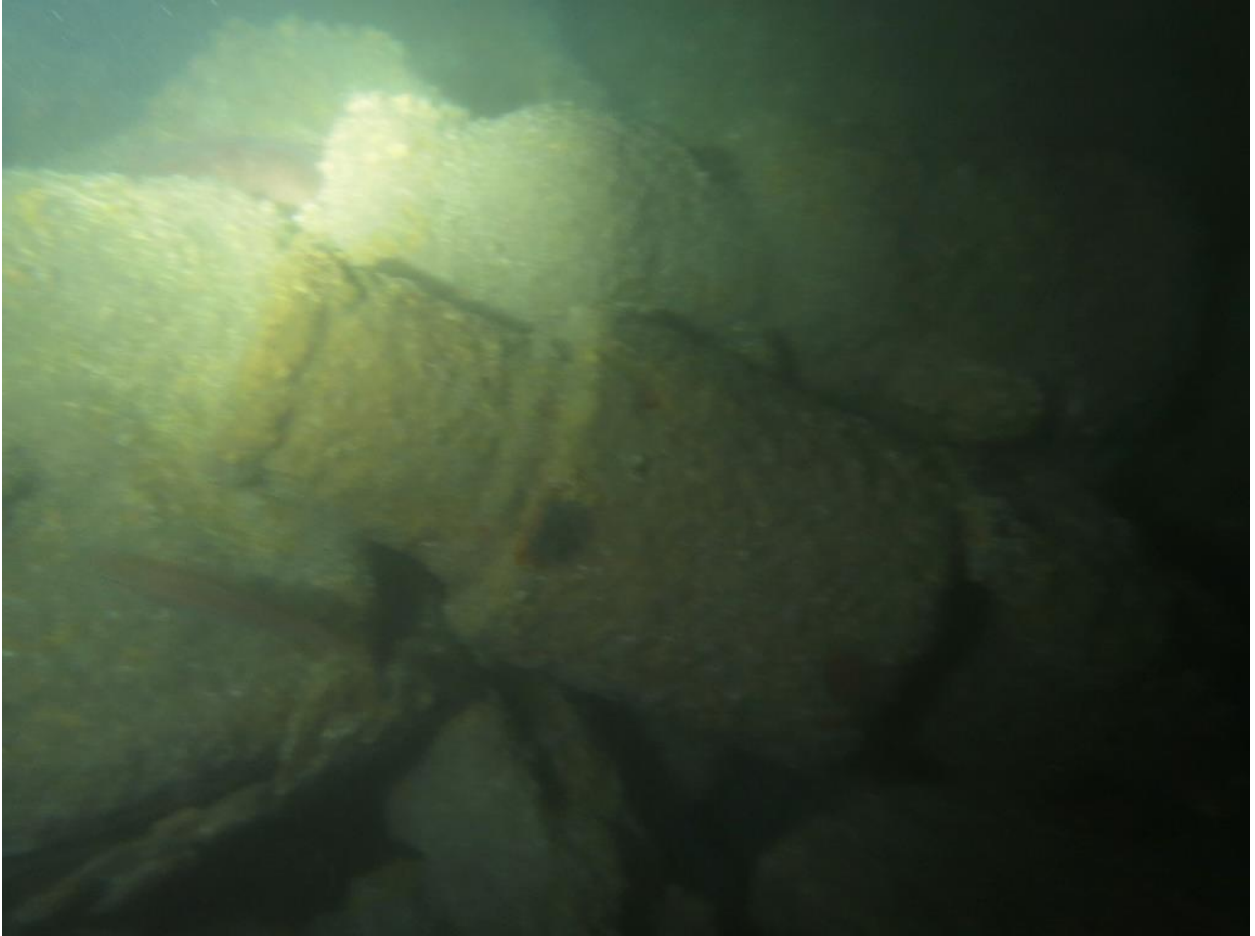
Figure 9. Pintle from rudder © Dave Robbins 2012

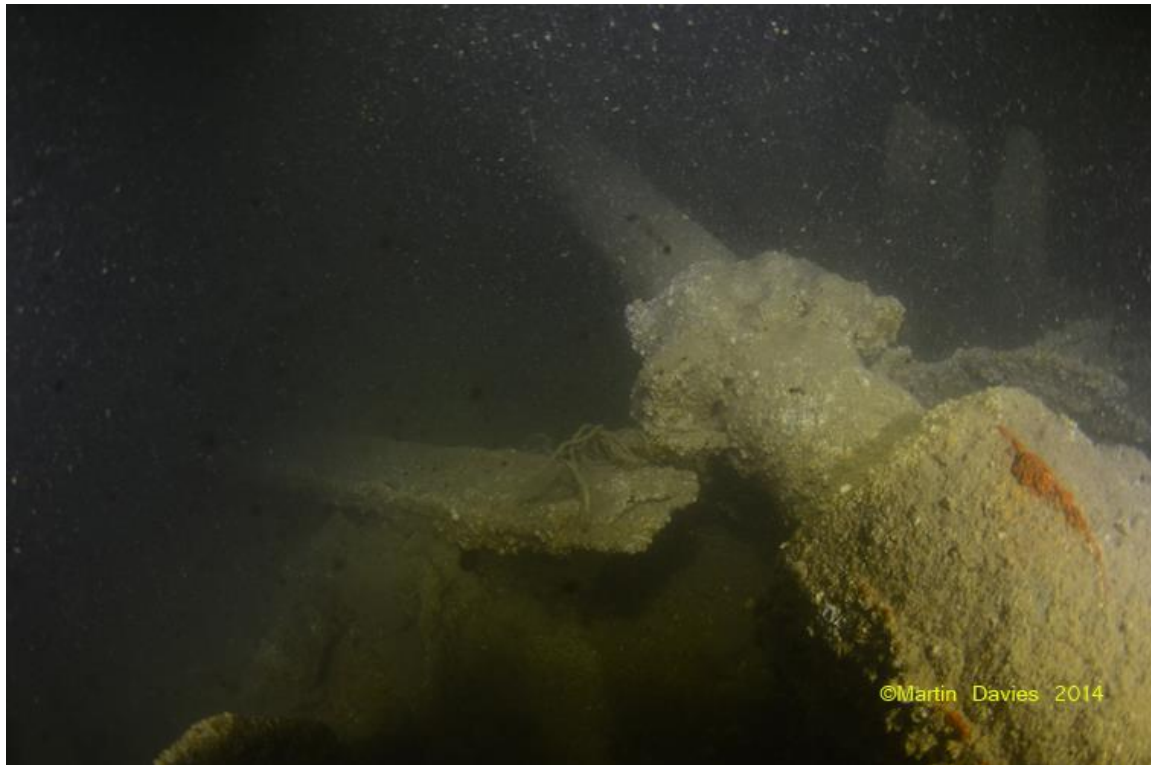
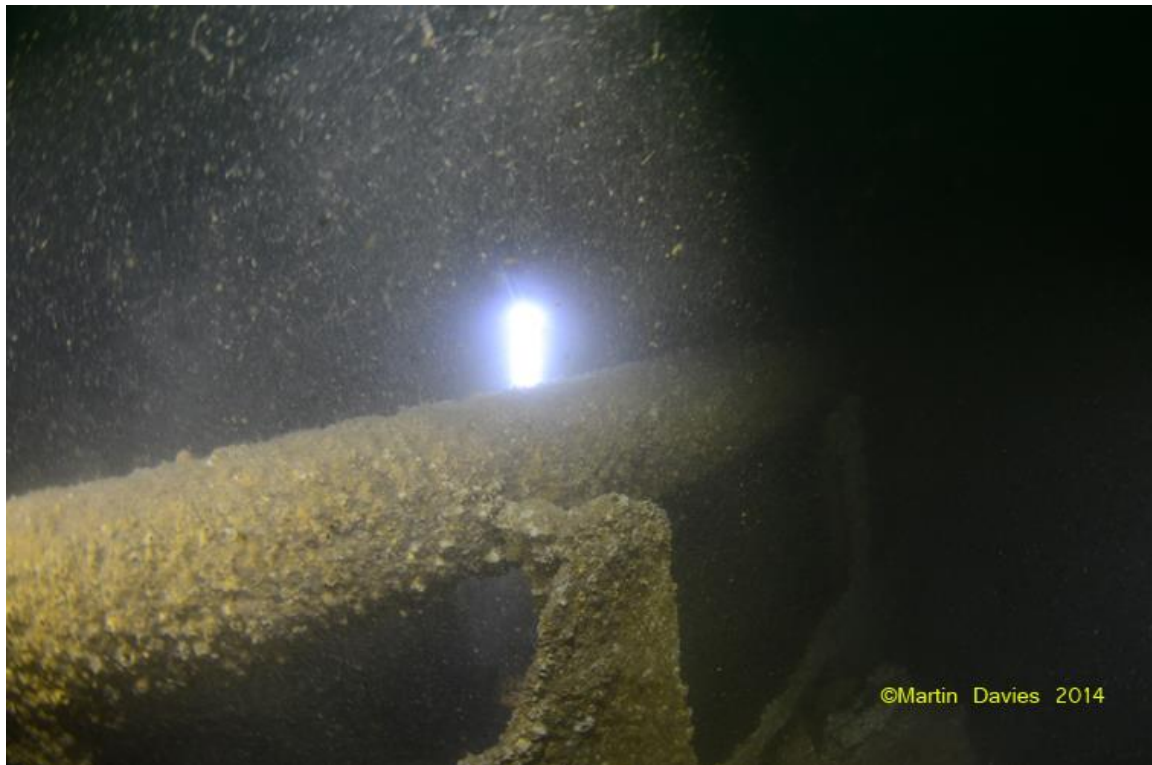
Figures 10 and 11. Propeller shaft showing the shaft, flanges and thrust block and bearings

The length of the propeller shaft was confirmed at 22.84m between the propeller boss and the final thrust block before the engine. The circumference was measured as 350mm. The overall length of machinery from propeller boss to forward edge of the boiler was 29m. As the engine and boilers were mid-ships at this period then the overall length of the wreck conforms to the measurements we have for the *Faith*.

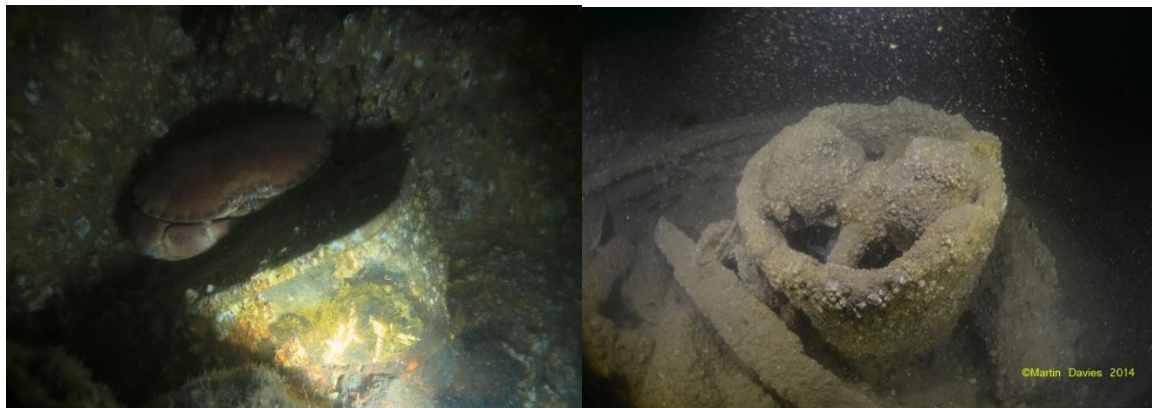
Figure14. Oiler and gas cylinder seen near engines. Oiler © Dave Robbins 2014

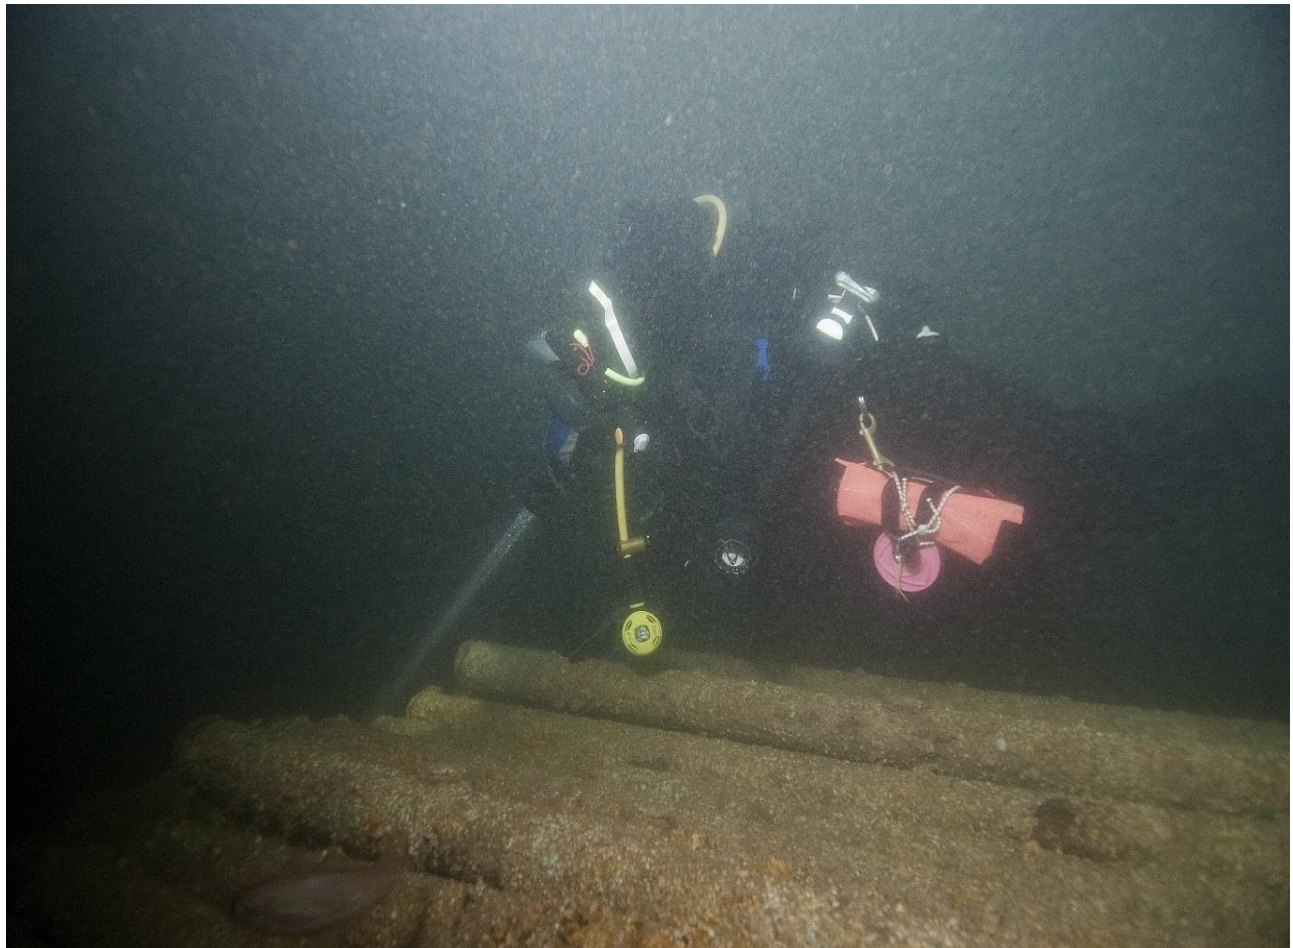
The dive in 2012 showed the boiler tubes as tidily organized in a rectangle, with lots of life living in it. Aspects of the metal box used to contain it were evident. There appeared to be only one level of tubes, suggesting it was not a two-layered box boiler. By 2014 it was clear that some disturbance had taken place as the tubes were disorganized, and some had fallen off the stack.

Figure 16. Image from 2012 showing boiler tubes in situ © Barry Jarvis 2012.

It is possible to suggest that she was a box boiler, perhaps even double stacked. A future dive should include careful images based on archaeological convention so that conclusions can be drawn with more confidence.

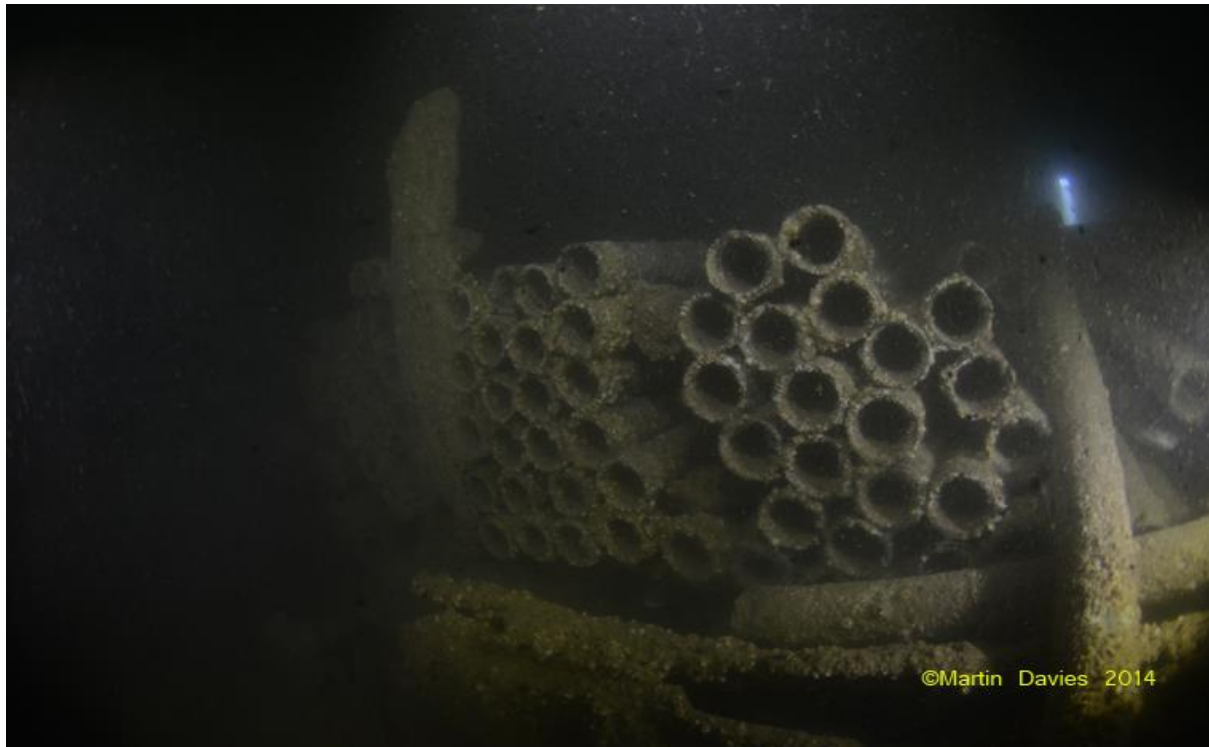
Three separate dives on the boiler showed evidence for the remainder of a box base 3.6m wide. There were eight layers of tubes which were two metres long and each tube was nine mm in diameter. These measurements were consistent over three diving events with three different buddy teams. By the final dive in 2016 it became clear that the tubes' original square profile was changing, as tubes seemed to be falling away from the stack.

Figure17. Boiler tubes showing evidence of a box-like metal structure

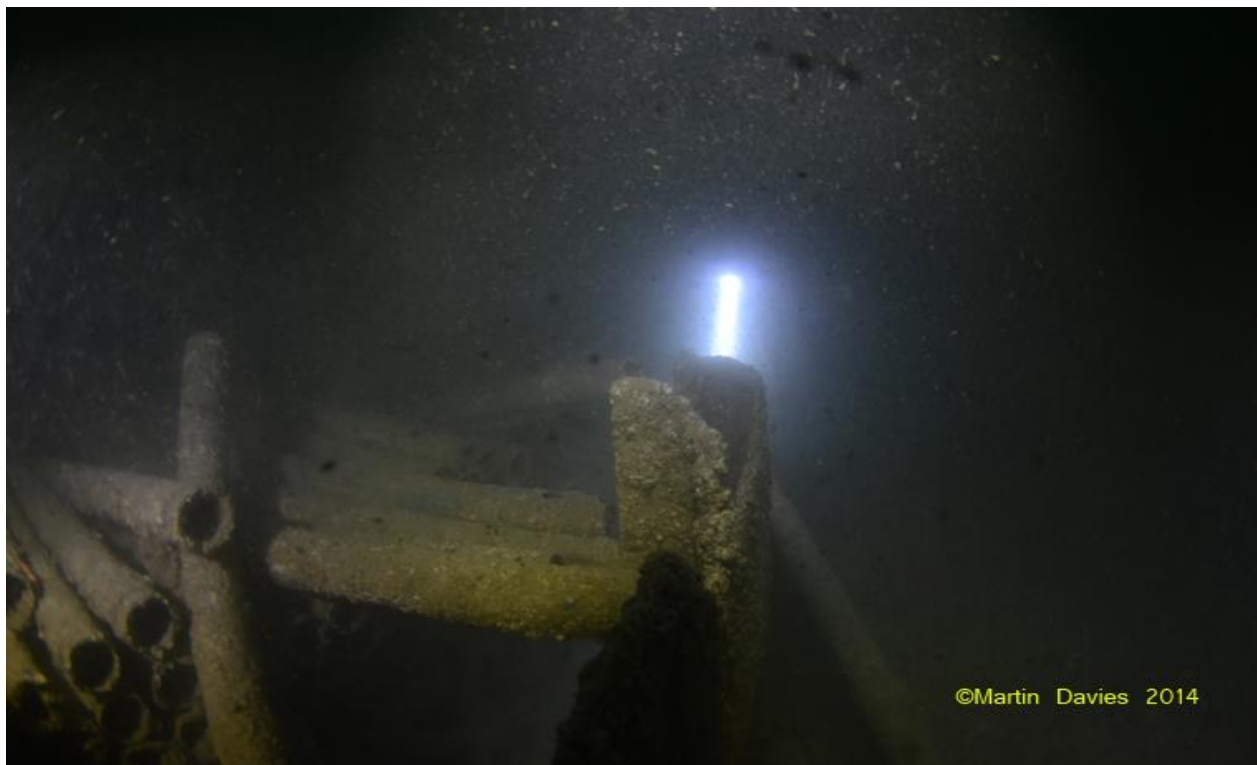
Figure 18. Boiler tubes possibly showing more of the containing iron work and showing the beginning of some structural breakdown.

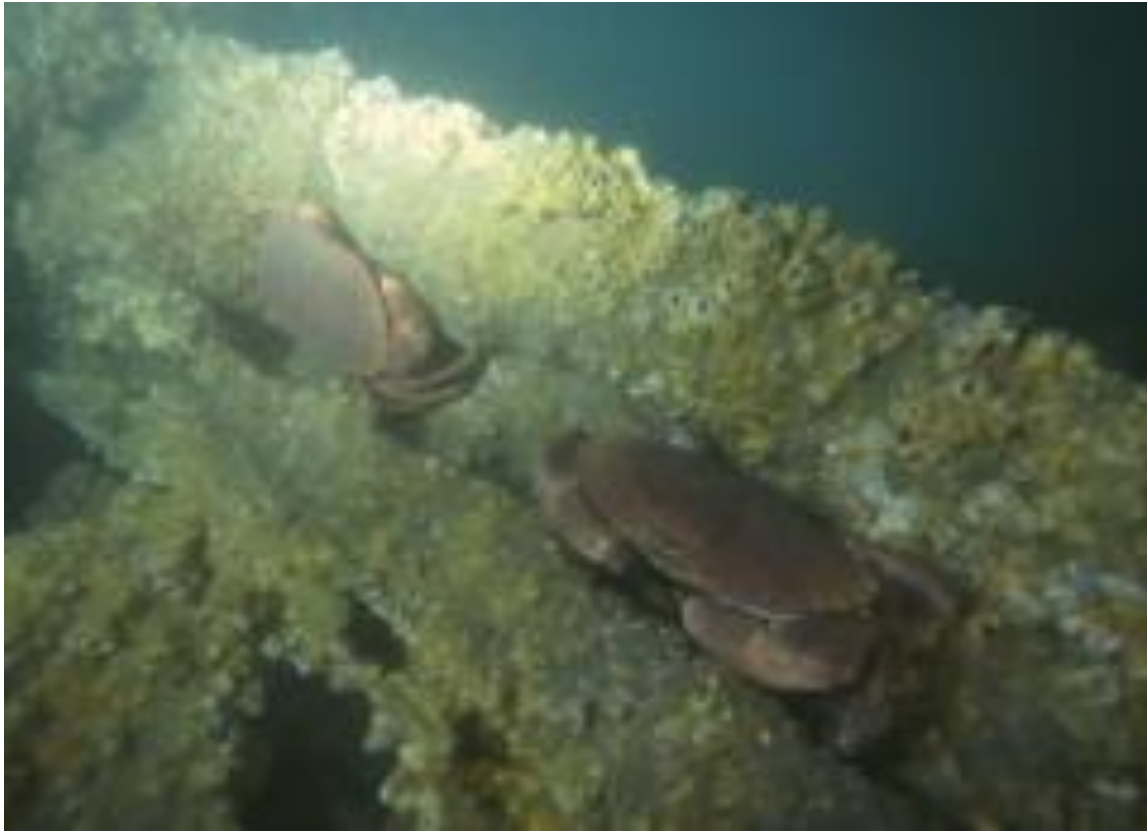
Figure 19. Part of the hull providing shelter for crabs © Dave Robbins 2012.

The remains of the hull are rare. The frames are more evident, and there are some parts of the hull visible as fragmentary plates. Iron has its limitations after 160 plus years underwater.
