The Messerschmitt Bf110 Project

Discovery is just the beginning

Project Report

September 2021

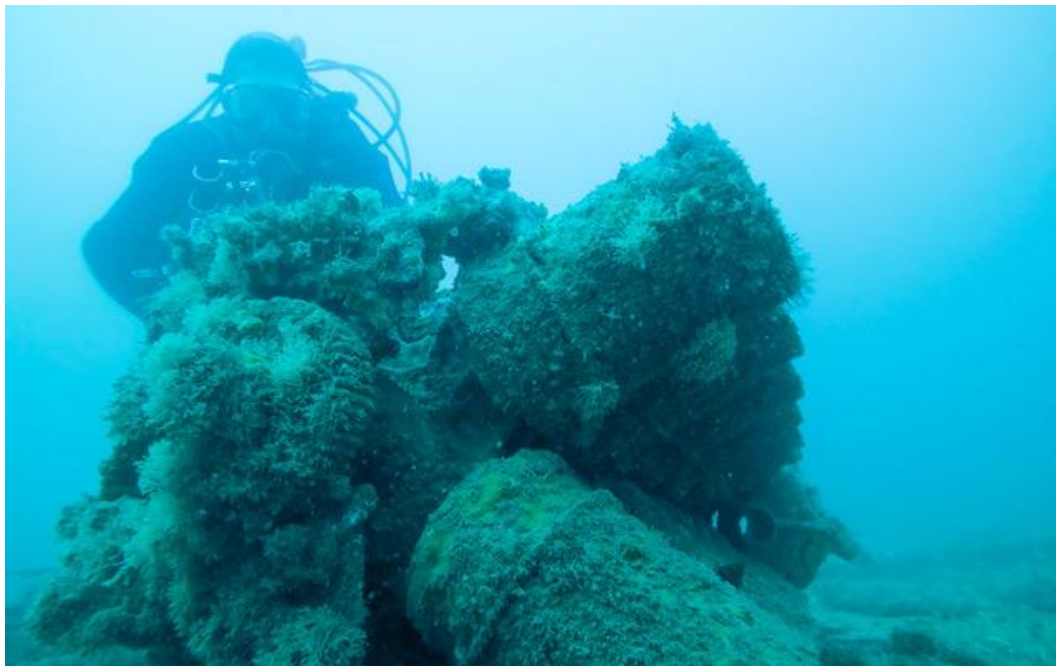
The first available evidence of the wreck site to the team came from John's initial video footage of the site (Figure 2). Early thoughts were that it might be a [de Havilland Mosquito](#) – a multirole combat aircraft which used twin RR Merlin V12 engines. But the chances of a lightweight, wooden plane surviving ~80 years underwater were slim to none. This theory was also discounted on account of the Merlin's engines being upright V engines, with the crank at the bottom; the engines had a dished cover on the crank to hold the oil. In contrast, the cranks on the engines at the wreck site have a dead flat cover meaning it had to be an inverted V engine. One nation in particular used an inverted V engine design: Germany.

Figure 2: Photo of the Daimler-Benz 600 Series V12 engine which helped identify the aircraft type.
Photo: John Coward.

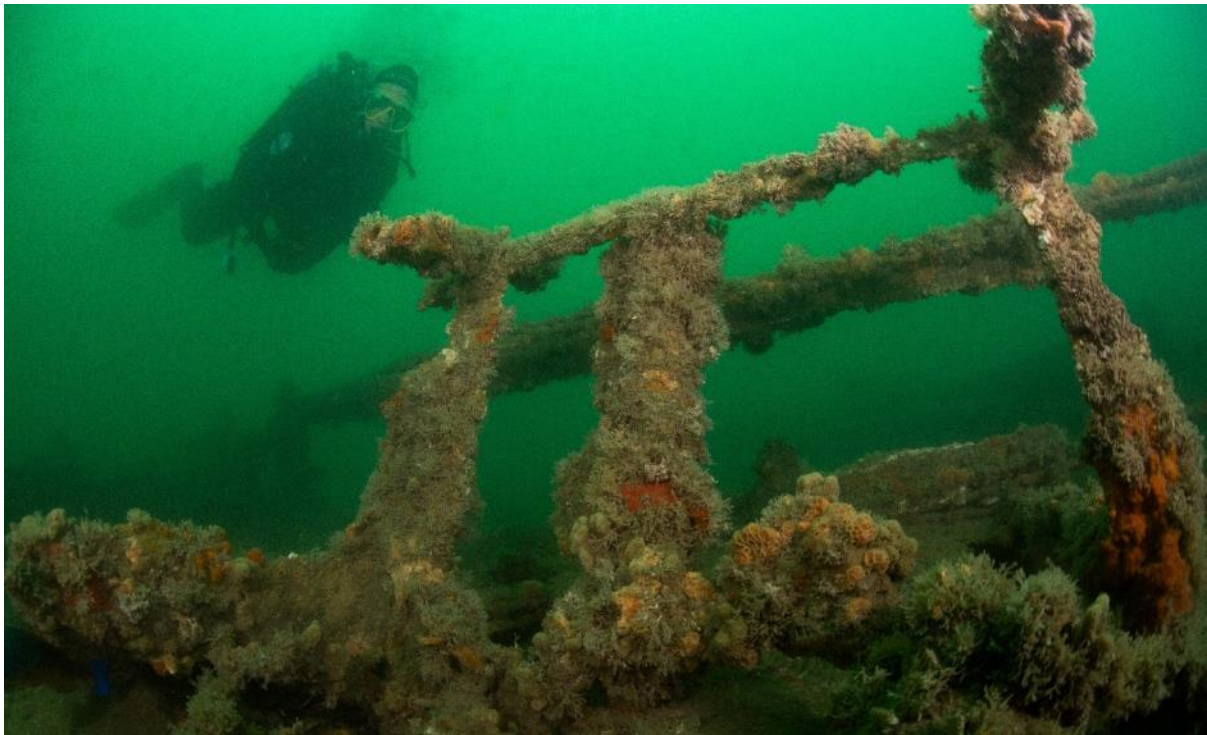
Figure 4: The portside nacelle which would have housed the V12 engine. Photo: Matt Doggett.

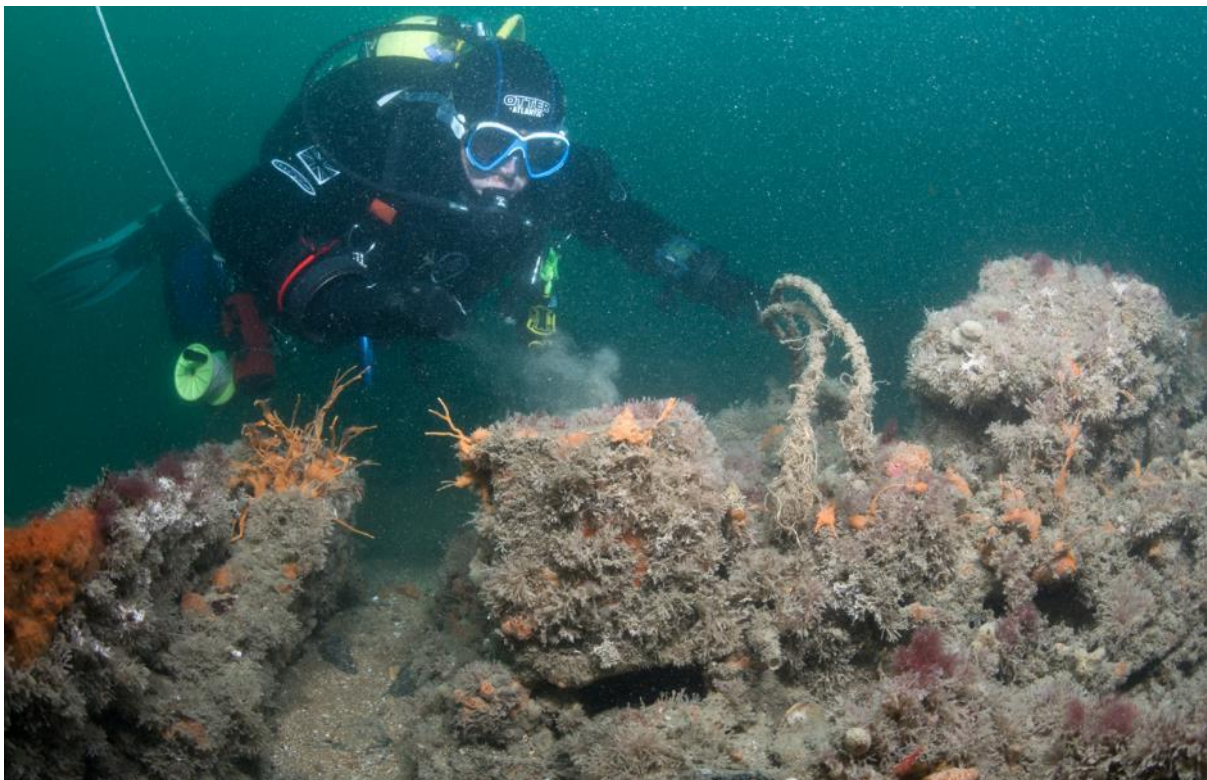
Figure 5: Matt Burleigh inspecting the cockpit remains of the Bf110. Photo: Lin Baldock.

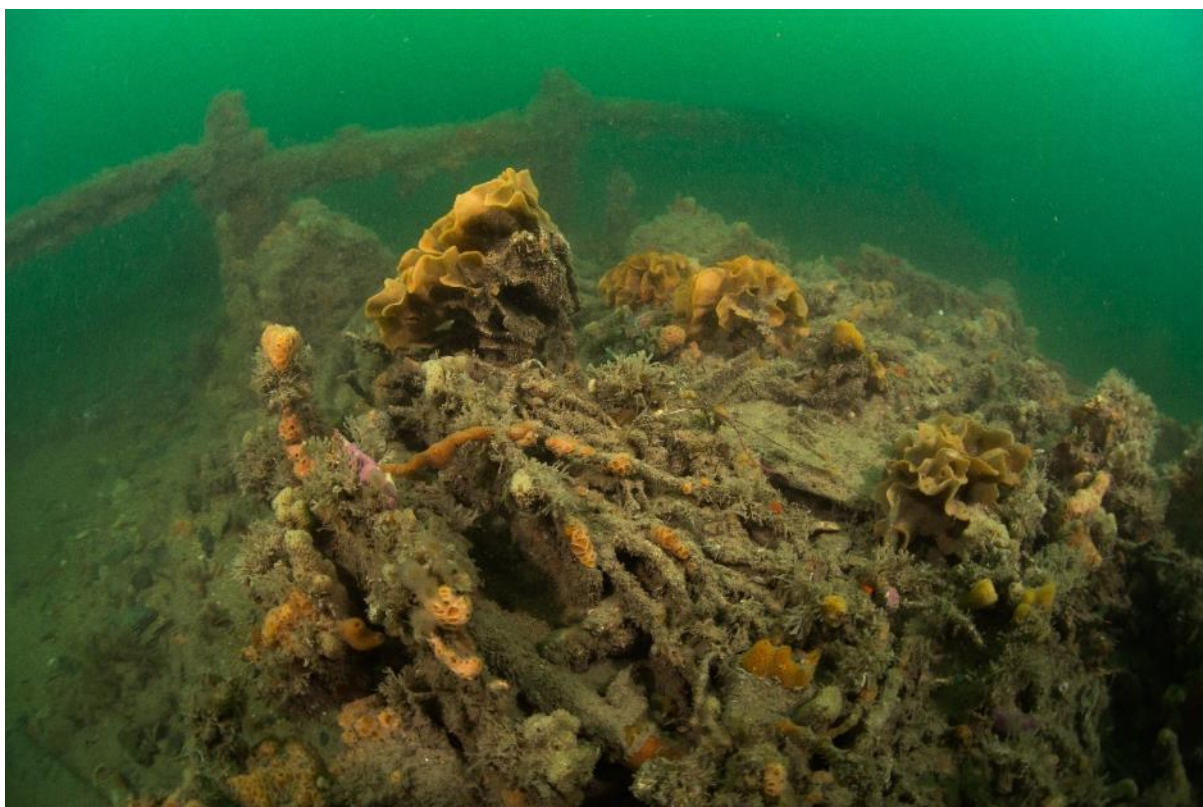
Figure 6: Remains of flight controls, radio equipment, air hoses and various armaments overgrown with seabed fauna and covered in coarse sediment deposits (top and bottom). Photos: Matt Doggett.

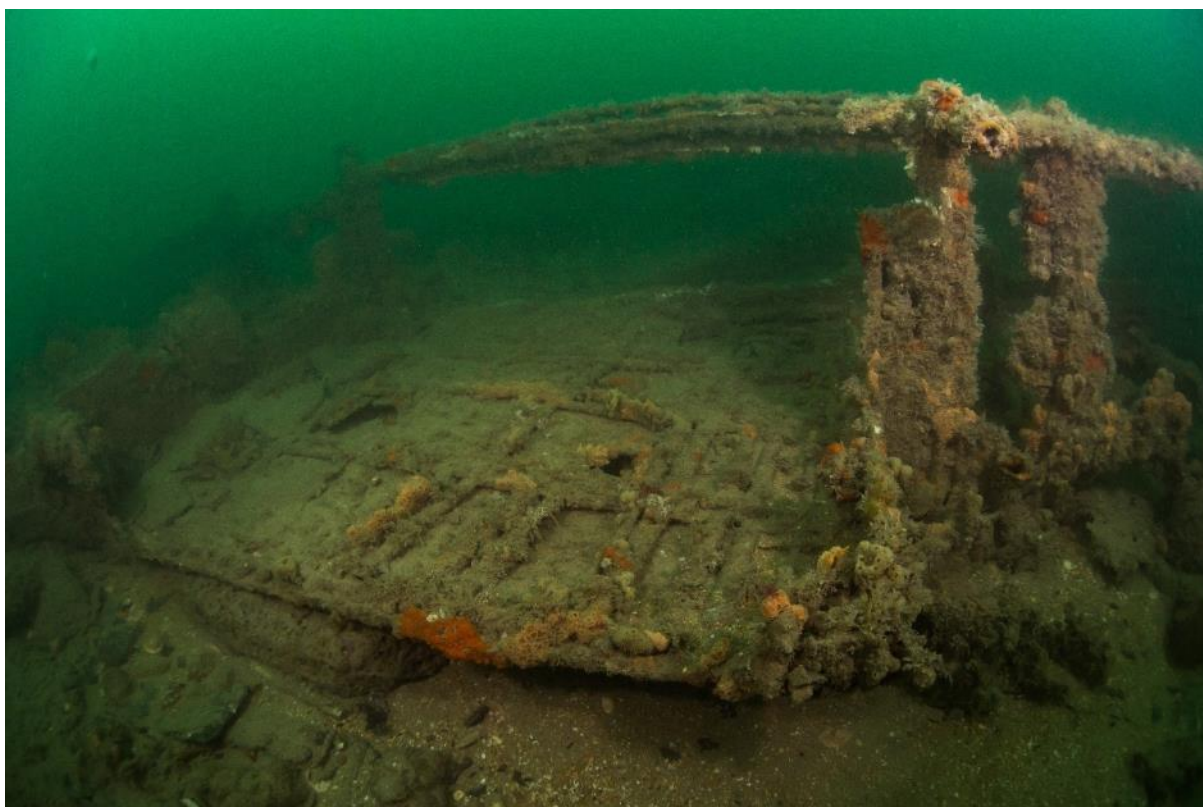
Figure 17: The lattice framework in the wing structures was where the forward and rear fuel tanks were housed. The nacelles which supported the engines are visible on the right. Photo: Matt Doggett.

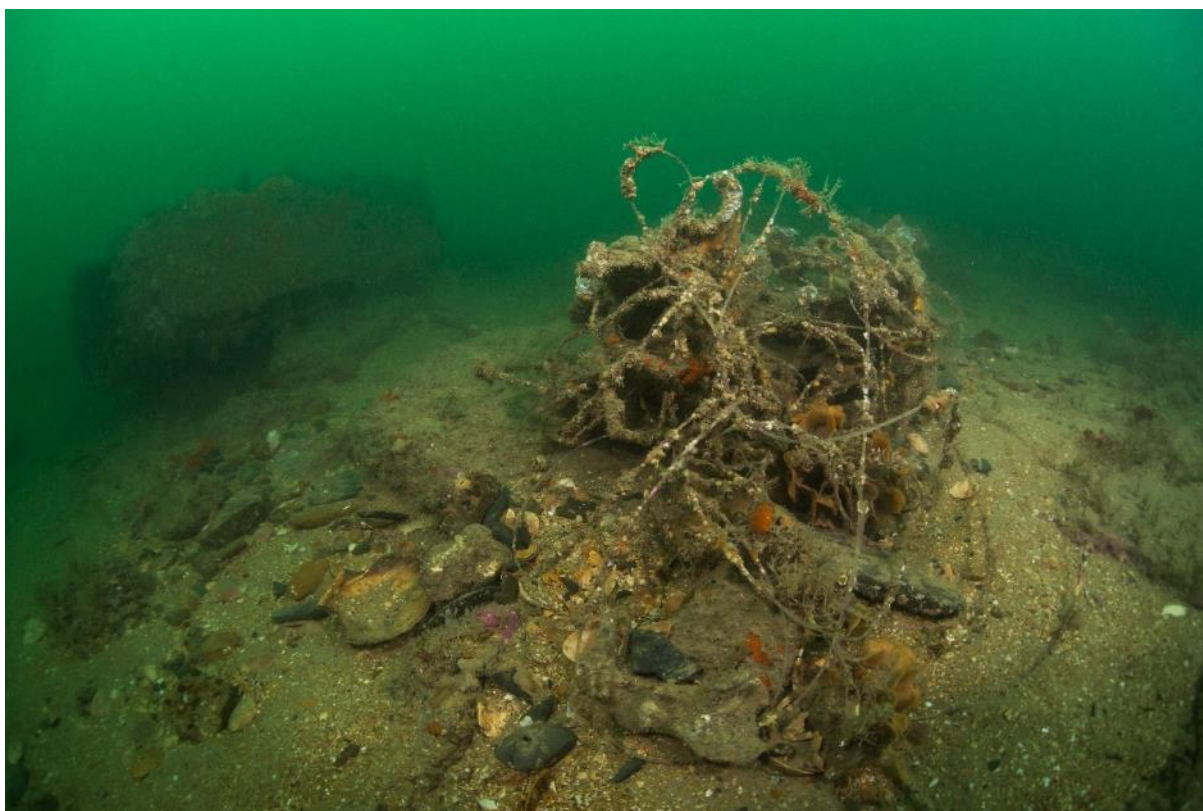
Figure 20: An unidentified section of wreckage approx. 1 m west of the starboard engine wrapped in thick monofilament line. Photo: Matt Doggett.

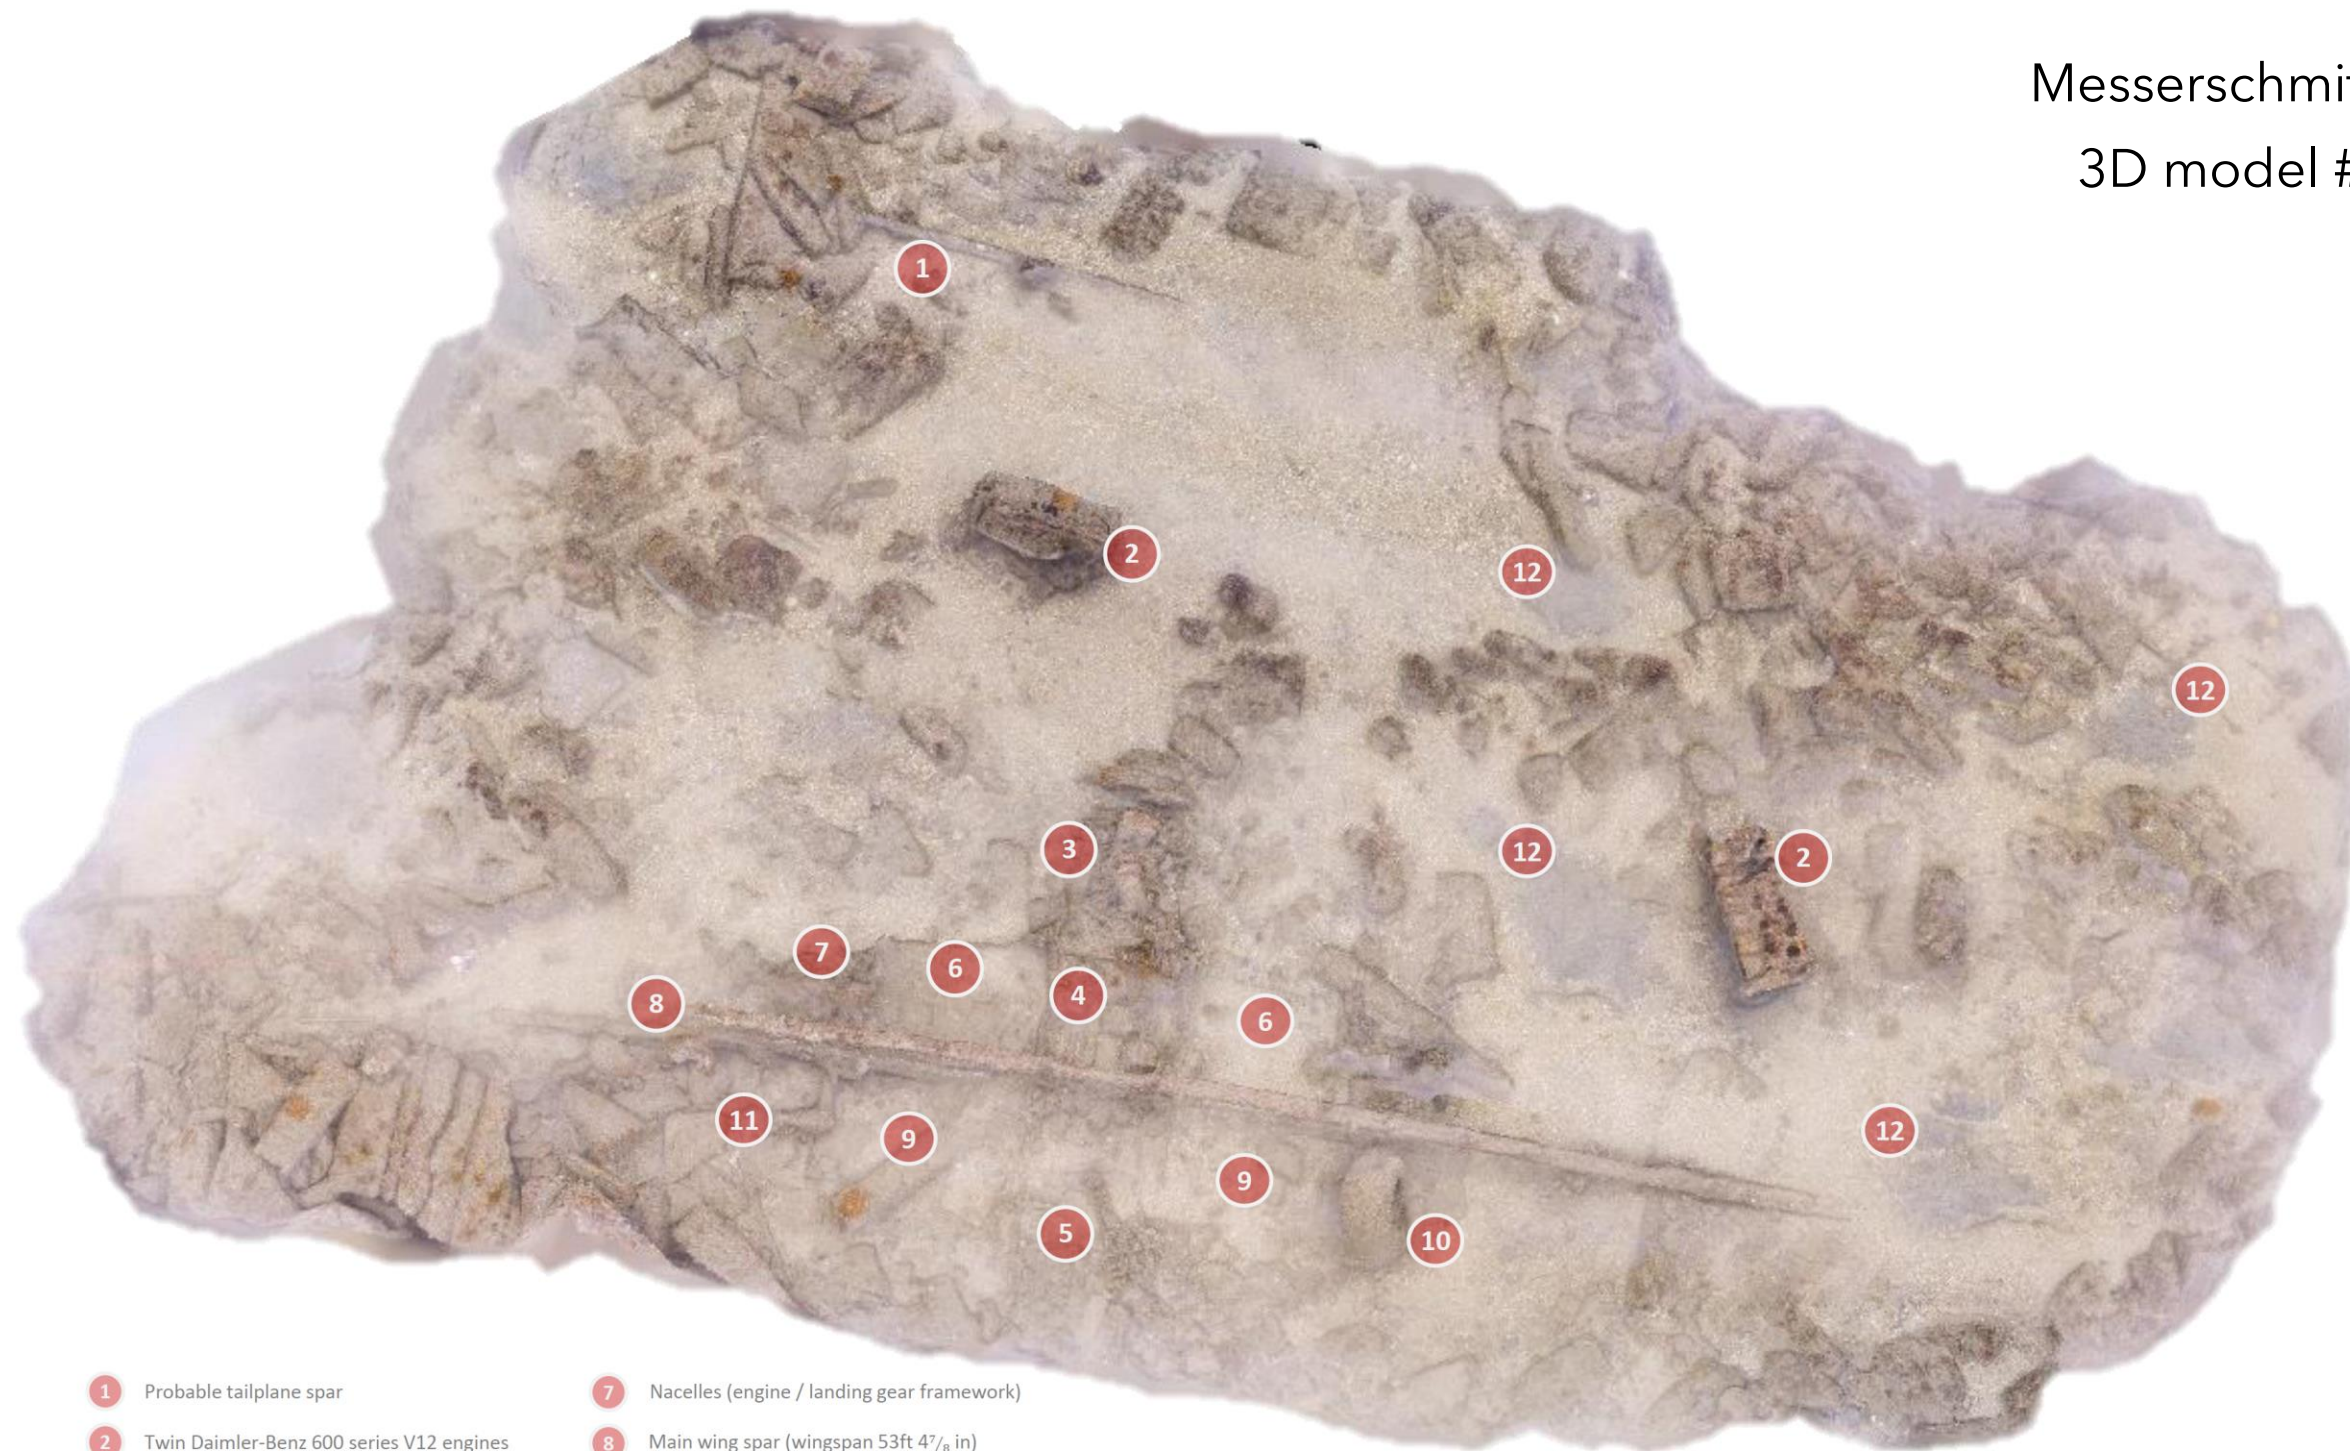
Messerschmitt Bf110 wreck site
3D model #1 - 22nd July 2020

| 1 Probable tailplane spar | 7 Nacelles (engine / landing gear framework) |

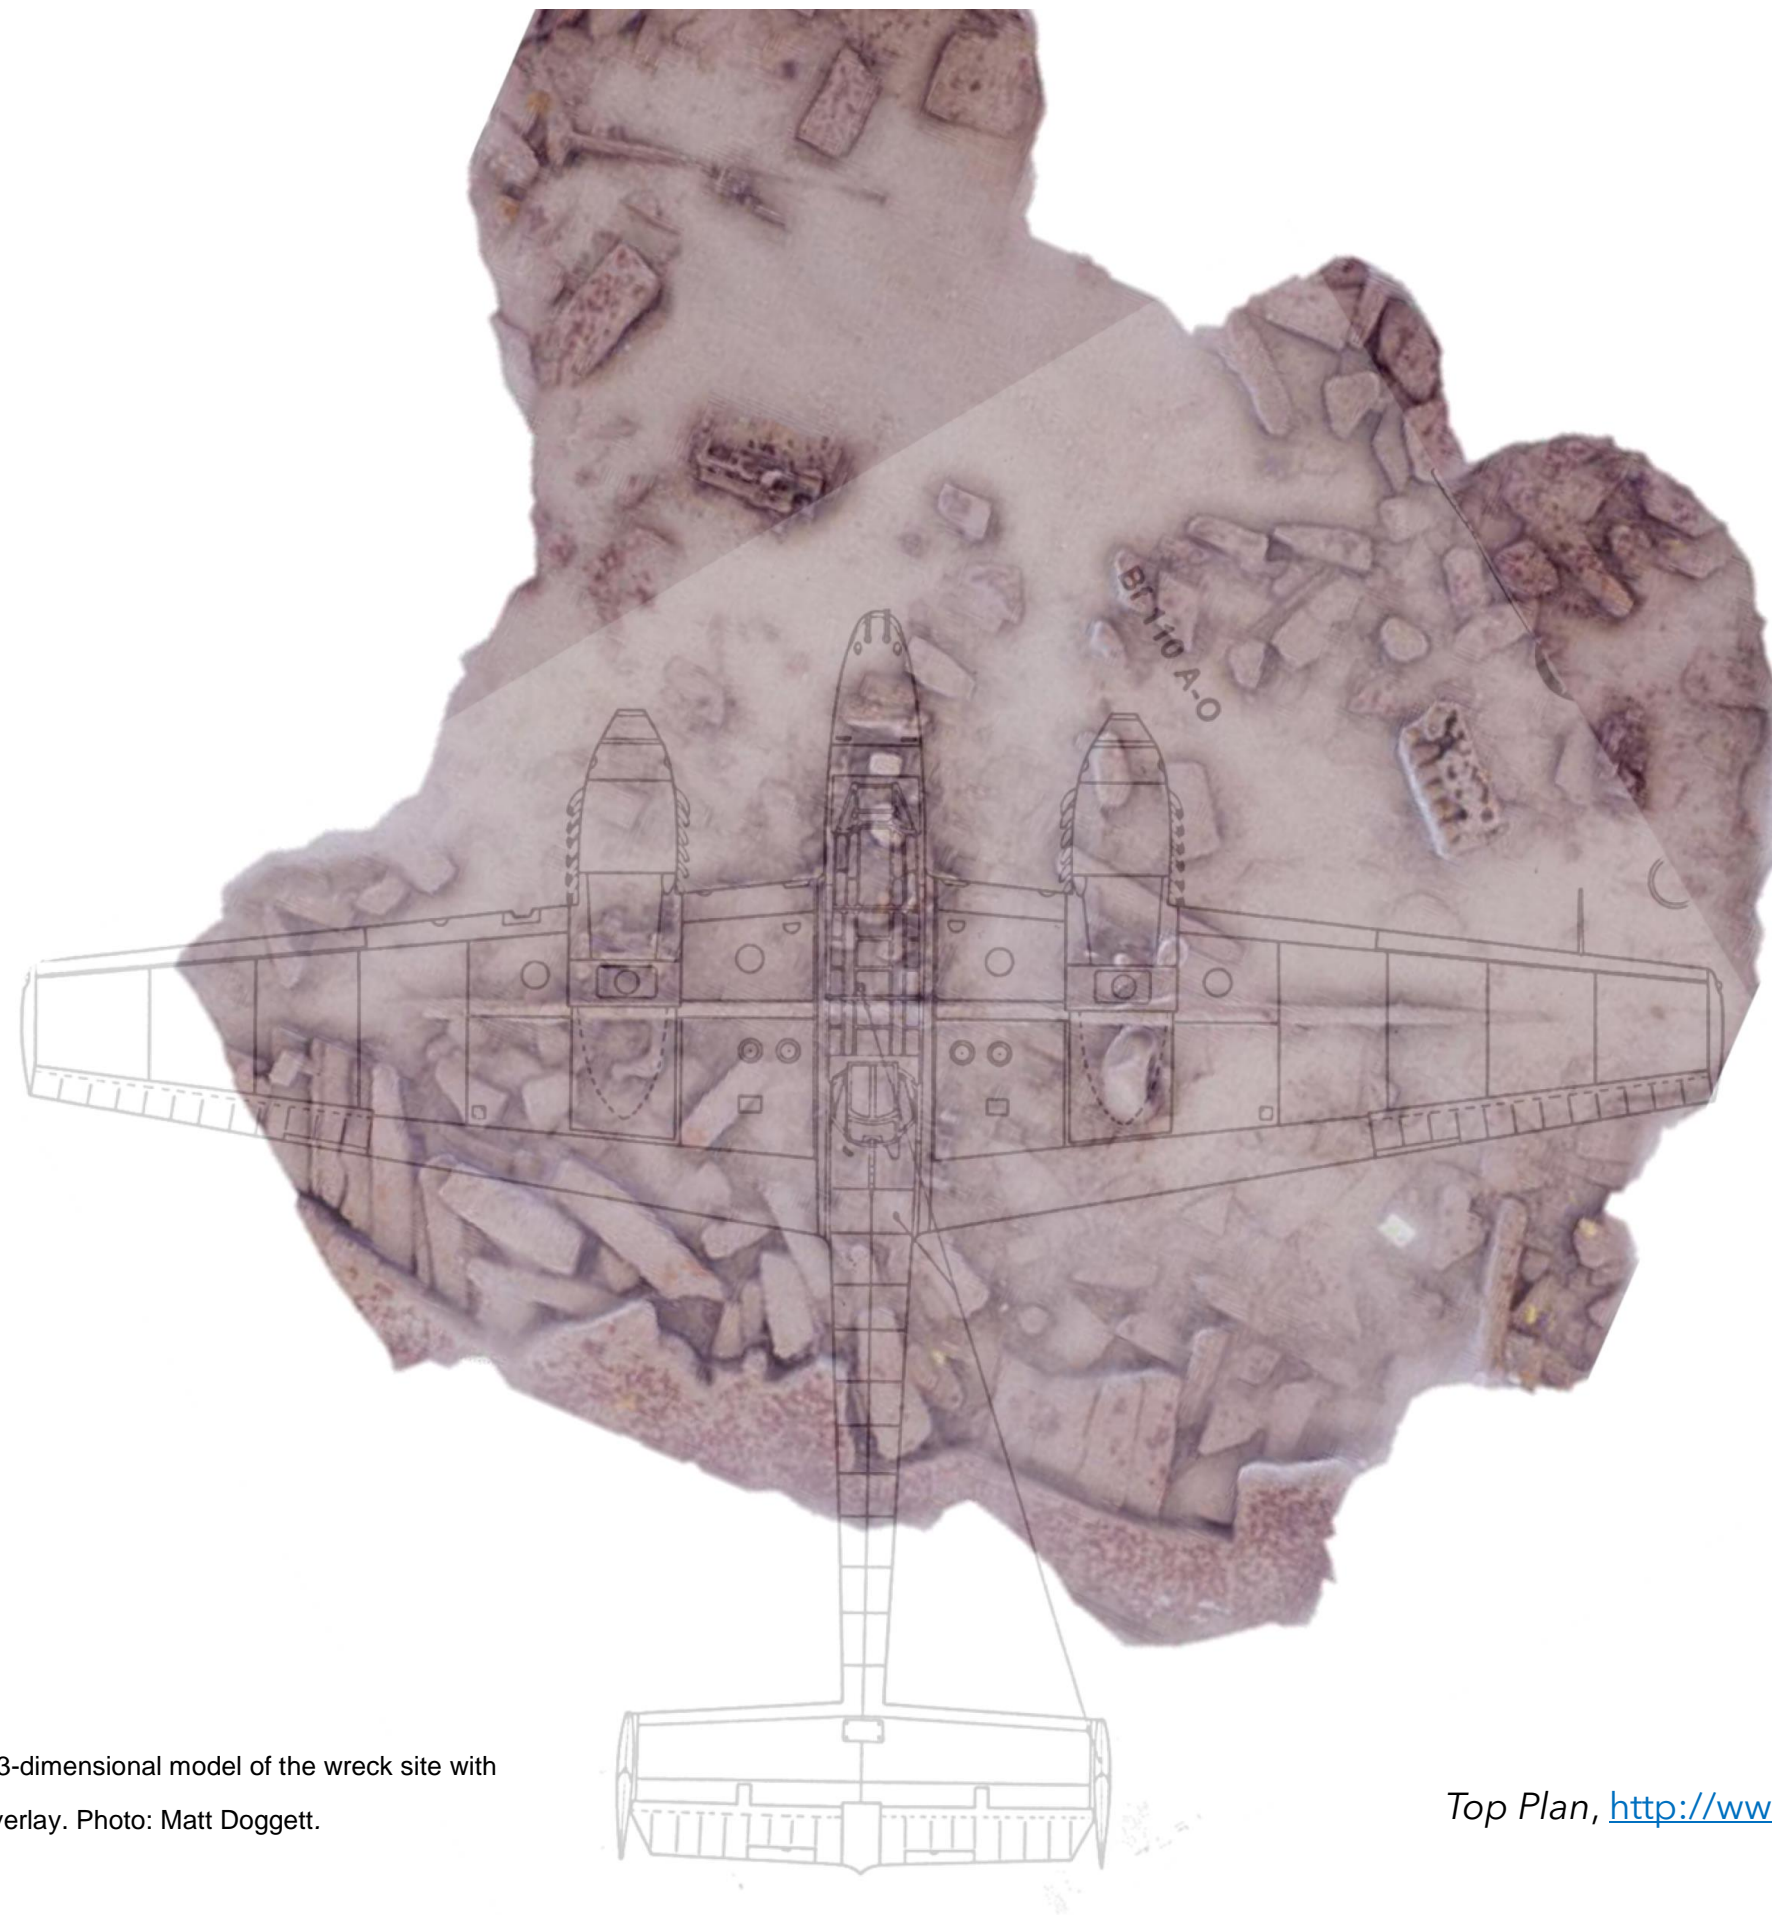
A second attempt to model the site on 18th April 2021 was more successful in capturing the reef behind the plane but was hampered by poor visibility which caused other areas of the model to suffer (Figure 22). Figure 22 shows the wreckage with a Bf110 technical drawing to illustrate the layout of the aircraft on the seabed with greater clarity.

Figure 22: 3-dimensional model of the wreck site with technical overlay. Photo: Matt Doggett.

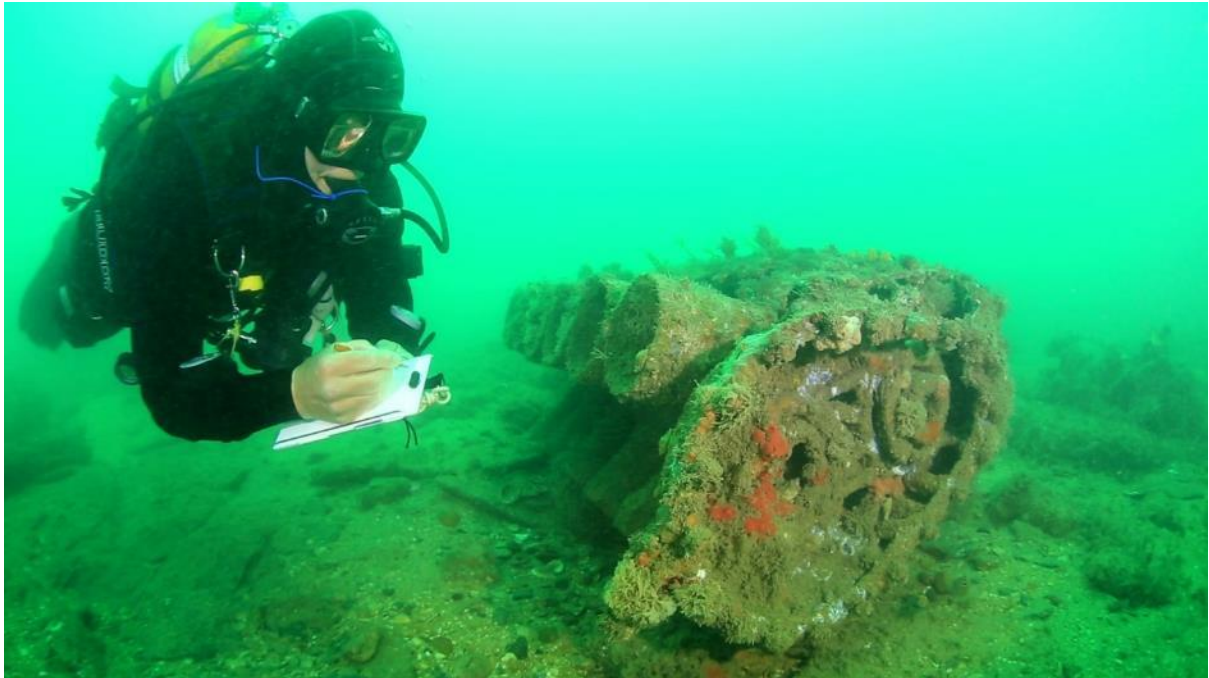
Figure 25: Lin Baldock makes notes of sponges and bryozoans growing on the starboard engine. Still from video: Matt Doggett.

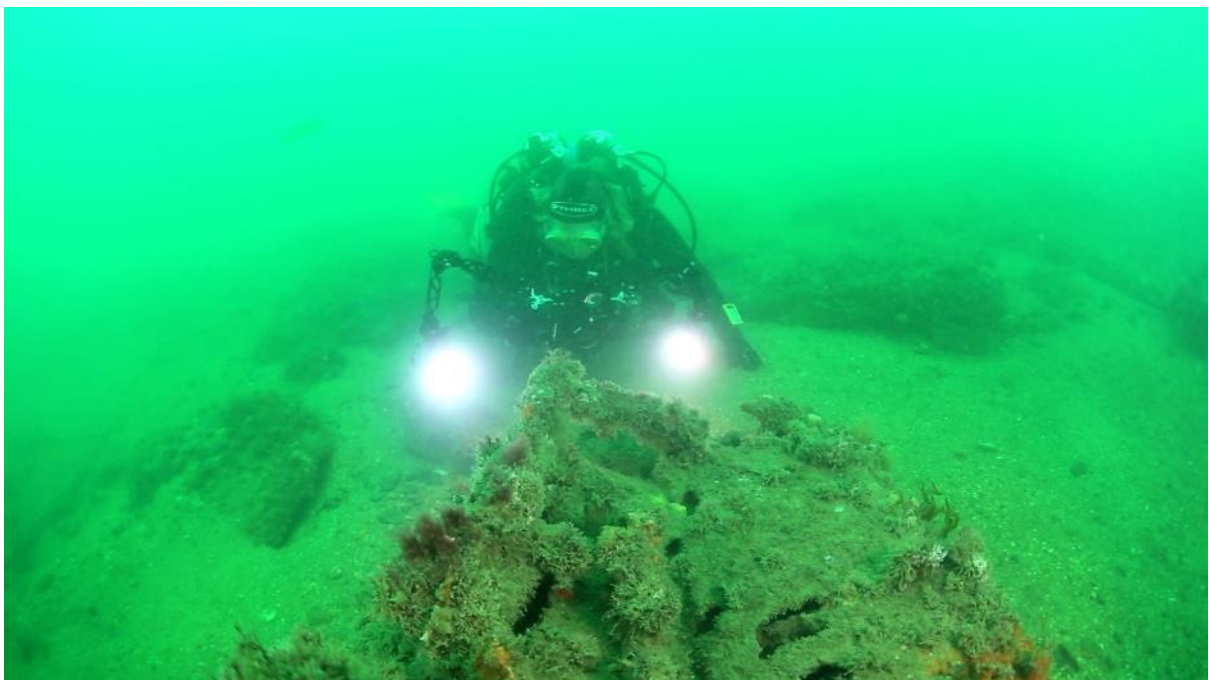
Figure 26: Sheilah Openshaw taking images of marine life on the port engine. Still from video: Matt Doggett.

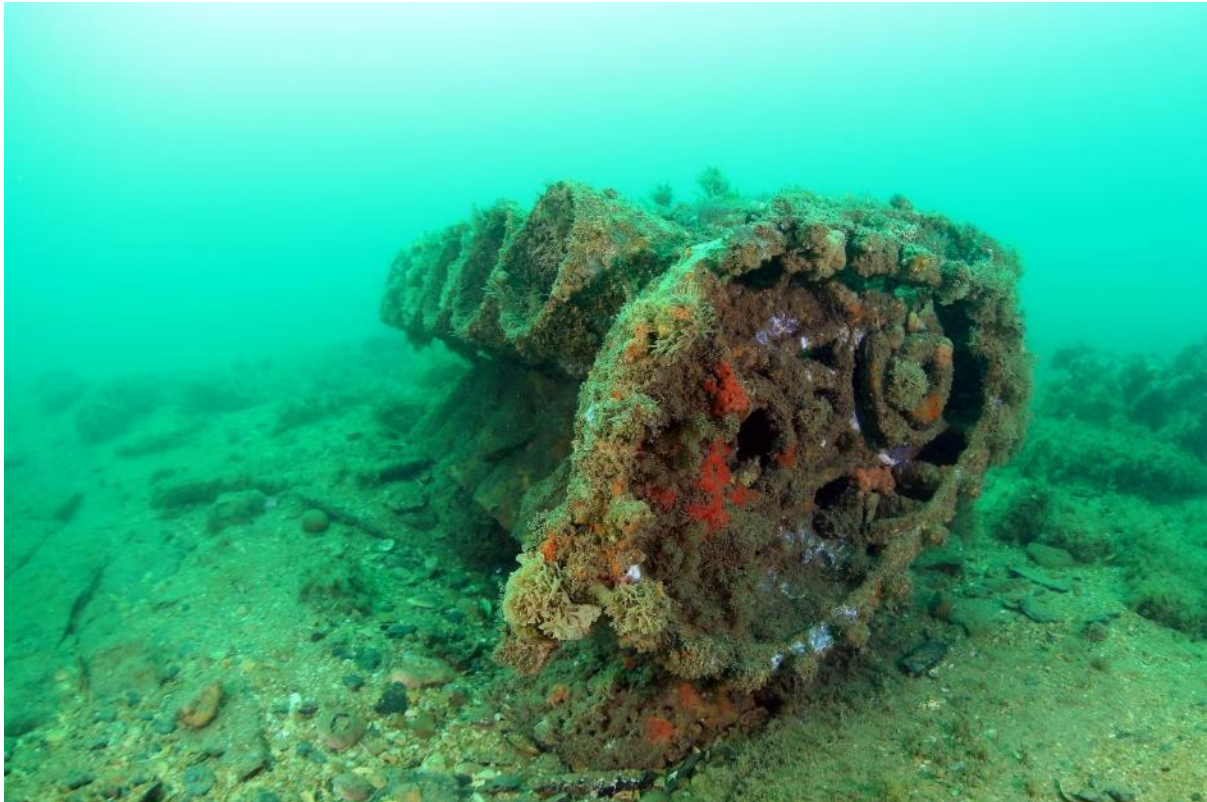
Being subject to coarse sediments moving across the site with tidal and wave action, much of the fauna growing on the wreck is scour-tolerant and short in stature. The most common sponges encountered included the goosebump sponge (*Dysidea fragilis*), an orange crater sponge (*Hemimycale columella*) and various other orange and yellow encrusting species. Shredded carrot sponge (*Amphilectus fucorum*) and small branching staghorn sponges (*Axinella dissimilis*) were also noted (Figure 27 and Figure 28).

Figure 27: The starboard engine block encrusted with colourful sponges, hydroids and bryozoans. Still from video: Matt Doggett.

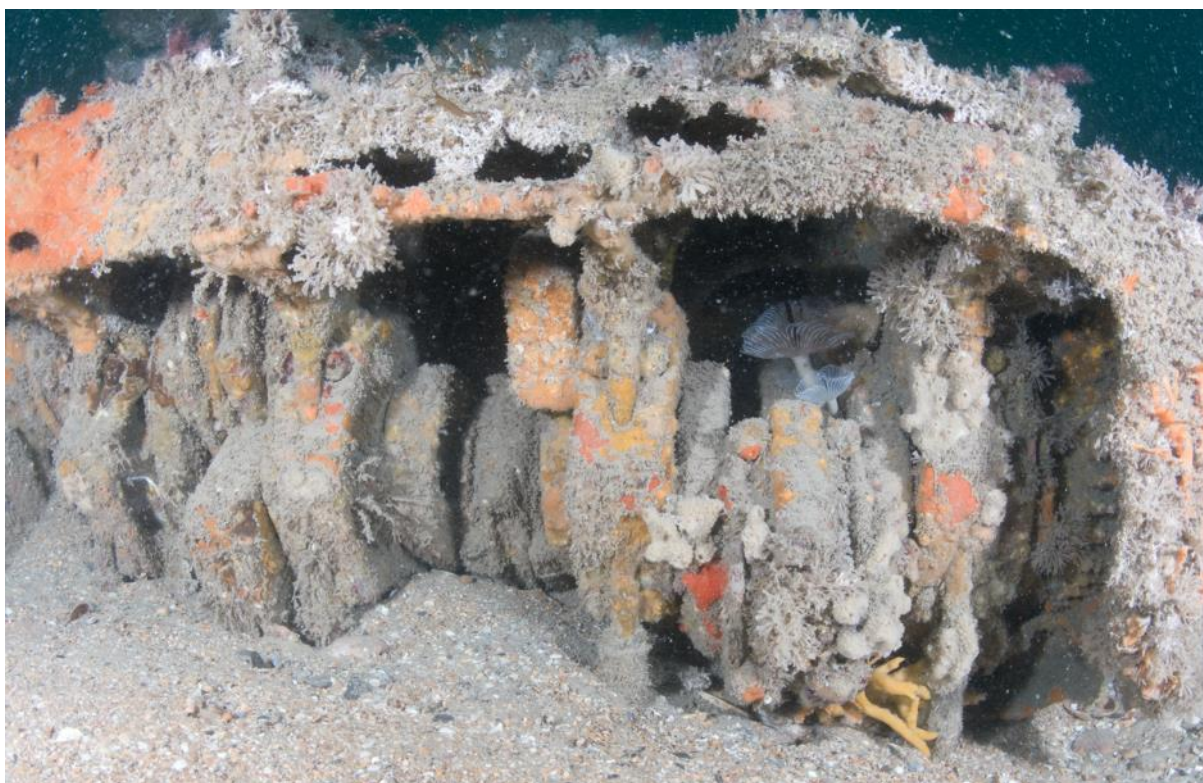
Figure 28: Encrusting life on the port engine pistons including the staghorn sponge *Axinella dissimilis*, goosebump sponge, *Dysidea fragilis*, the bryozon *Chartella papyracea*, short hydroids and fan worms, *Bispira volutacornis*. Photo: Lin Baldock.

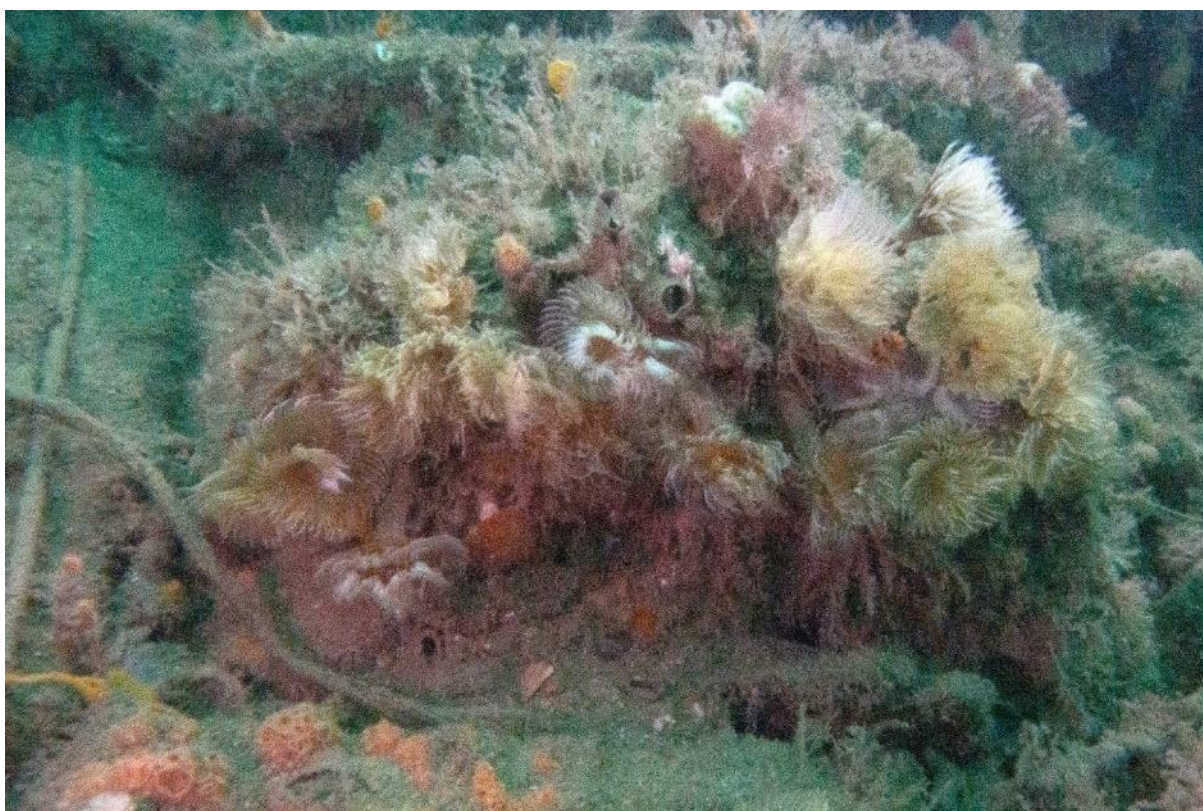
Spiral fan worms (*Bispira volutacornis*) were encountered throughout the wreckage (Figure 28 and Figure 29) as were colonies of filigree worms (*Salmacina* / *Filograna* spp.) and occasional serpulid worms (*Serpula vermicularis*).

Figure 29: Spiral fan worms (*Bispira volutacornis*) amongst other 'turf' species in the cockpit structure. Photo: Sheilah Openshaw.

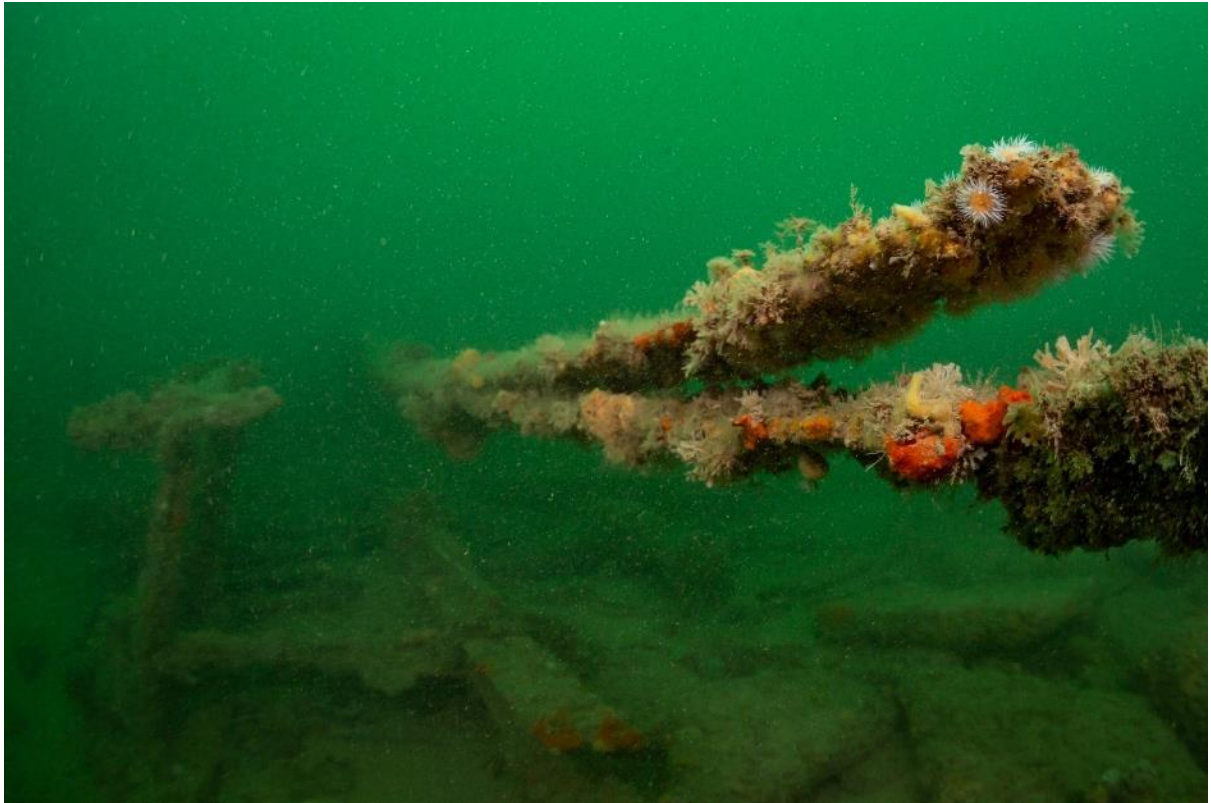
The sandalled anemone (*Actinothoe sphyrodeta*) colonised various sections of the wreck but was particularly noticeable on the main wing spar as was the occasional plumose anemone (*Metridium dianthus*) (Figure 30 and Figure 31).

Figure 30: Sandalled anemones (*Actinothoe sphyrodeta*) growing on the main wing spar. Photo: Matt Doggett.

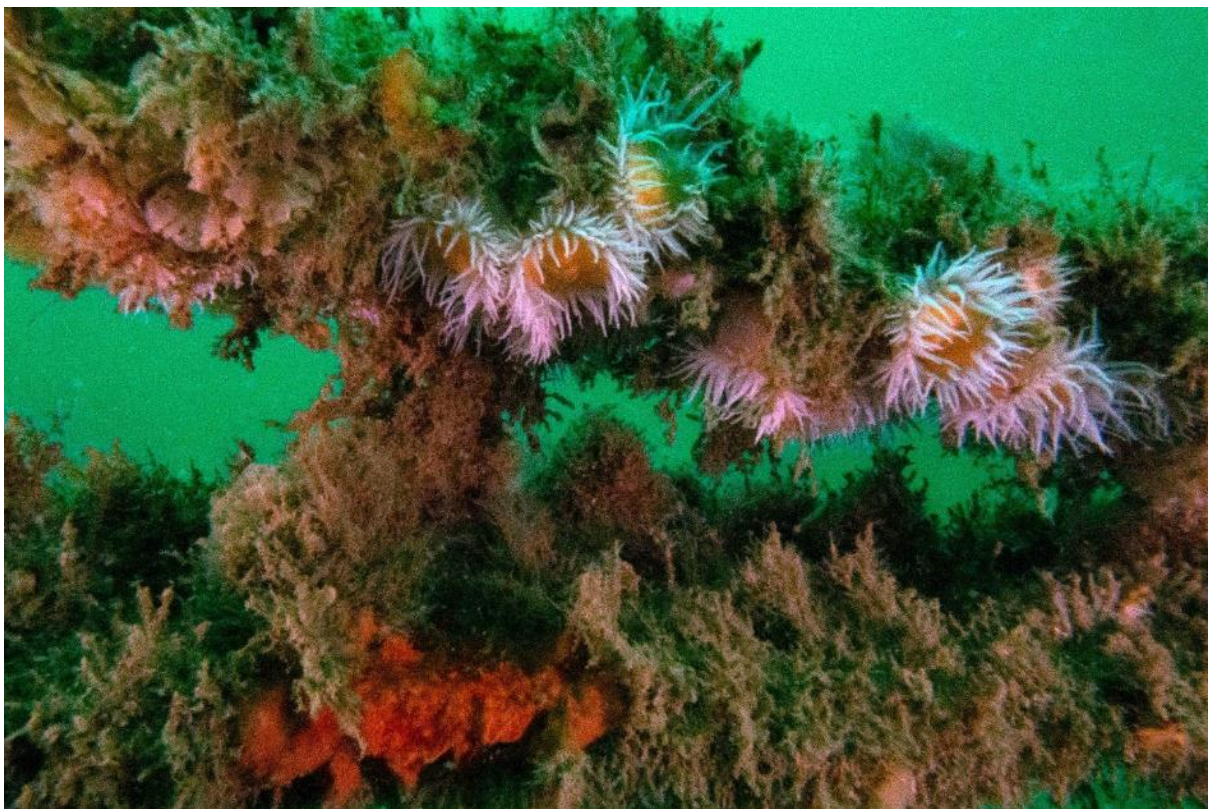
Figure 31: Close-up of sandalled anemones (*Actinothoe sphyrodeta*) growing on the main wing spar. Photo: Sheilah Openshaw.

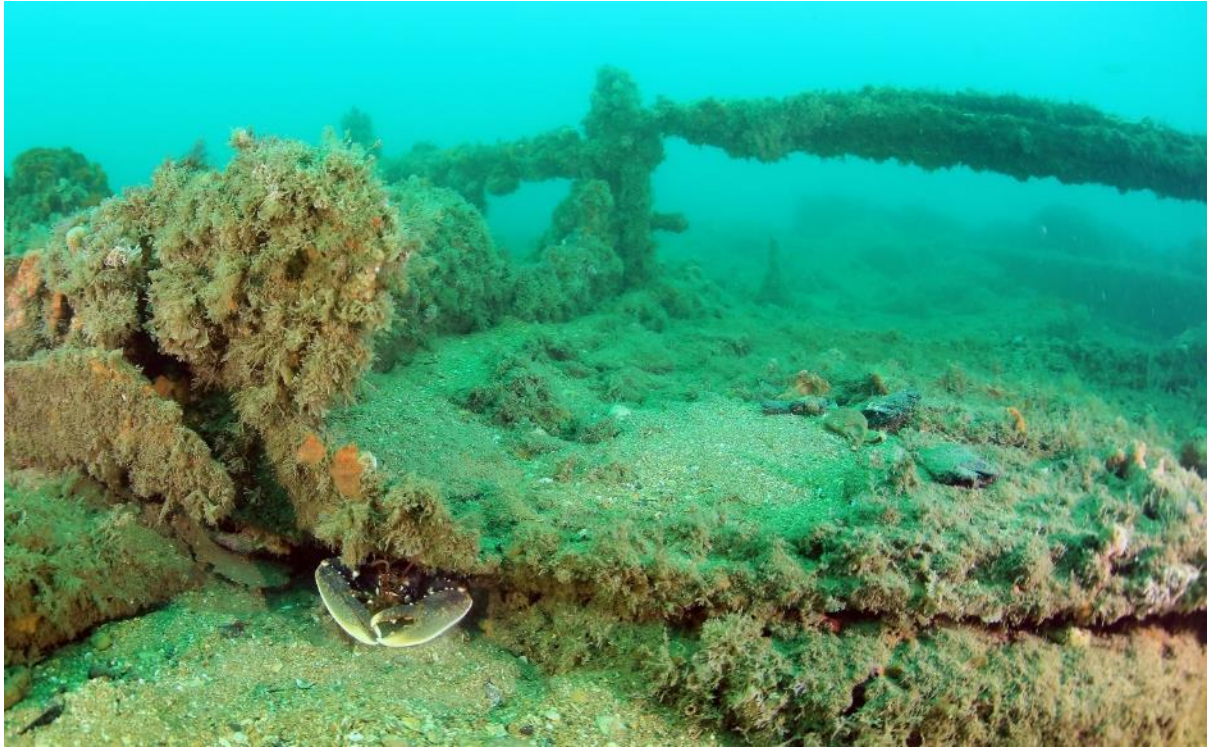
Figure 32: A lobster takes shelter in its burrow beneath the port wing. Photo: Matt Doggett.

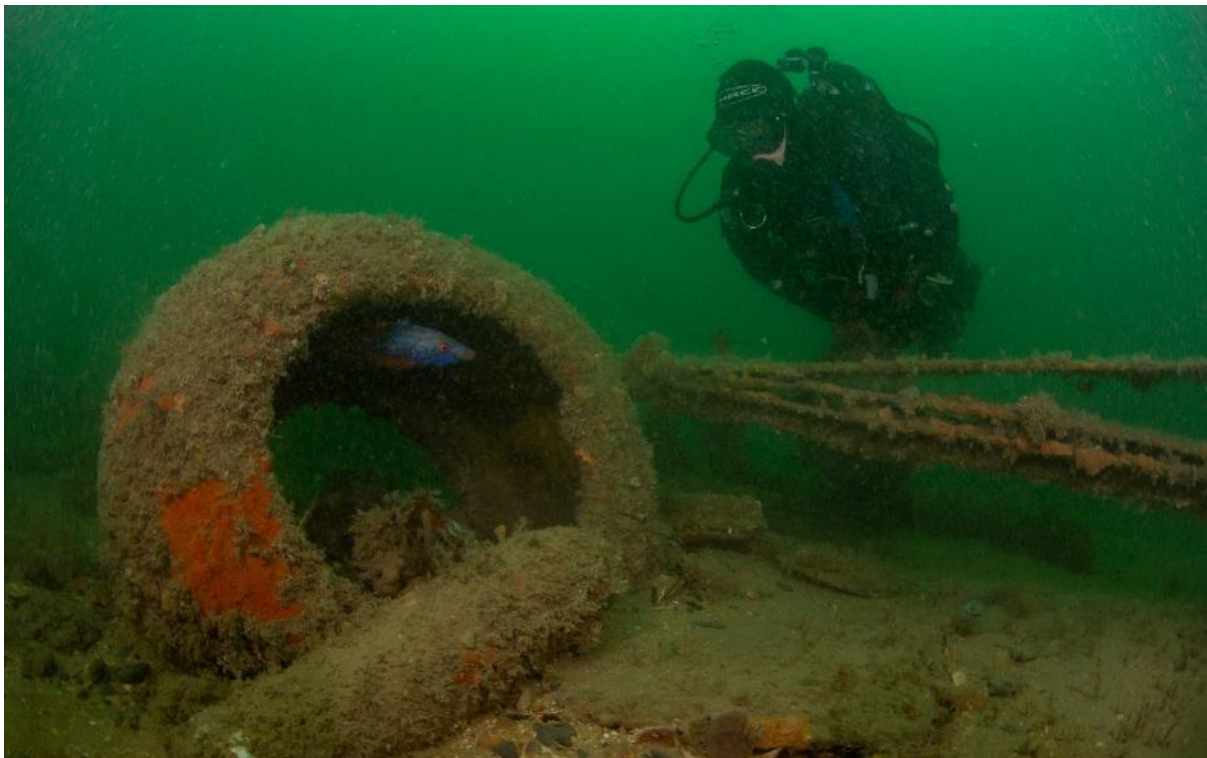
Figure 33: A male cuckoo wrasse peers out from the starboard tyre. Photo: Matt Doggett.

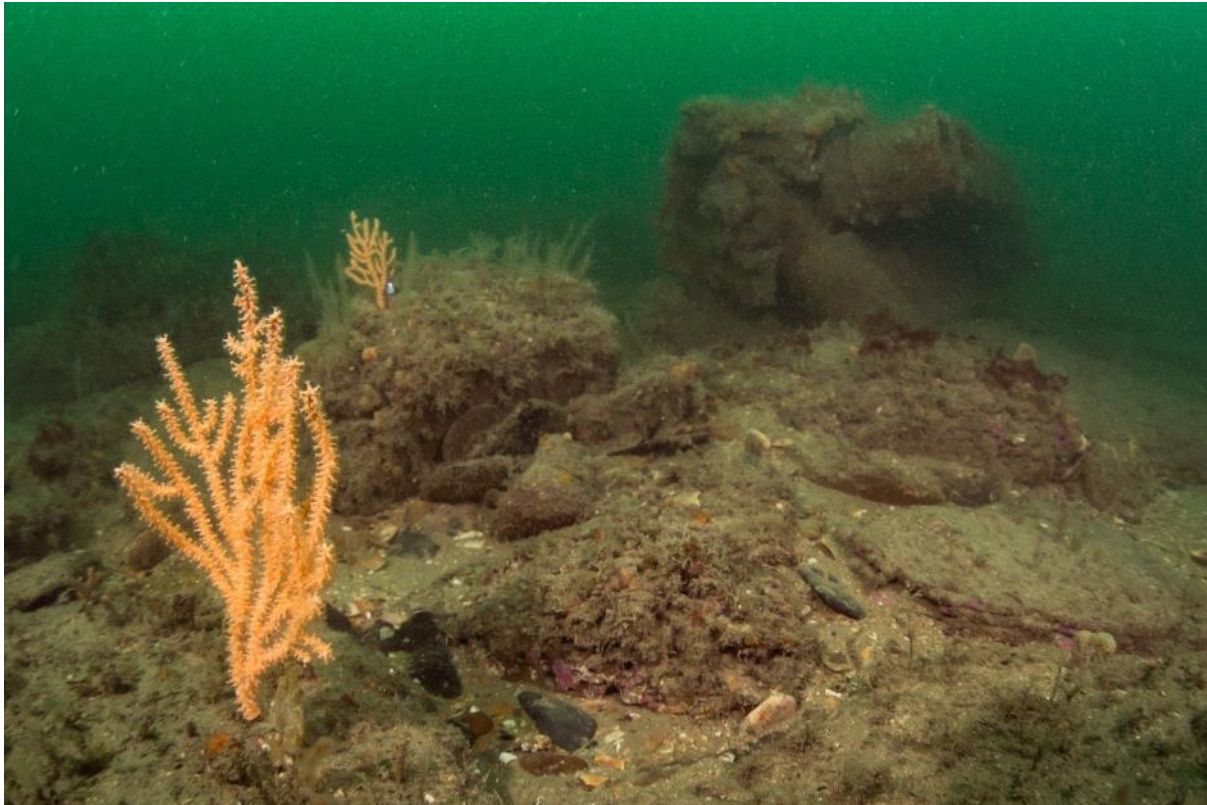
Between the wreckage the seabed was mainly low-lying to flat bedrock scattered with cobbles and small boulders and covered in a thin veneer of pebbles, gravel and coarse sediment. On several of the larger, stable rocks were colonies of the pink sea fan (*Eunicella verrucosa*) (Figure 34) including some small colonies less than two years old. Antenna hydroids (*Nemertesia antennina*) also covered the upper surfaces of these small boulders and occasional filamentous and foliose algal species.

Figure 34: Small pink sea fan colonies (*Eunicella verrucosa*) close to the starboard engine visible in the background. Photo: Matt Doggett.
