OPERATION DAKOTA

D.M.MCELVOGUE

(September 2018)

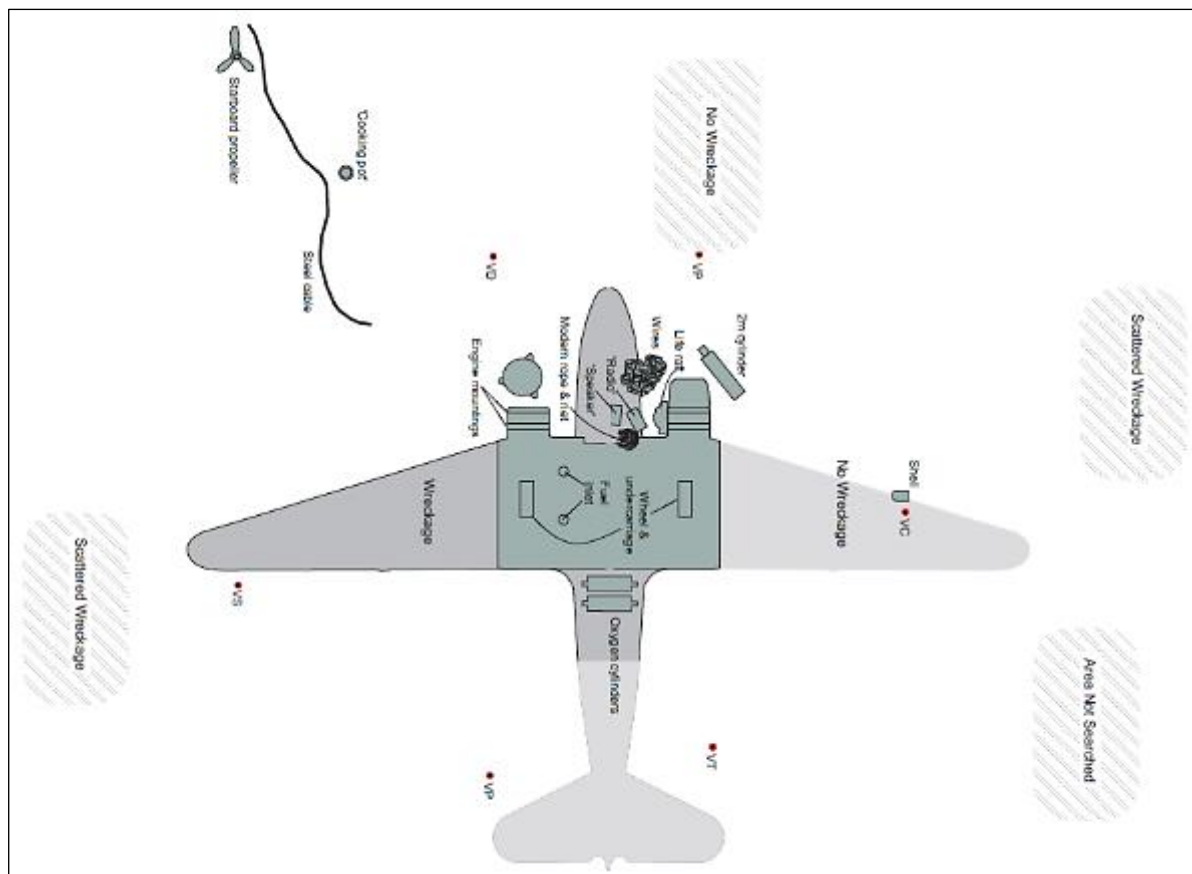
Figure 3 Wessex Archaeology site plan (Reproduced with kind permission Wessex Archaeology)

Wreck B was originally identified as a wreck during a hydrographic survey in 1989 by *HMS Gleaner*. The WA diver survey between 4th and 6th July 1997 established that the “wreck” was a twin radial engine aircraft, most likely a DC3 or C-47 Dakota (WA 1997a:10-15). The site consisted of a central wing section with two engines, lower fuselage and associated fixtures plus the undercarriage and propellers (Figure 02 Wessex Archaeology site plan).

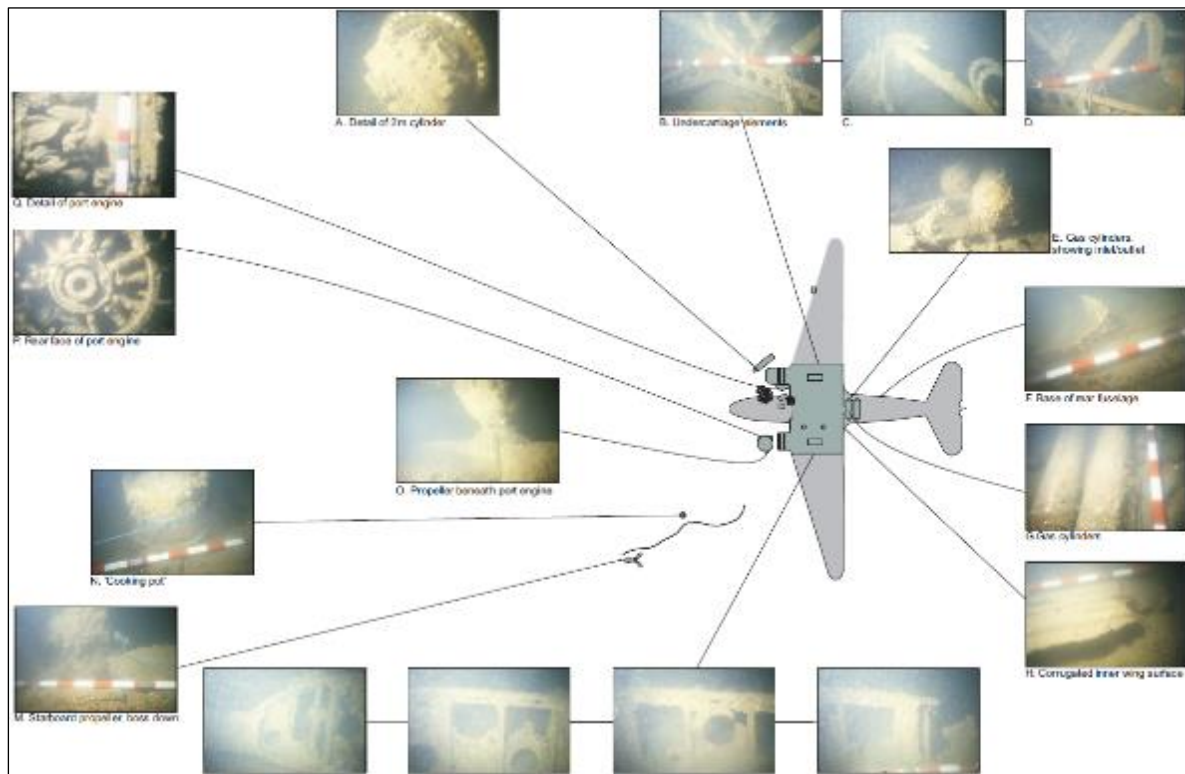
Figure 4 WA site plan with photographs of features on site (Reproduced with kind permission Wessex Archaeology).

“To port, sections of wing - possibly the tip of the port wing - and other scattered wreckage were found lying adjacent to datum VS. Datum VS was located 8 m outboard of the centre wing to outer wing joint (see Fig. 4 L-I); the outer wing section would have extended 10.8 m

from the joint. The seabed in the vicinity of VS consists of relatively soft and deep sediment, so some wreckage may be buried in this area. Swing searches during the initial diving investigation reported the presence of scattered wreckage beyond VS.” (WA 1997b:8)

“No wreckage was found starboard of the centre wing section with the exception of a ferrous object 250 mm in diameter, shaped like an artillery shell, located adjacent to datum VC on a featureless stone and silt seabed.” (WA 1997:8)

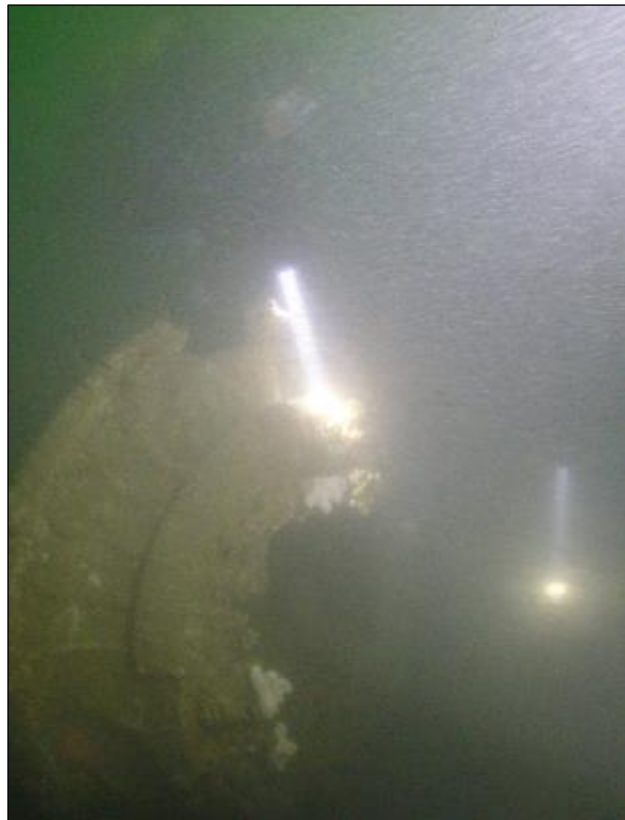
The site though is noted for having poor visibility, so whilst other off shore sites were experiencing good visibility the C-47 was still had poor underwater visibility. September is noted as being variable for weather and October, whilst offering days of good visibility was notably darker underwater.

Figure 7 Divers experiencing poor visibility on site.

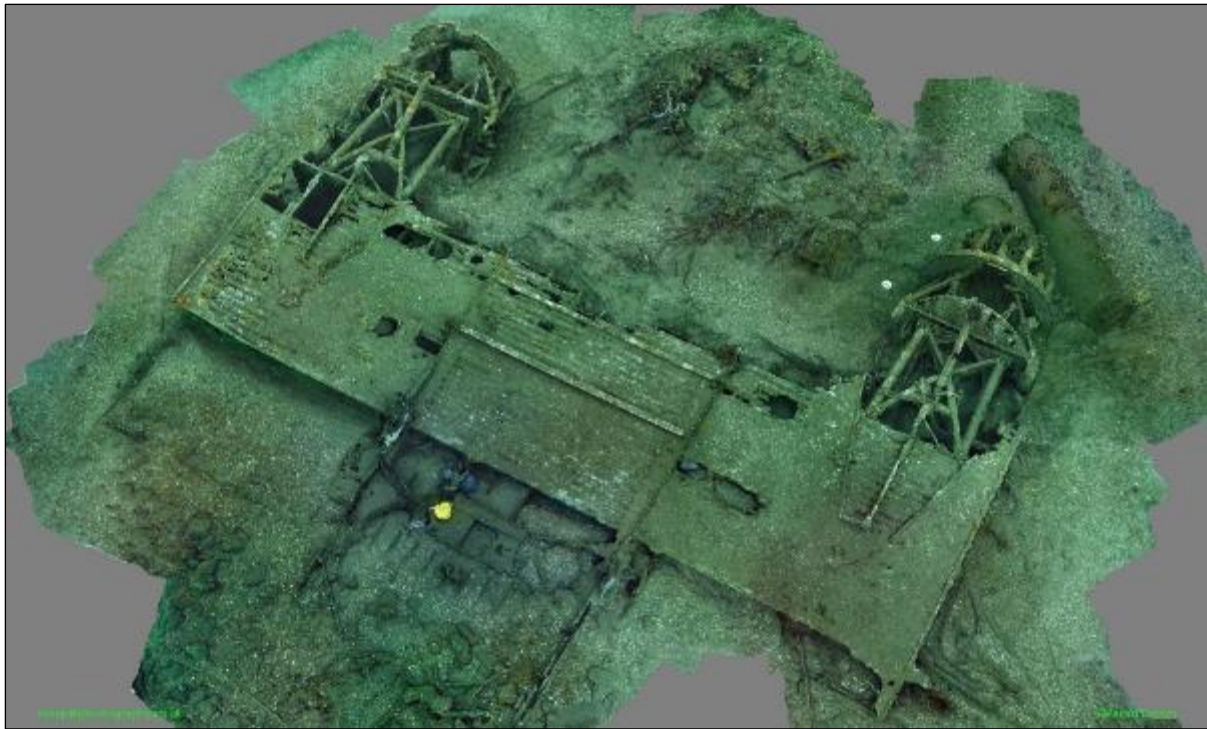
Figure 10 Screen shot from 3D photogrammetric model of a plan view of the central wing section.

The main cohesive part of the site consists of the centre wing section of a C-47, from the bulkheads either side of the two engine mounts (see Fig. 10). These bulkheads represent the joints at which the port and starboard outer wing sections were once attached. There is no further fuselage apparent between the engine mounts, such as the cockpit area. The engine mounts are 5.650 m apart between its centres whilst it is c. 8.250 m long from bulkhead to bulkhead. These measured dimension compare with those from 1997 (WA 1997a and b)

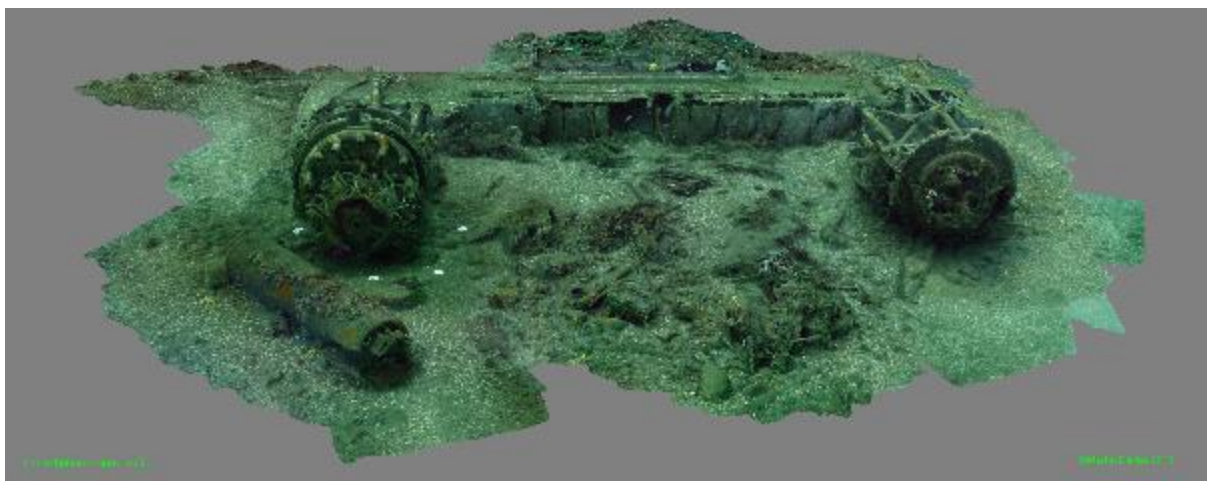
The 3D photogrammetric survey was carried out over two dives in 2018. Each survey took over 1500 photographs. The 3D photogrammetric surveys used up to 650 photographs each to produce their 3D models. The main area of the site was captured and has proved invaluable to interpret the site. This has shown that there is more of the C-47 between the engine mounts than can be seen whilst diving. It also highlights the linear nature of the features on the seabed.

Figure 11 Screen shot from 3D photogrammetric model of the central wing section looking forward of the engines back towards them.

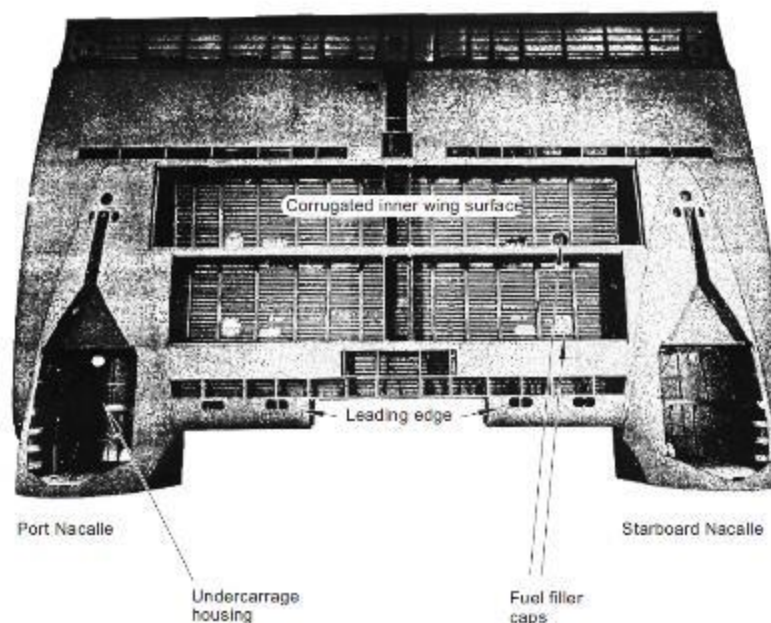
- the distance between the centres of the two engines 5.6 m
- the breadth of wing at c. 4.25 m
- a corrugated inner wing surface
- the inner wing section to outer wing section bulkhead being perforated by series of round holes identical to those expected on a C-47
- the 14-cylinder radial engines in two banks of 7 cylinders
- size and shape of surviving propellers
- the position and form of the fuel inlets with their associated rubber Grommets.
- the perforated X-shaped cross brace for the undercarriage
- the undercarriage short jack,
- the long undercarriage retraction jack
- the pair of low-pressure cylinders observed behind the centre wing section

Figure 26 Comparison to the C-47 maintenance manual diagram of the central wing section.
