SOLENT ARCHAEOLOGICAL DIVERS SUB AQUA CLUB

SOLENT WRECK PROJECT REPORT 2012

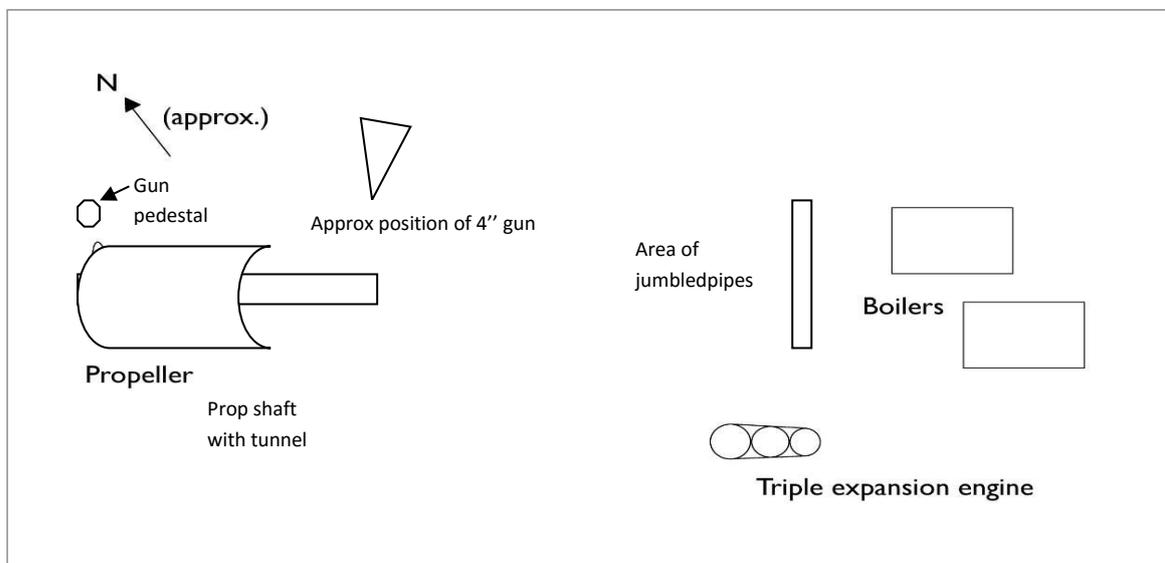
Figure 7. Updated swim over survey plan of SS Serrana.

The *SS Serrana* has substantial though fragmented structure on the stern section. The 4" stern gun is still on the vessel and the mounting for the other gun is still present close to the stern. She has a large, single screw propeller (Fig 6), with an extant drive shaft covered with a very noticeable propeller tunnel (Fig 7). There are also the remains of the bearings that directed the thrust to the spinning propeller. Continuing forward there are two large single ended boilers, suggesting that the remains of another triple expansion engine may be somewhere in the debris just in front of the boiler. The alignment of boilers and engine suggests that one boiler has fallen out of position. There is one engine in the correct position, the engine has fallen on its side and has lost coherence. Nothing has been seen of the condenser.

The archaeological record could be enhanced by a fully measured plan of the remaining structure. If a measured plan was produced it could be used for training in archaeological recording methods in conditions of poor visibility.

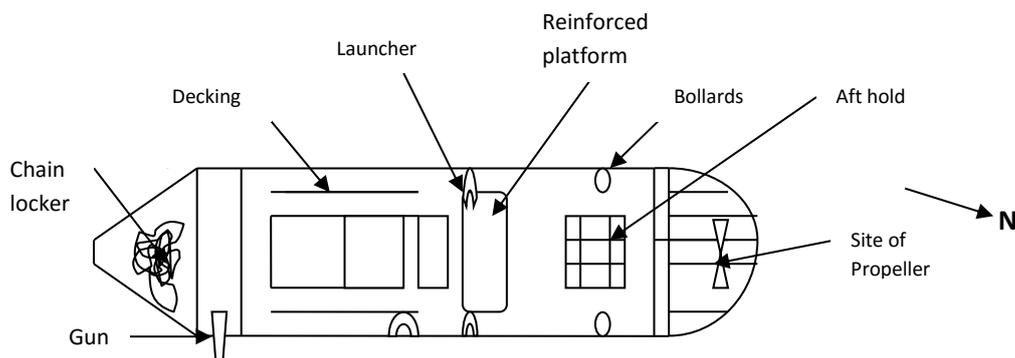
Figure 11. Diagrammatic representation of the swim over survey on HMS Warwick Deeping.

The site is at a general depth of 36m and the wreck stands some 5m proud of the seabed and lies on an orientation of 150°/330°. The site consists of an upright hull and almost fully-decked upper elements. A swim-over survey of the deck shows a remarkable degree of preservation with structural elements, fixtures and some fittings still *in situ*.

There are depth charges lying on the deck by the gunwhale, so some caution is probably good (fig.10). On either side the mooring bollards are still in the correct position. Forward of this are there was a covered foredeck, allowing the anchor to be raised and lowered in shelter. This is now very open, and the chain is visible. The bow is intact, and stands up at least four metres.

From the deckhouse going aft the wreck is quite open. Just forward of the stern are pairs of bollards. The stern area still has some evidence of decking, in poor condition, and some of the steering mechanism is visible. The stern is a round or fantail stern. The propeller and rudder are still attached and visible, in a scour pit at 38m.

With a clear deck plan any subsequent diving on her can be targeted at recording various structures. A measured survey of the vessel, with supporting stills photographs with scales could be a really good way to record the vessel, and make it a more interesting dive for recreational divers. Accurate recording of the *in situ* depth charge launchers and any evidence of her change of use from steam trawler to anti-submarine vessel would also be useful additions to the archive.

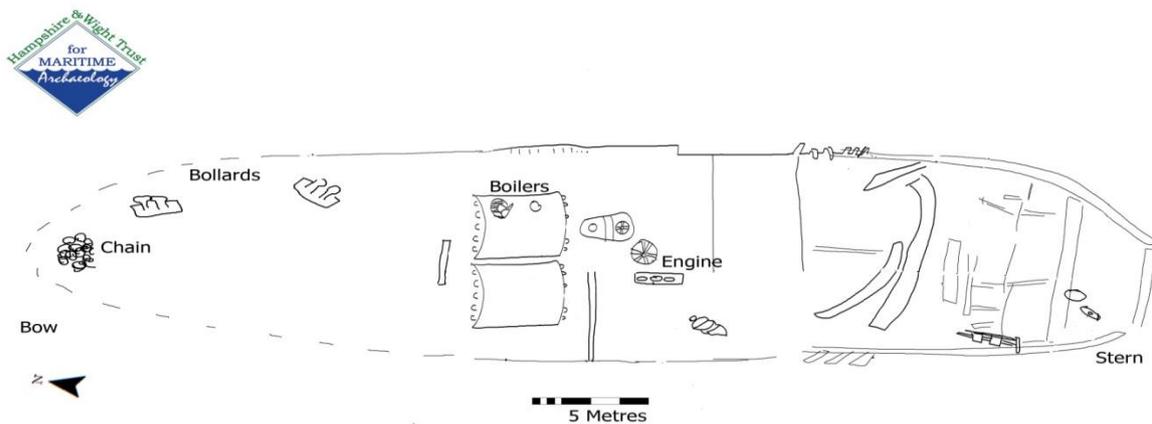
Figure 19. HWTMA survey results 2011 ©HWTMA 2011

The HWTMA generously made their 2011 results available to SADSAC, and the results of our survey will be made available to them (figs.19 and 20).

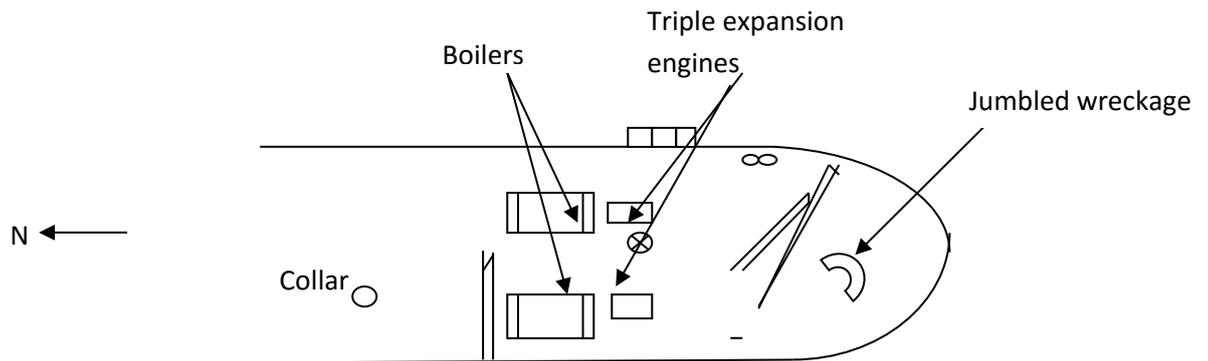
Figure 20. Results of SADSAC survey 2012

On July 24th the site was dived again by a member of the SADSAC team as part of another diving group. On this occasion visibility was excellent and it was possible to see the second engine, and to identify those structures noted by the May 15th team. A sketch plan was produced showing the existence of the second triple expansion engine and possible remains of an after steering position, or possible part of a steering arc at the stern, as well as bollards on her stern which had collapsed inwards (fig.20). Remnants of a possible bulkhead between the boiler room and the forward part of the vessel were also found. Immediately forward of that bulkhead was a hoop, similar to a mast hoop, lying on the surface (Stone 1993:64). This may have been part of a derrick or mast securing system. No attempt was made to locate the forward bollards or anchor chain found by the HWTMA earlier in the year.

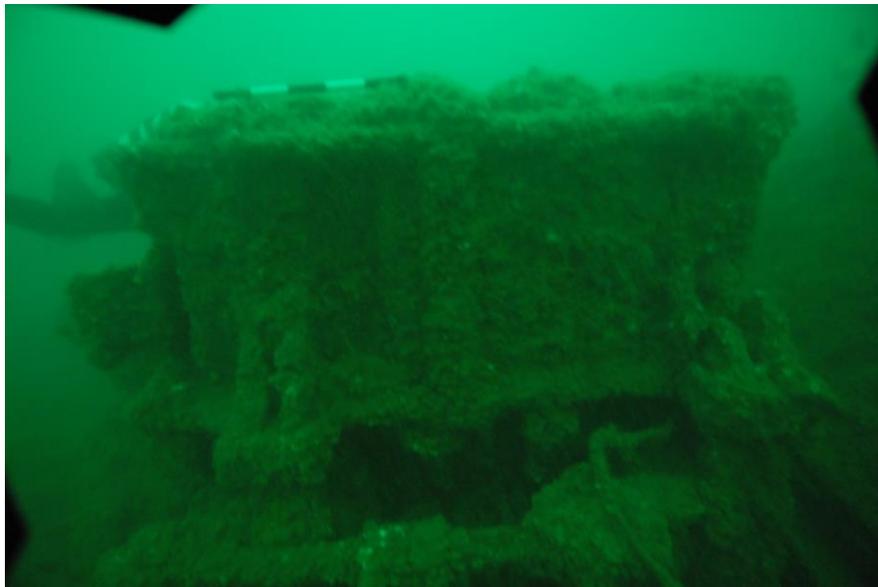
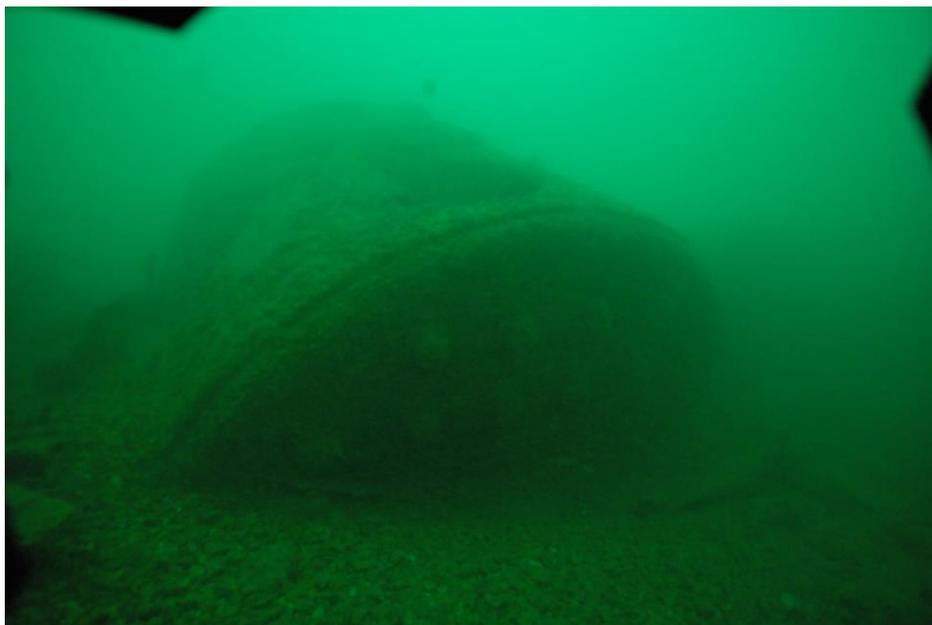
Figure 21. Triple expansion engine photo ©HWTMA 2011

Figure 22. Boiler from Venezuela HWTMA

both boilers (figs.21 and 22) very clearly. Going towards the stern it was possible to see the area of jumbled frames and possible mast structures. Some plates had fallen outwards. The shingle seabed seems quite mobile. There is evidence of substantial structure below the seabed, and the area of the bow is almost completely covered with shingle. It was difficult to establish what structure remains in the bow area, and it could be useful to dive again to see what is happening with the shingle.

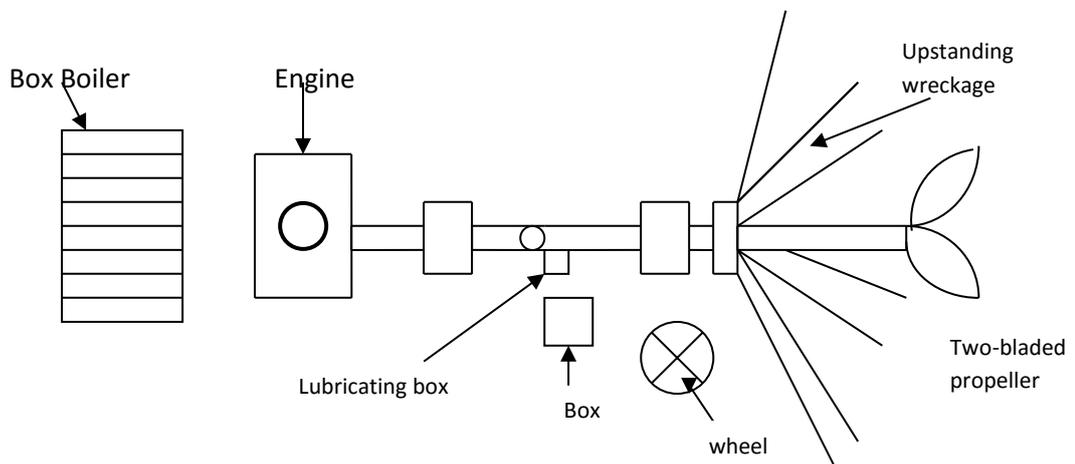
Figure 30. Sketch plan of observed structure of SS Faith. Not to scale.

This vessel was dived on August 18th 2012 after another period of wet weather. The visibility was less than four metres, and it was dark. The shot was right by the propeller shaft, which enabled straightforward navigation in otherwise poor conditions.

At the rounded stern are the remains of a two-bladed iron propeller, with the boss still evident (fig. 27). This leads to a fairly intact and still straight shaft. Close to the propeller on the port side is a wheel, function unknown (fig. 28). Similar wheels on other vessels are used in controlling derricks or cargo loading systems. There is a considerable amount of structure here, but it is confused. The iron frame sections appear triangular, suggesting that the frames come from lower down in the vessel, near the keel. From here, swimming towards the bow, are two or three large thrust bearings. Just forward of the thrust bearings, and just aft of the engine, is an oil box, still with the lid on (fig. 26). About a metre to the port side of the box is another, larger box, function unknown. Some few metres towards the bow is part of the engine, possibly the piston for one of the cylinders and immediately behind that are the remains of the box boiler (fig.30).

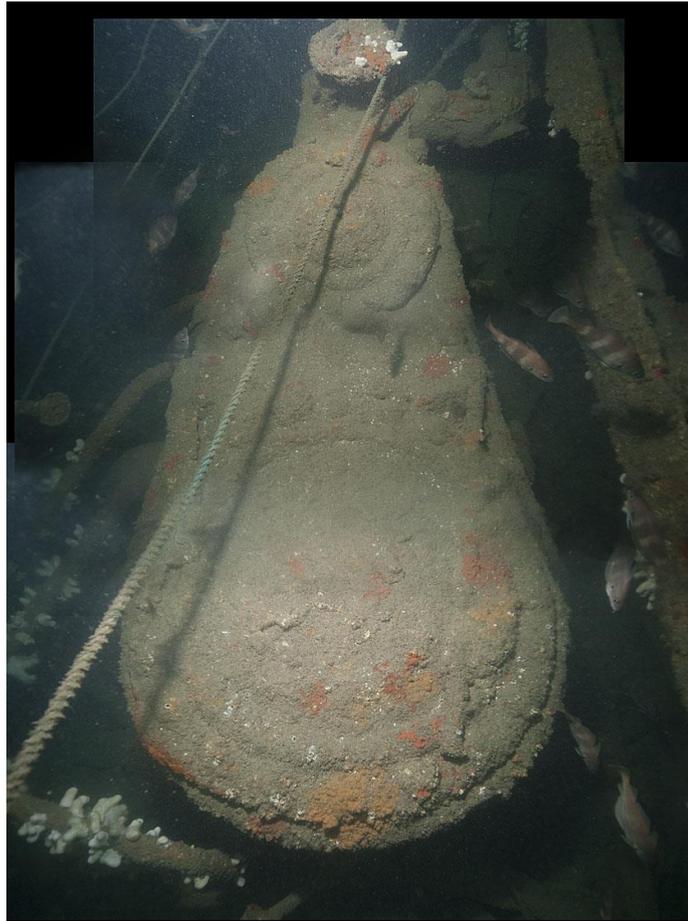
Engines can be harder to see. They have often fallen over, and can be a jumble of machinery. Many of the engines we see are compound engines (they have more than one cylinder) and are usually triple expansion engines. This means that the steam pressure is used three times in cylinders that get larger as the steam pressure drops. There will be three cylinder heads on top of the engine (fig.44). Sometimes, in older ships there will only be two cylinders (fig.45).

Figure 45. A compound engine underwater showing only two cylinders ©Barry Jarvis 2012.

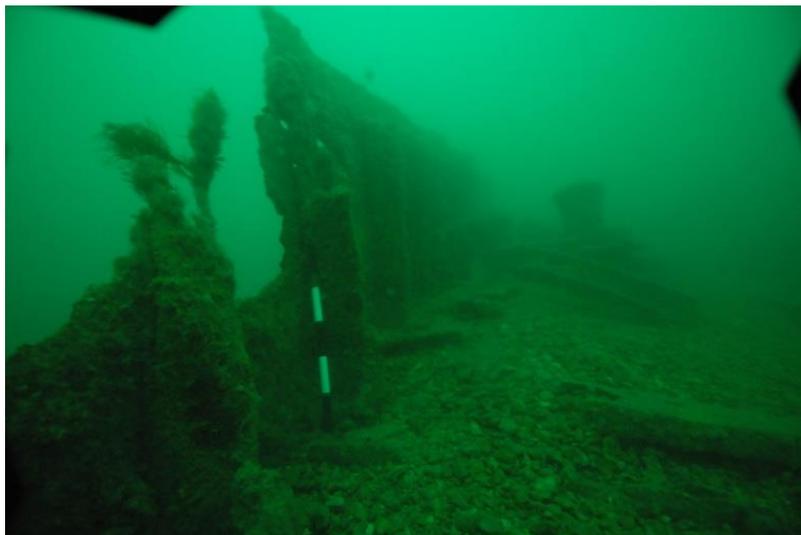
Figure 46. Hull remains on wreck ©HWTMA 2012

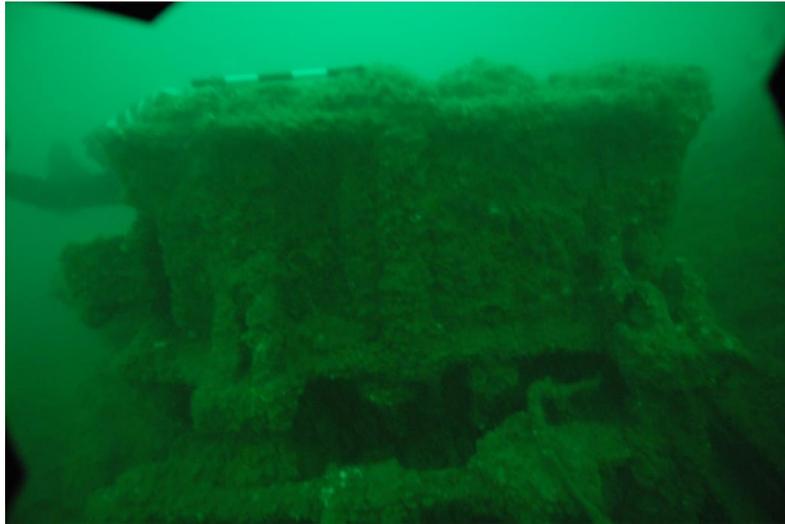
Figure 47. Upright triple expansion engine © HWTMA 2012

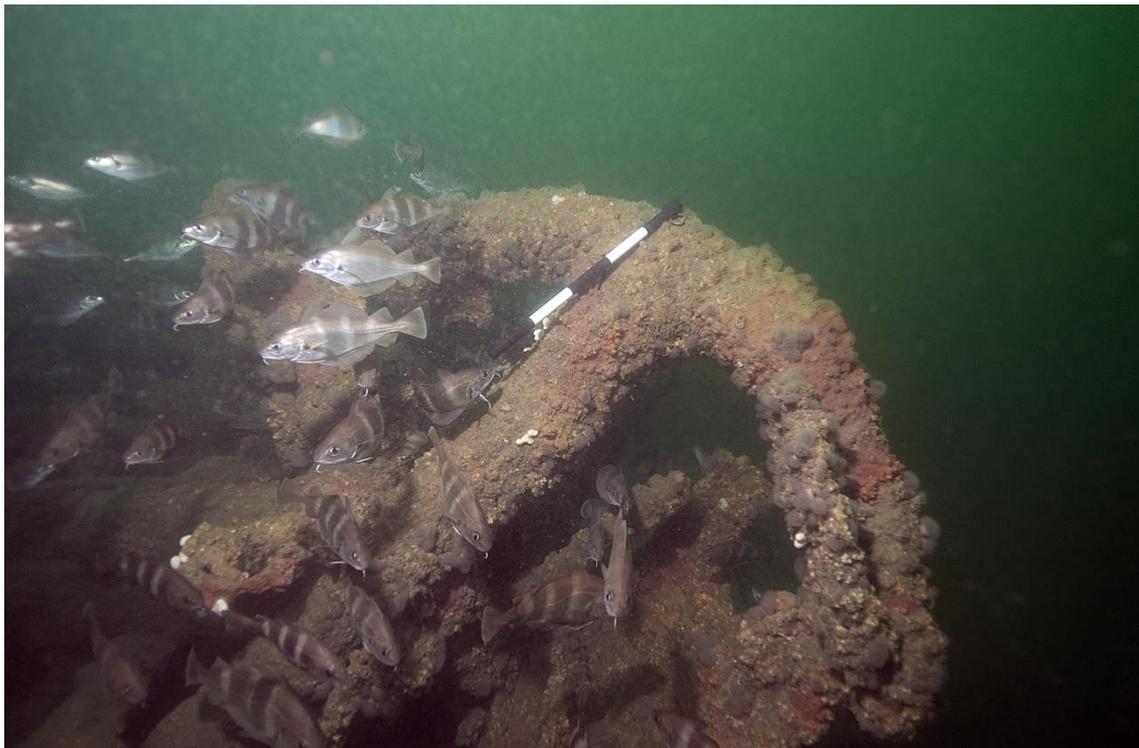
Figure 48. Anchor ©Barry Jarvis 2012

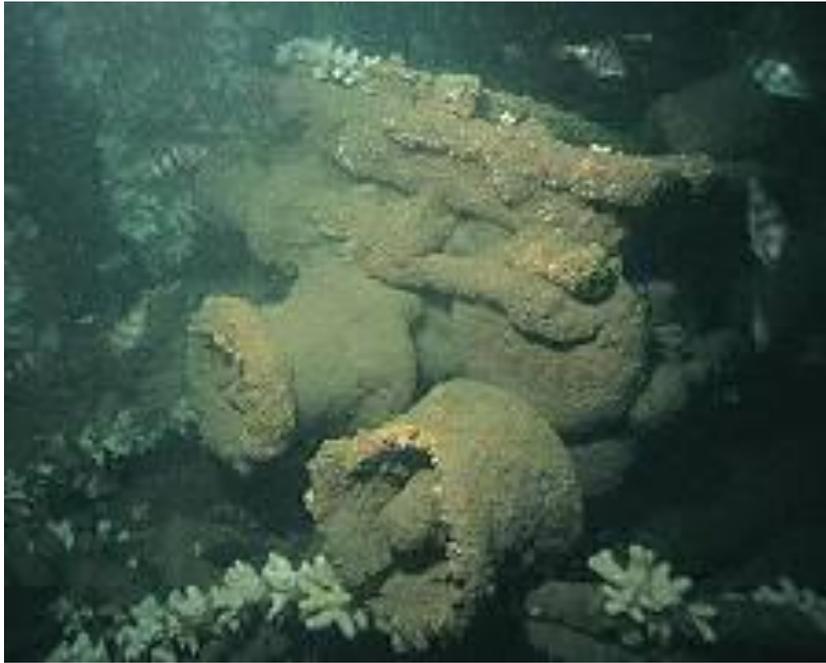
Figure 49. A cargo winch © John Liddiard

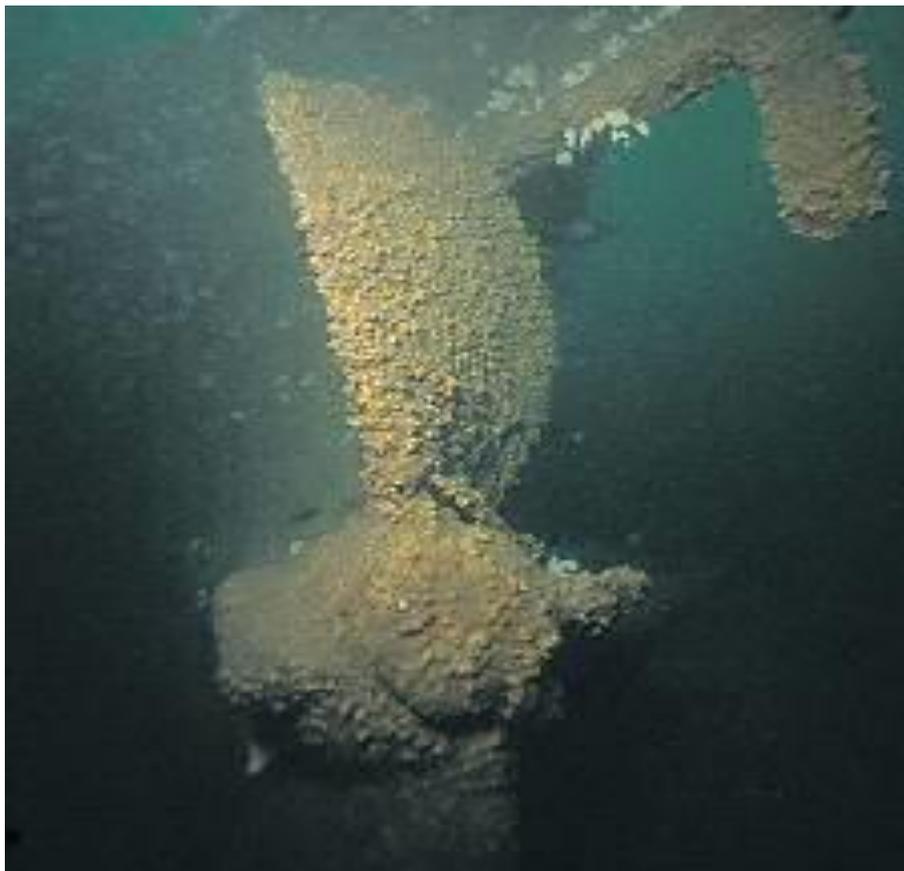
Figure 50. Propeller © John Liddiard

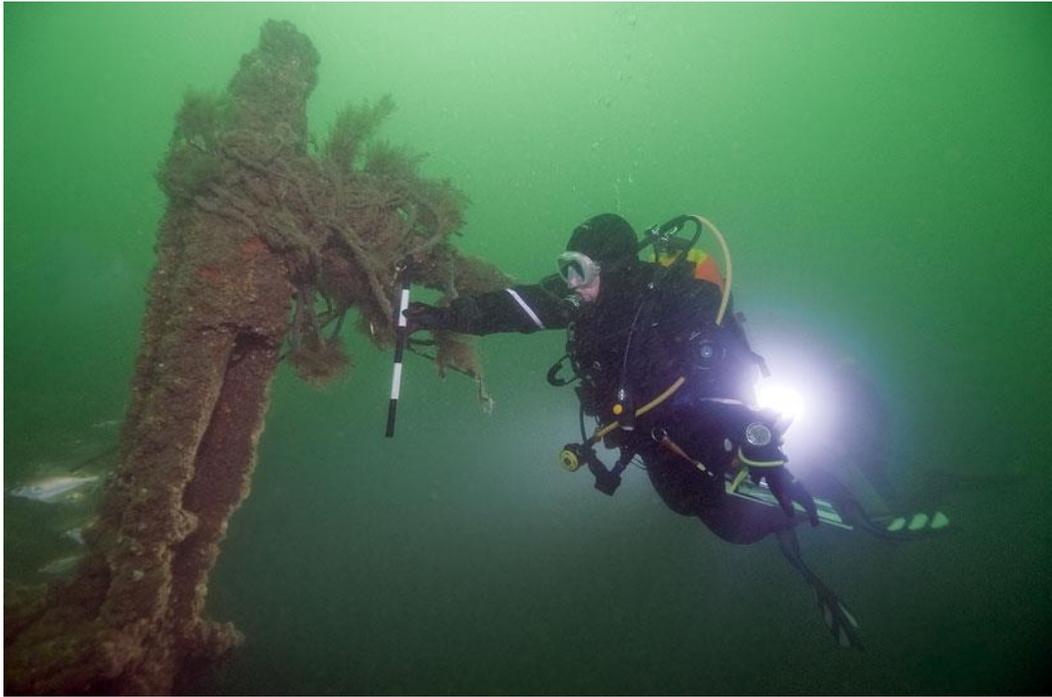
Figure 51. Rudder post and arm ©Barry Jarvis
