Ship, Rock, Selsey

A REPORT ON THE WRECKS OF TWO WOODEN SAILING BARGES
AND THEIR CARGO OF STONE.

Alison Mayor | Southsea Sub-Aqua Club | May 19

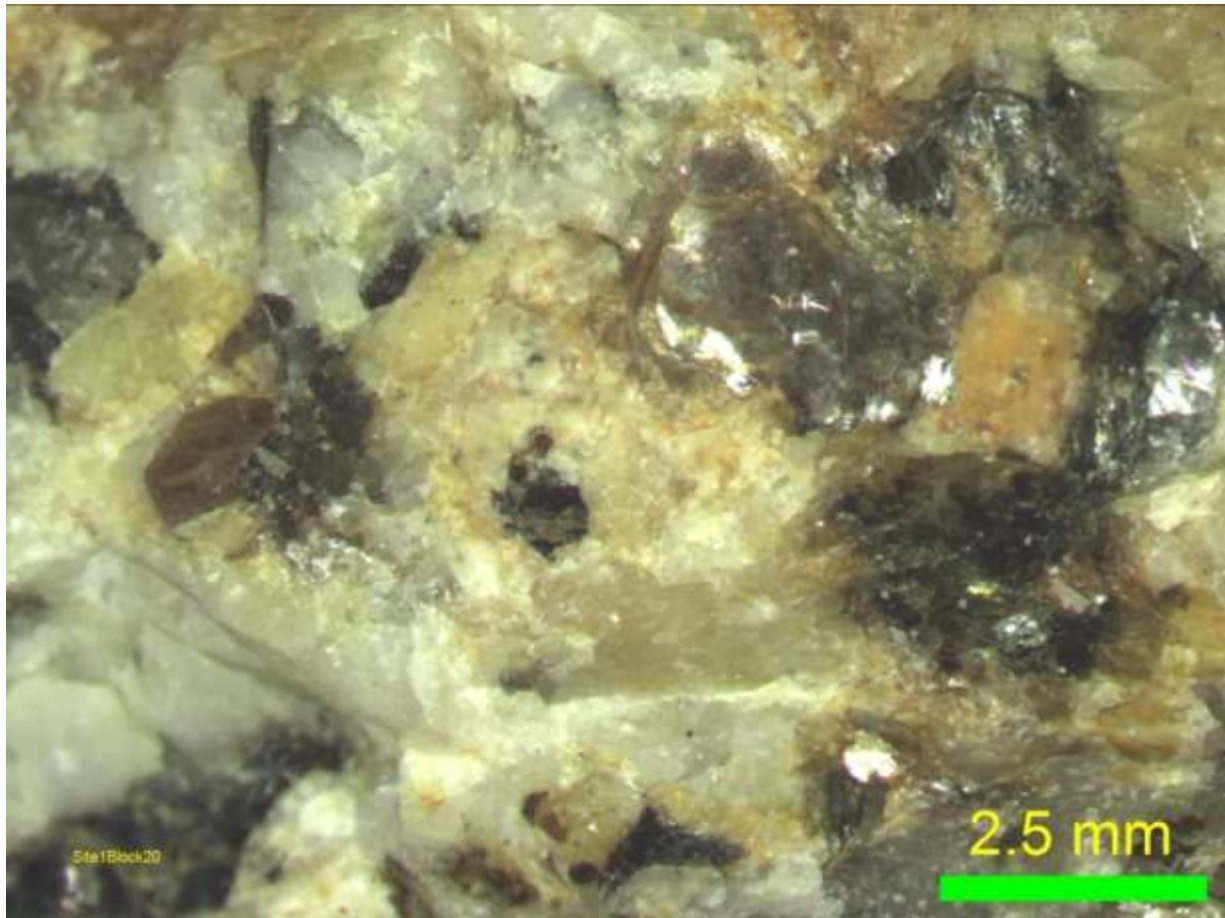
Figure 12 sample of Block 20 magnified 0.8 (© Pete Dolphin)

We had hoped to have the sample analysed by the Earth Science Department in Portsmouth University but they were unable to assist us on this occasion. However we do not believe the samples are those from a limestone block. This is consistent with the NAS report (David Carter) which noted that the erosion of the surface by marine worms was not evident as with the Weymouth stone barge which has a cargo of Portland stone which would support the granite theory.

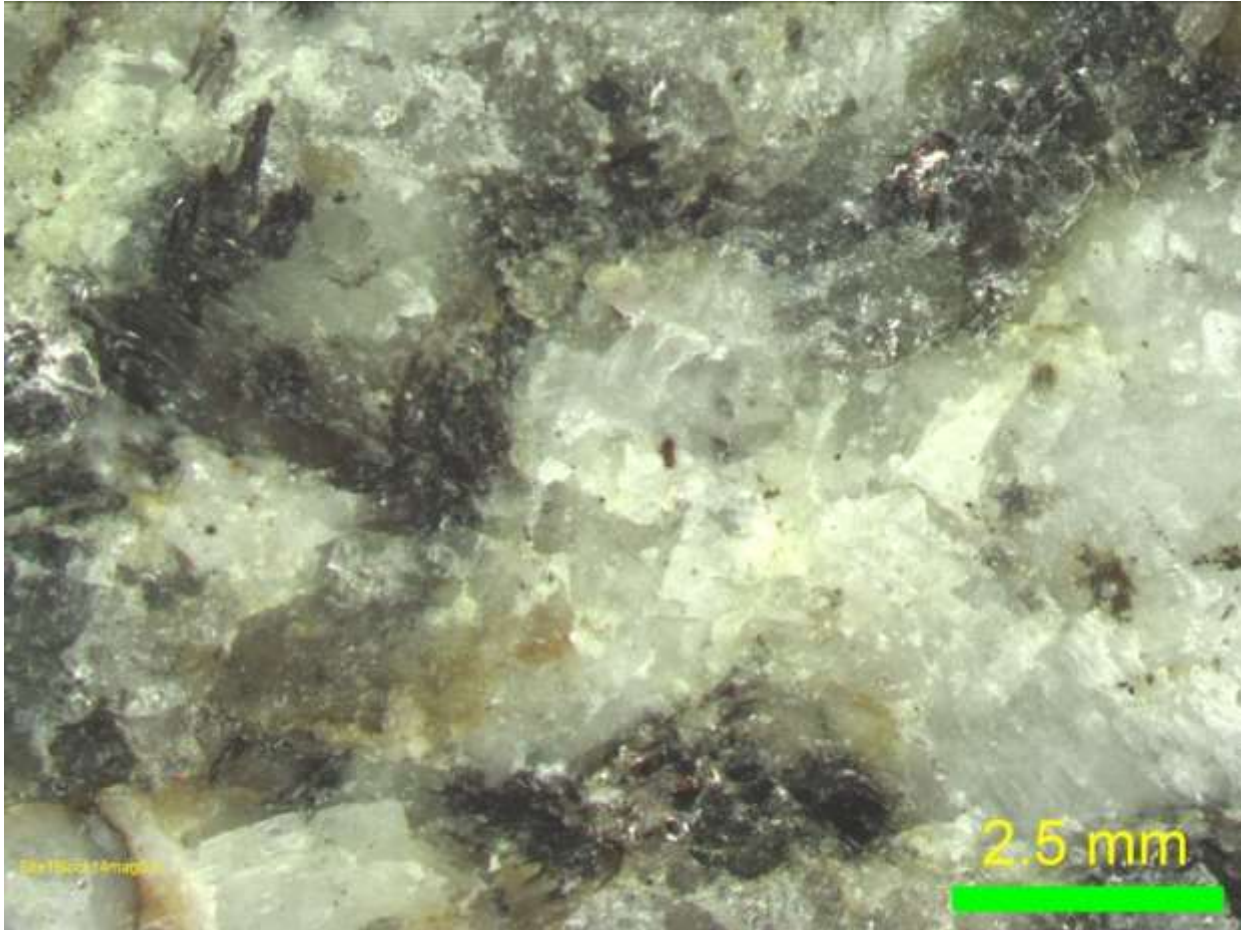
Figure 14 Sample of Block 14 Magnified 0.8 (© Pete Dolphin)

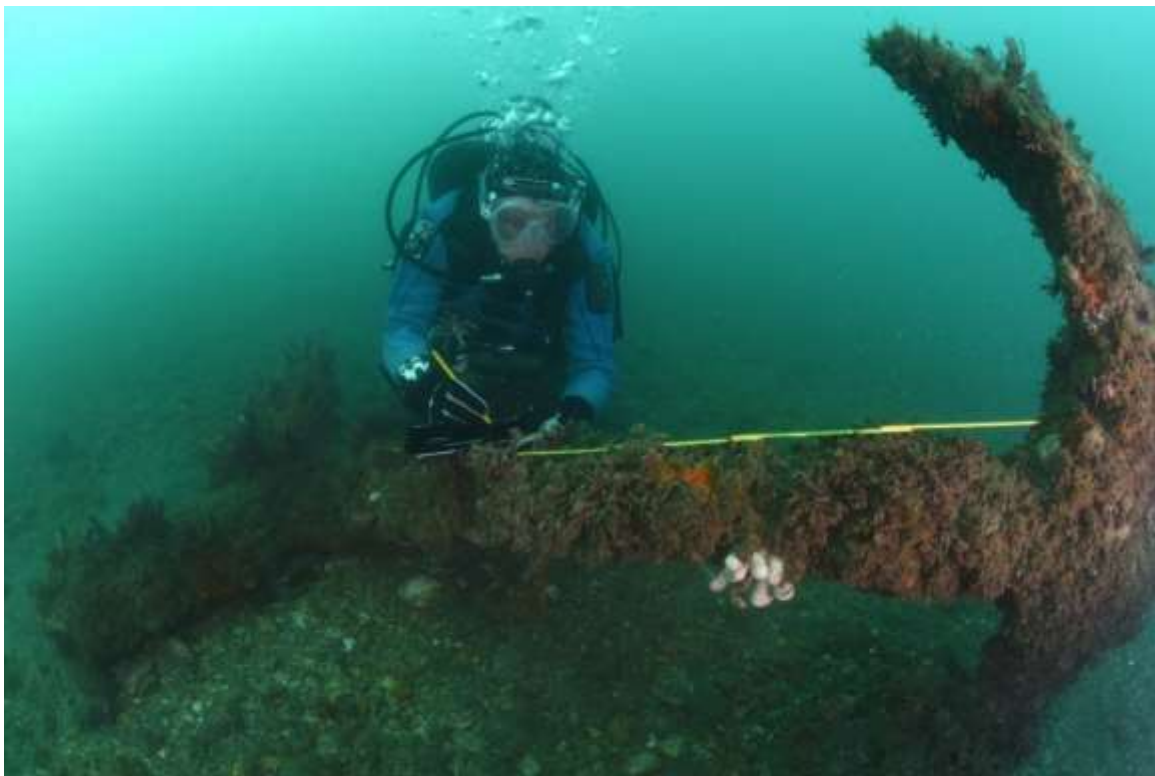
The anchor is an Admiralty Pattern type and made of iron. It can be found towards the stern on the port side approx. 3m from the last block. The stock is 1.8m across as is the shaft. The stock and lower fluke are exposed.

Figure 19 diver measuring the anchor. (© Martin Davies)

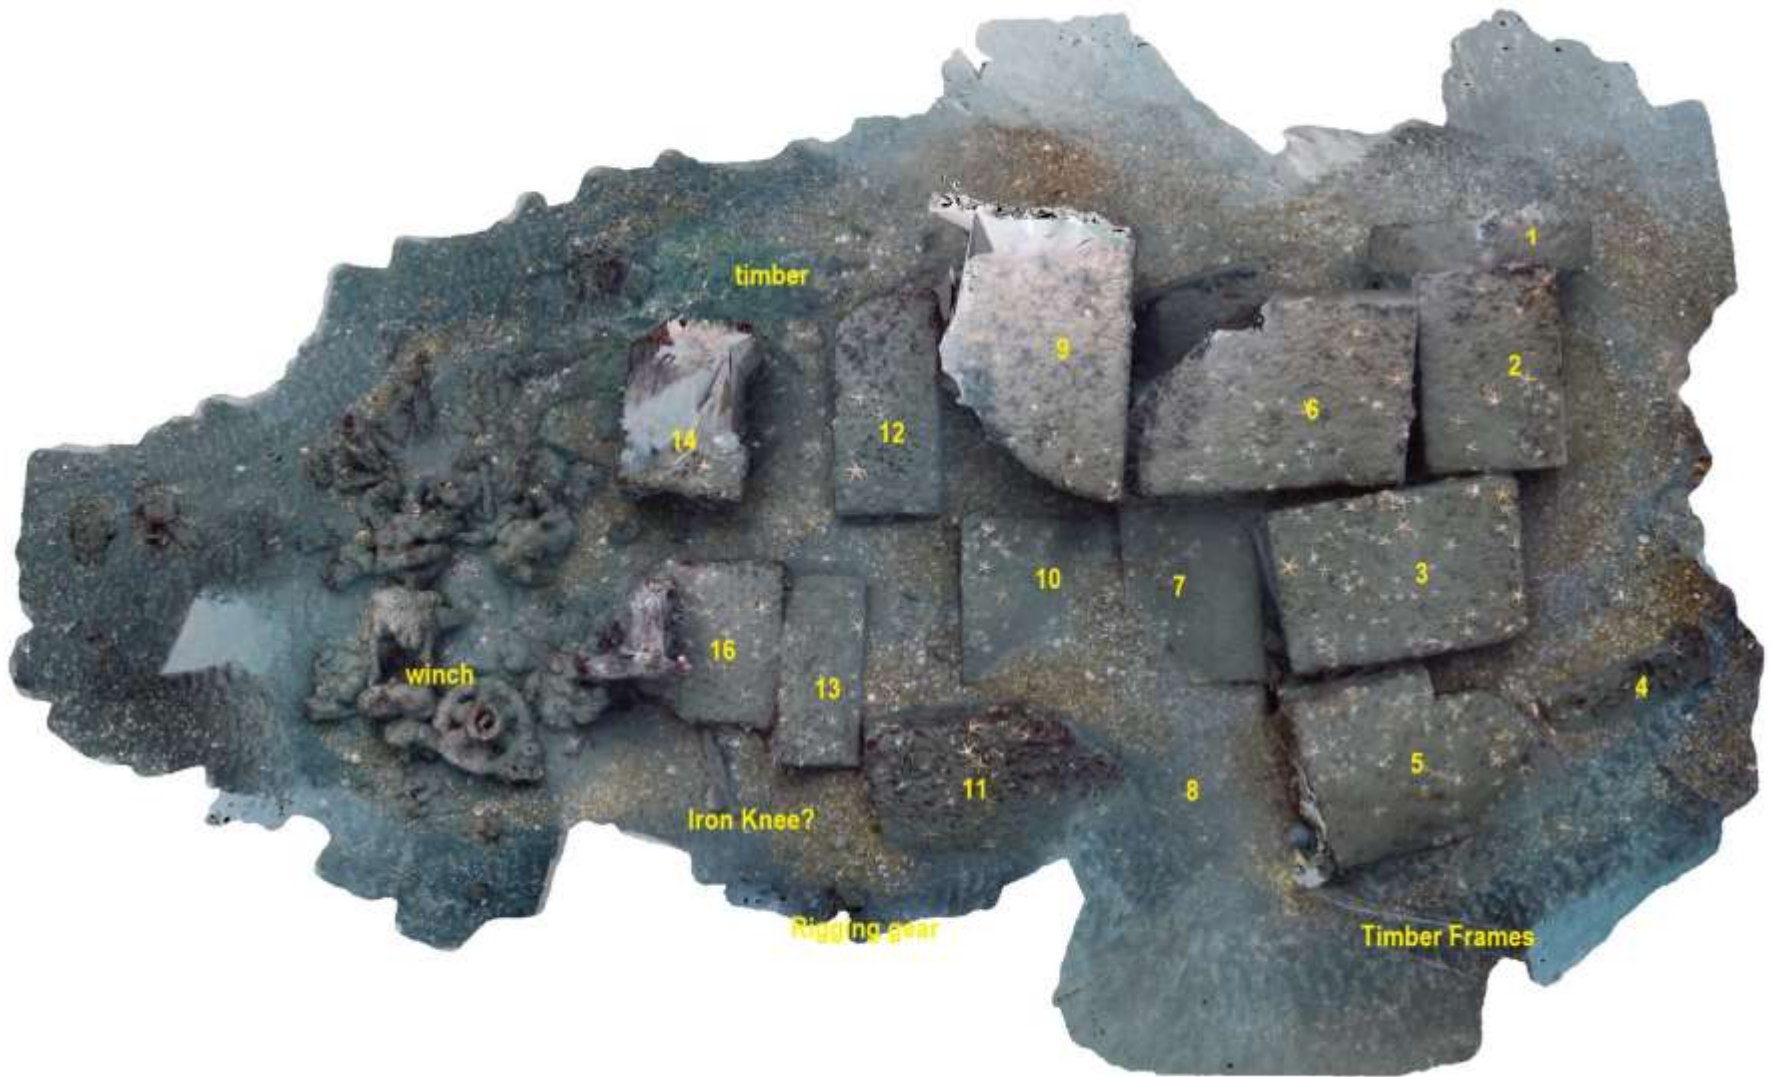
The site has degraded significantly since the Wessex Archaeology survey in 2005 when it was reported that timbers were exposed and much of the iron features were relatively intact. The cargo remains the main element of the wreck and is unlikely to degrade due to the nature of the stone blocks.

Figure 21 Extract from photogrammetry model - Plan view of site 1 bow to left (© Martin Davies)

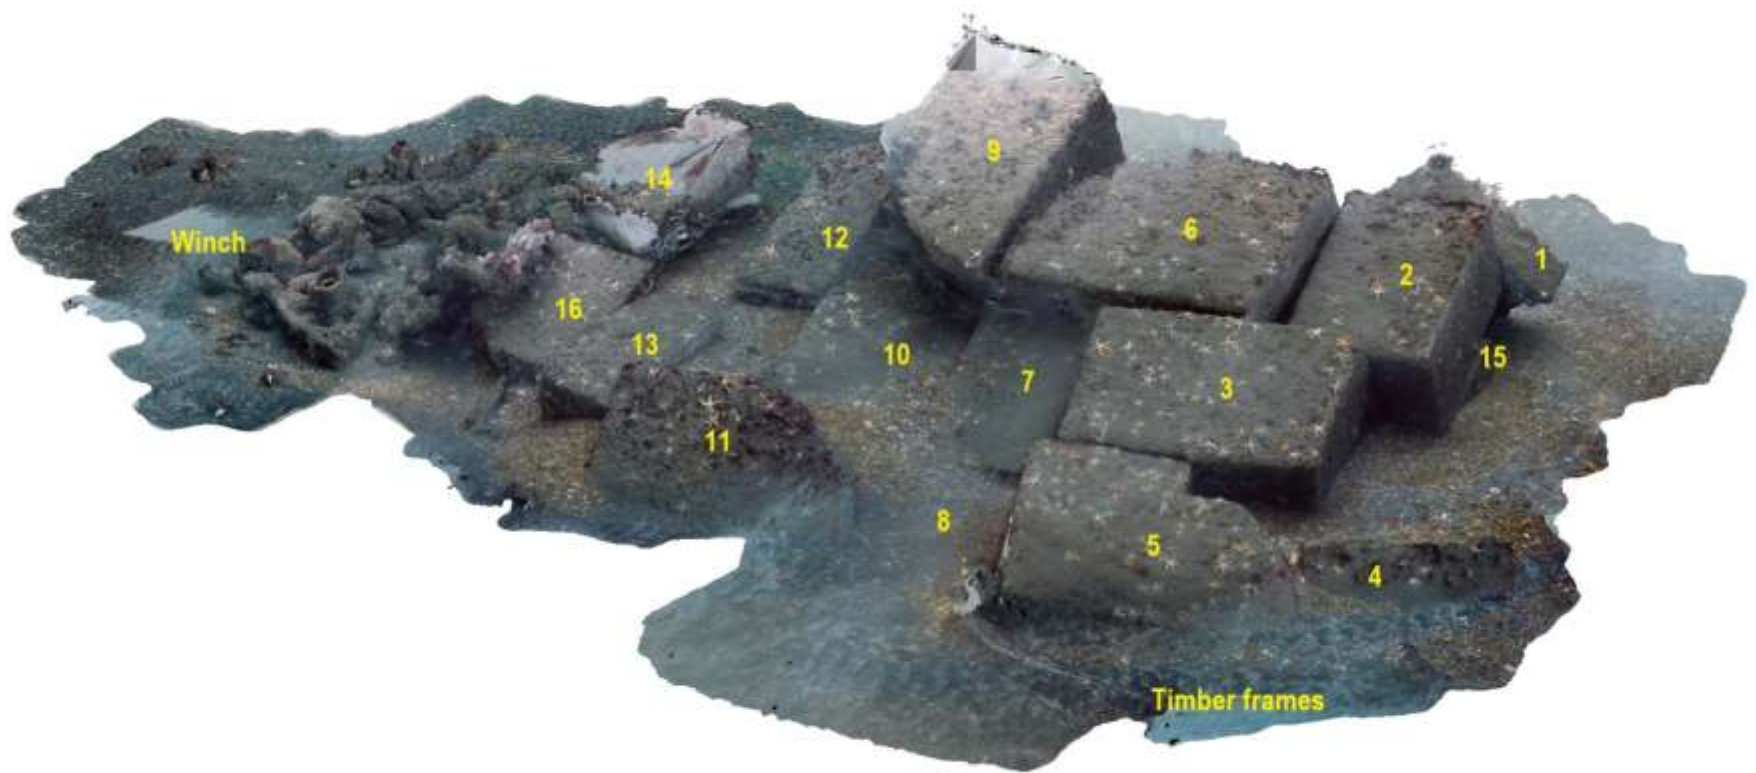
Figure 22 Extract from Photogrammetry image - Port side view, bow to left. (© Martin Davies)

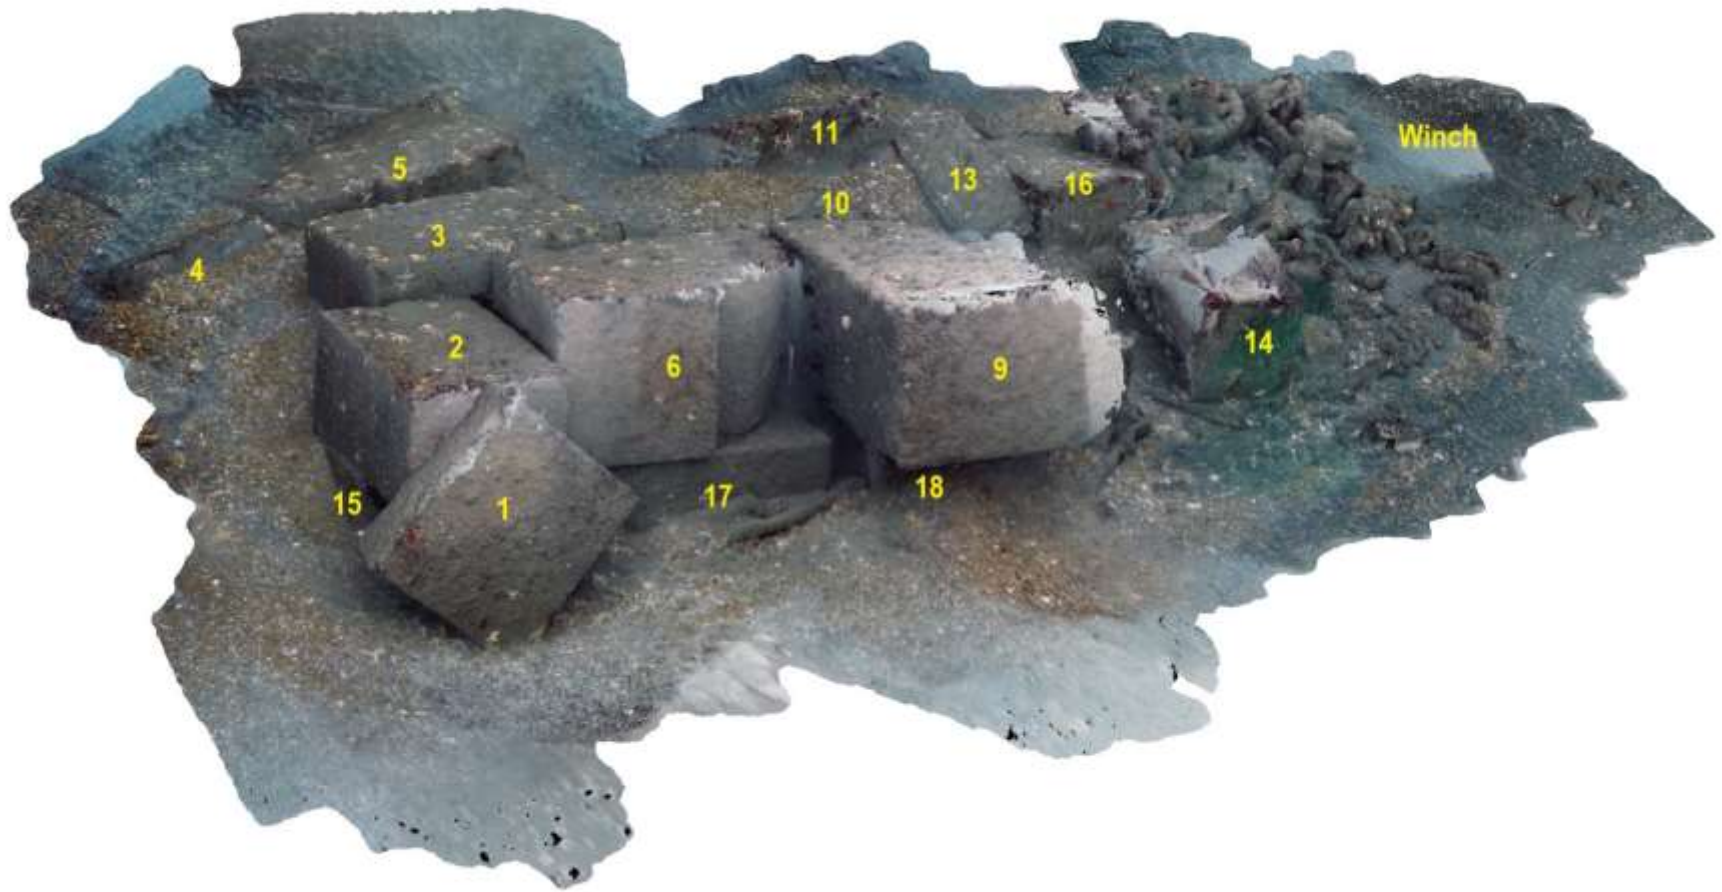
Figure 23 Extract from photogrammetry model - starboard view, bow to right. (© Martin Davies)

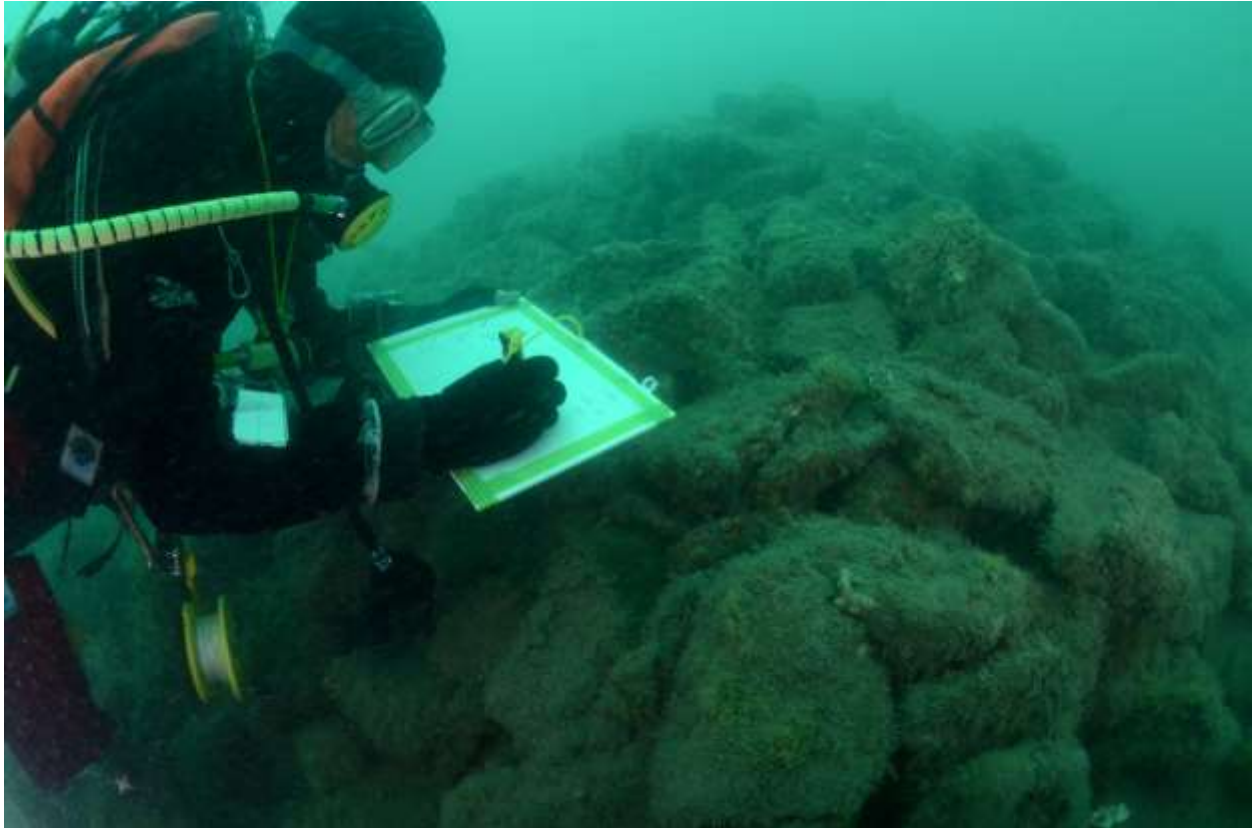
Figure 26 A diver surveying the ballast mound. (© Martin Davies)

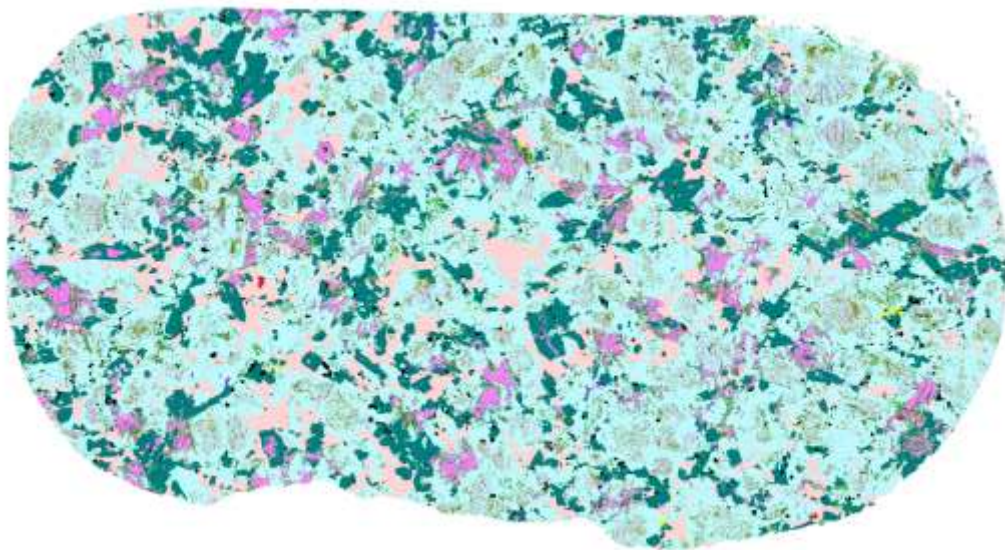
It was also noted that the absence of pink Feldspar meant that the sample was not a granite from Cornwall but would have originated elsewhere. A thin slice of rock sample was examined under a powerful polarizing microscope, then a detailed chemical analysis of the composite minerals and was undertaken.

Figure 29 A thin section of the rock sample from Site 2 (© University of Southampton)

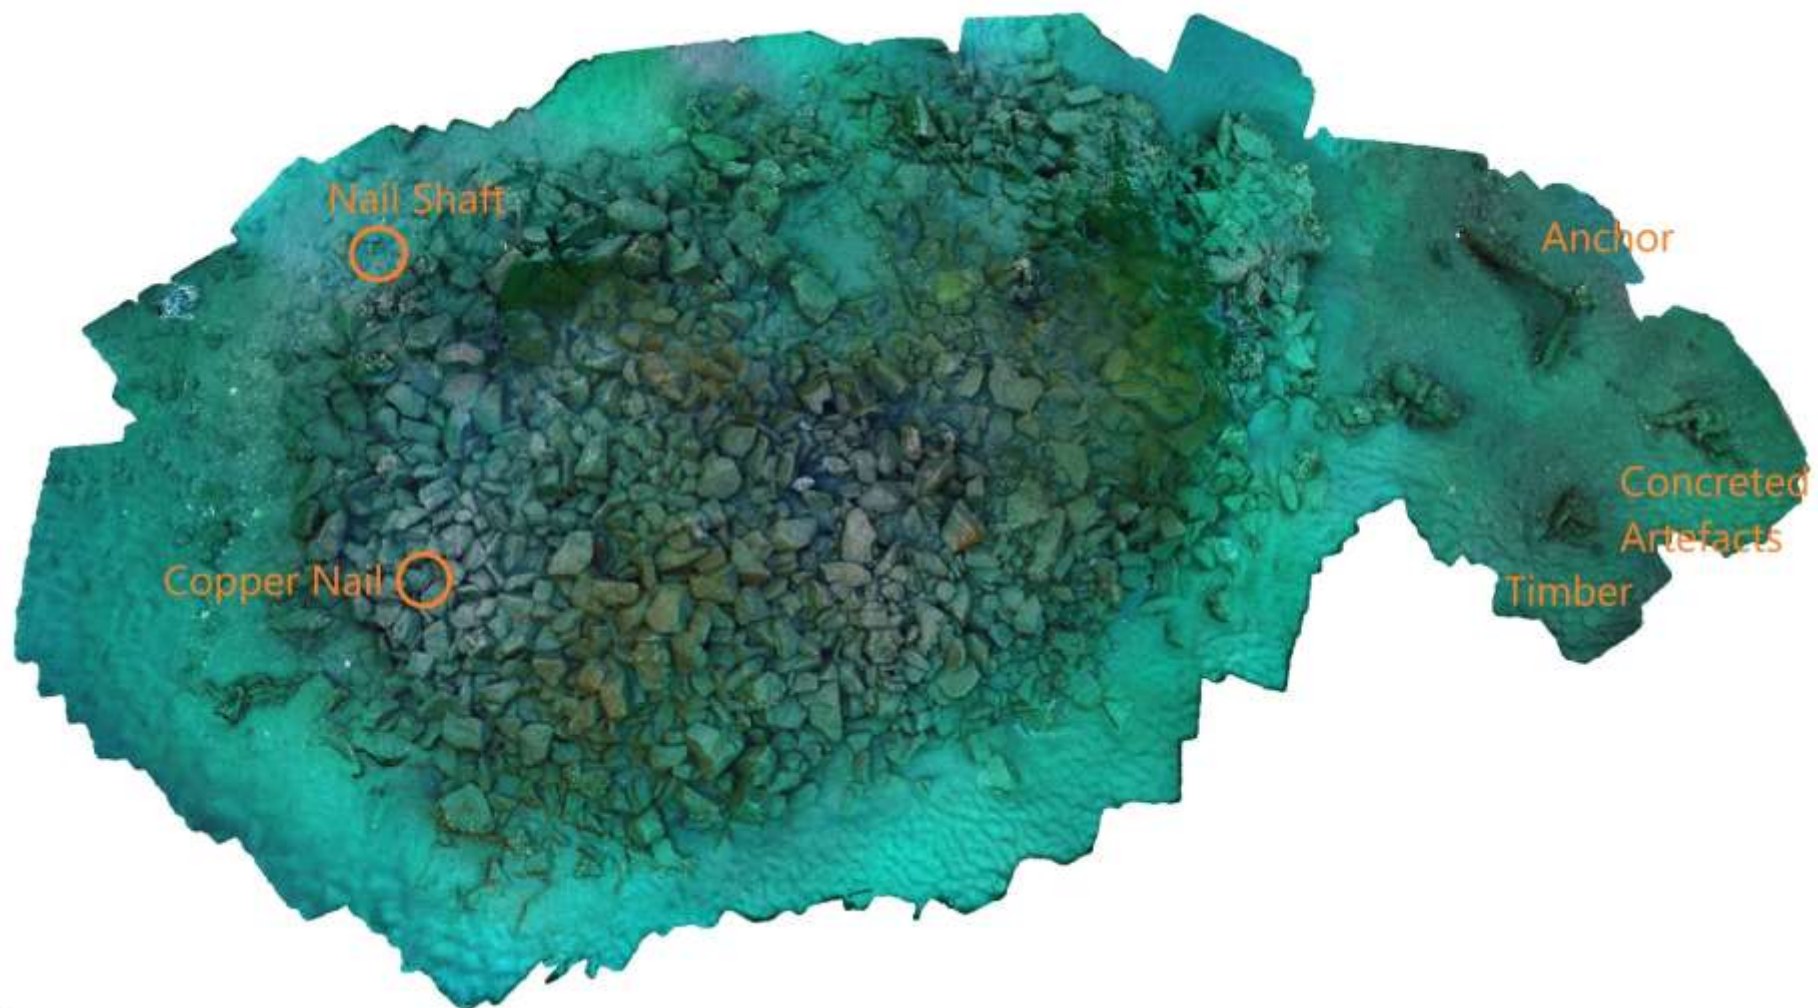
Disappointingly we have not been able to find out very much about the vessel or conclude how and when she may have sank. The site is much degraded and without the ability to excavate and take wood samples for dendrochronological analysis it is unlikely that we will be able to determine anything further.

Figure 33 Extract from photogrammetry model of Site 2 - Plan view 1, Bow to the right. (© Martin Davies)

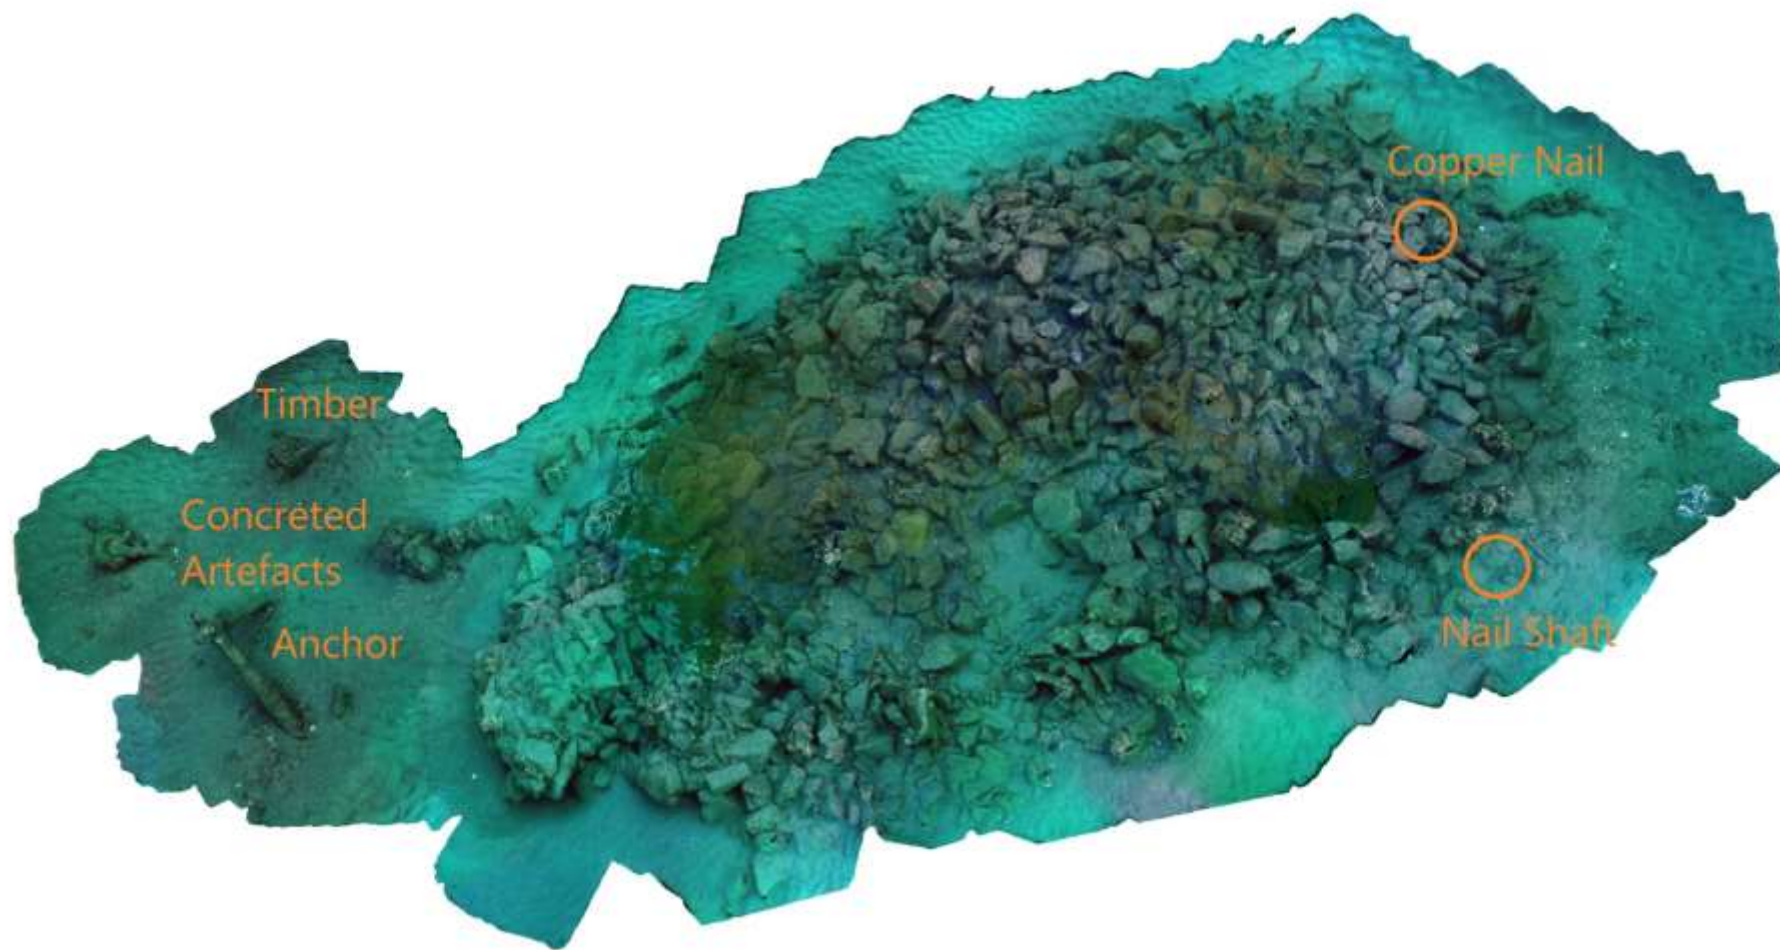
Figure 34 Extract from photogrammetry model of Site 2 – Plan view 2 – bow to the left. (© Martin Davies)

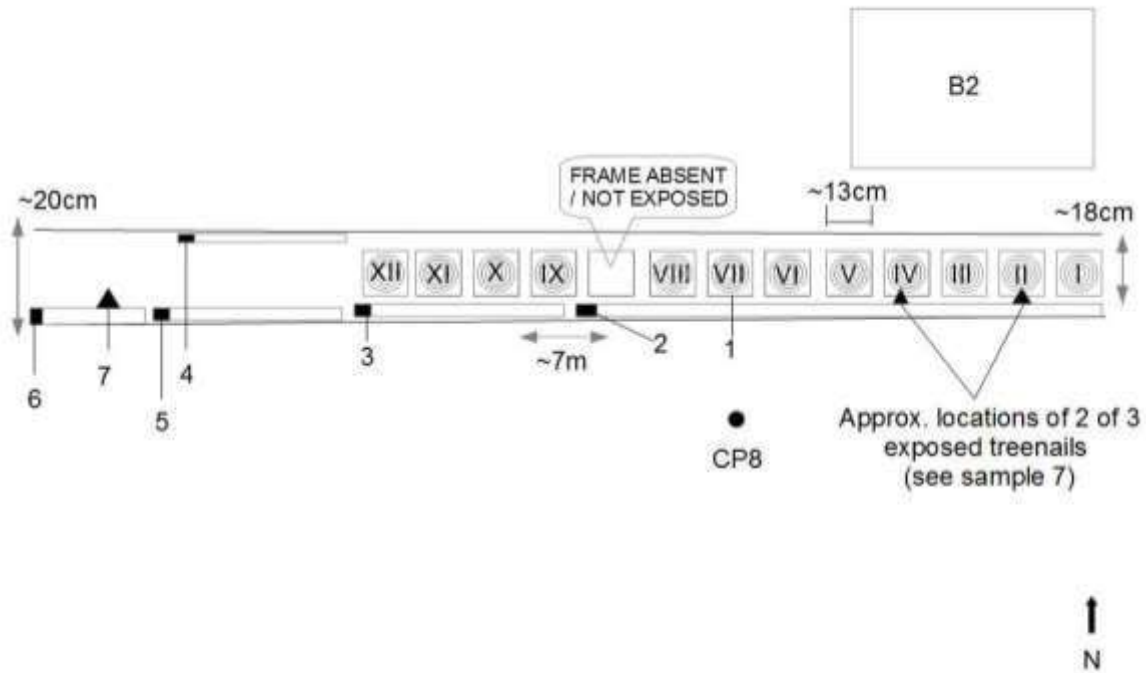
It should be noted that while not sampled, Frame VIII features very narrow growth rings and was most probably cut from a rather slow-grown oak. This frame would make an ideal sample for dendrochronology if one could be taken without too much disturbance between the planking. The absence of an exposed frame to the west could make this task more feasible (Figure 1). Other possible candidates for dendrochronological sampling are noted below (Table 1).

Figure 1. Schematic plan of the sample area of the Selsey Stone Barge Wreck. Plan is not to scale and sample locations (noted in Arabic numerals) are approximate.

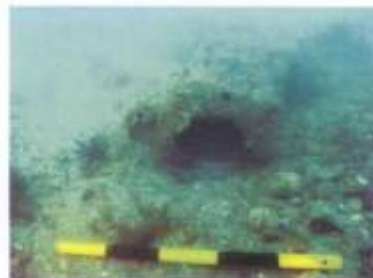
Stove

This could be a pump pipe, although the pipe wall seems to be very thick. In the far stern of the vessel, approx. 3 m from the stone cargo, a small cast iron stove was found and recorded. The 0.5 m high, 29 cm wide and 25 cm deep cast iron stove is lying on the side, attached to a broken iron baseplate. The main opening in the top has a diameter of 14.5 cm. The flue hole in a base at the back of the stove is 10 cm in diameter. The stove has an 11 cm base at the bottom, to which 5cm feet are attached. At the top, a 6 cm rim runs around the stove.

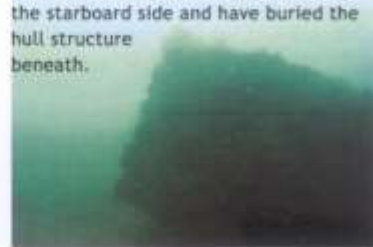
The cargo consists of large stone slabs, presumably of Portland stone. All slabs have different sizes. One example was measured as being 1.2 m long, 1.3 m high and 40 cm deep. The stones are neatly stacked in the position of the former hold. They are angled towards the starboard side and have buried the hull structure beneath.

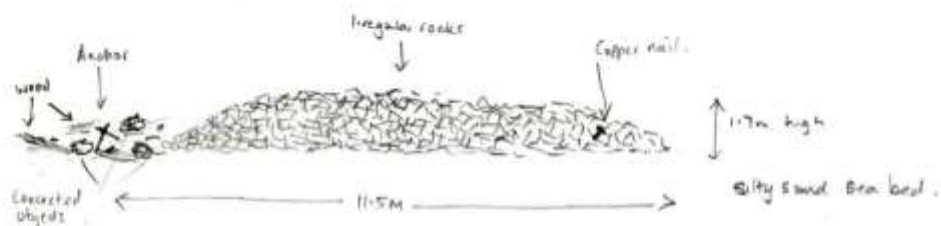
Remains of a wooden vessel. Rocks cargo or ballast? Anchors and other metal objects (at bow?)
Copper nail round head + shaft extend 16cm from rocks.

Figure 1. Not the remains of a Mulberry but an old wooden shipwreck. (© Alison Mayor)

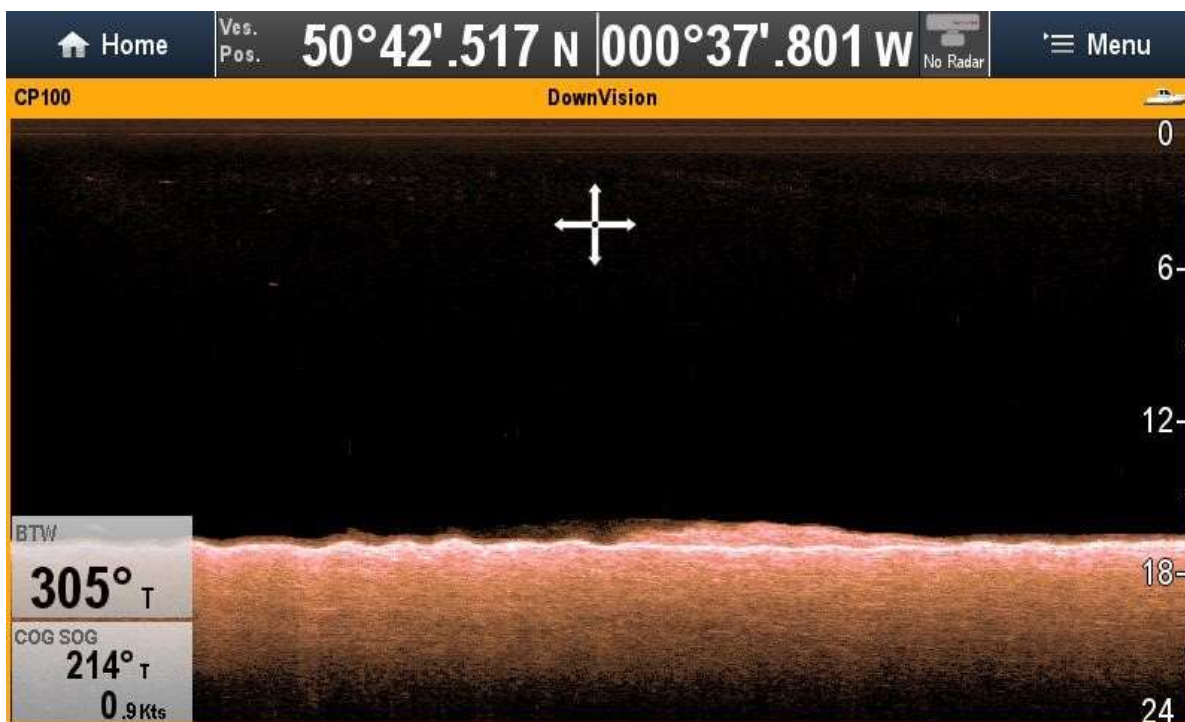
Figure 2 Sonar image of the mound of rocks.

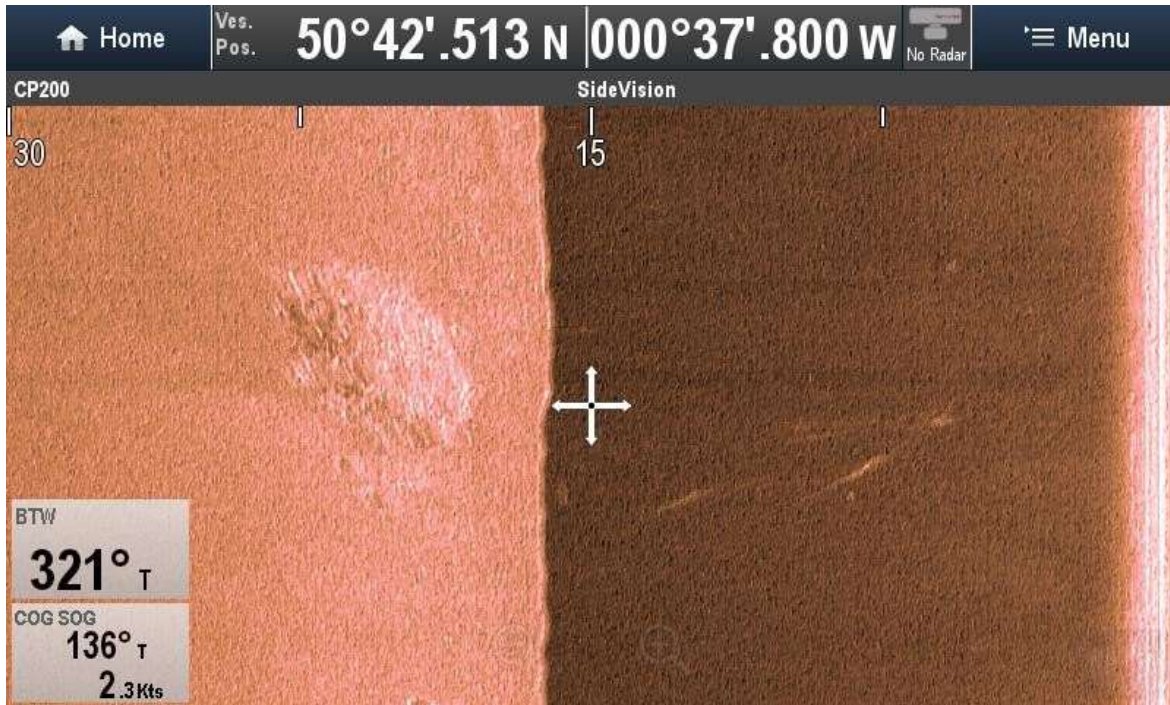
Figure 3 Side scan image of the wreck site showing the oval rock mound.

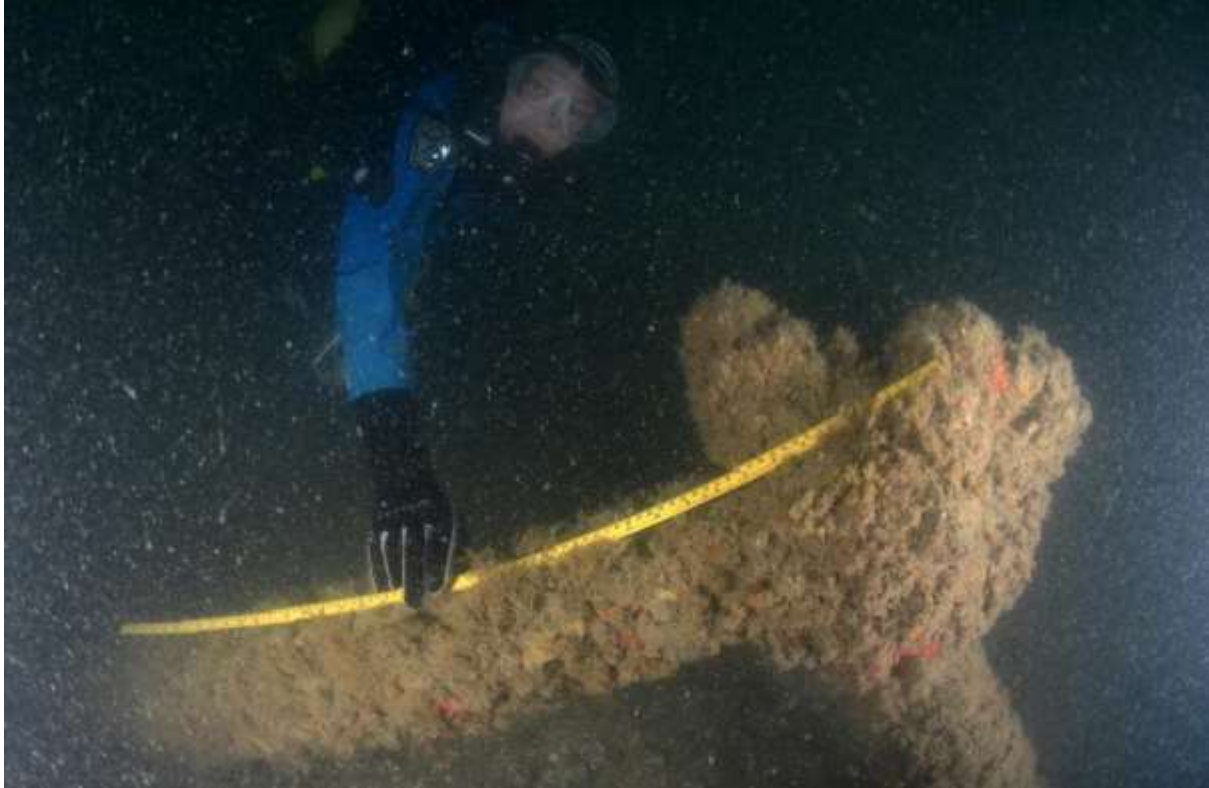
The anchor is an Admiralty style anchor though it is much degraded. It is smaller than the anchor at site 1 and partly buried. Part of the stock is missing and it is difficult to determine whether the anchor has one fluke or two. We assume it has two. Just visible near the fluke are what appear to be a couple of links of chain.

Figure 5 Diver measuring the anchor. (© Martin Davies)

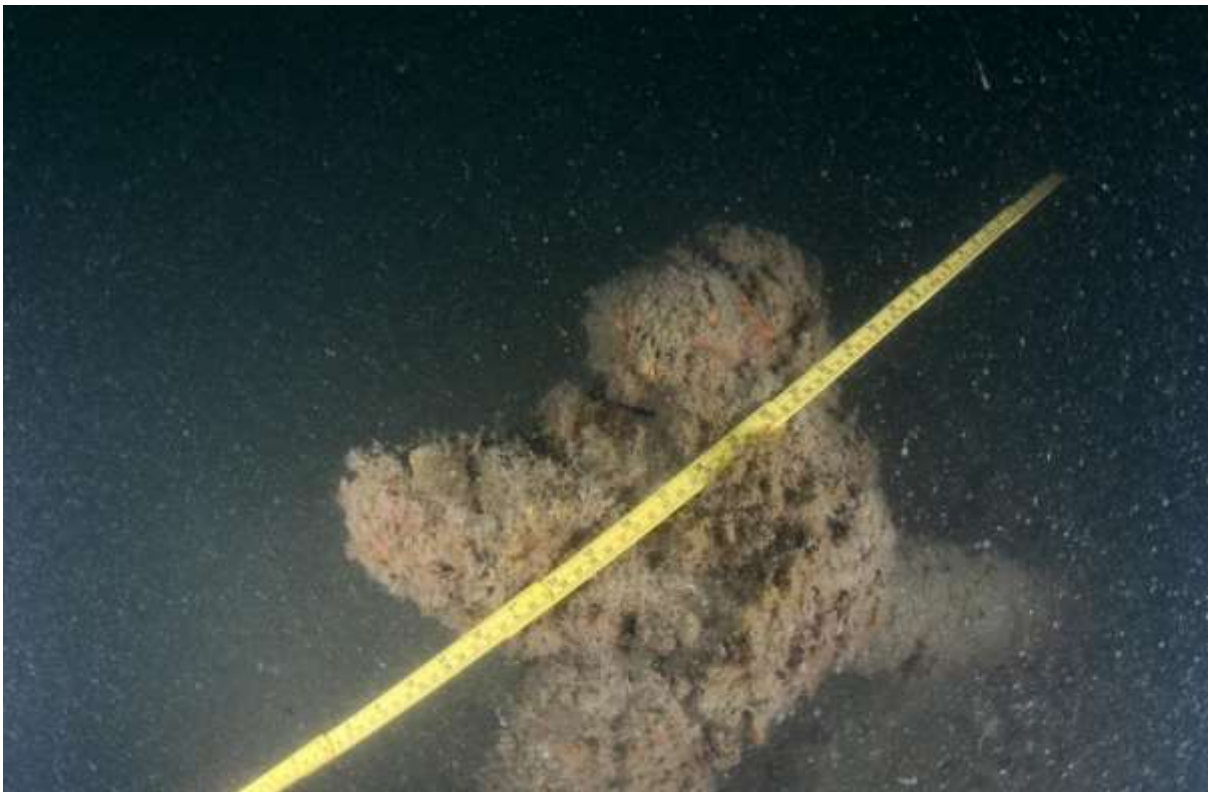
Figure 6 the top of the anchor. (© Martin Davies)

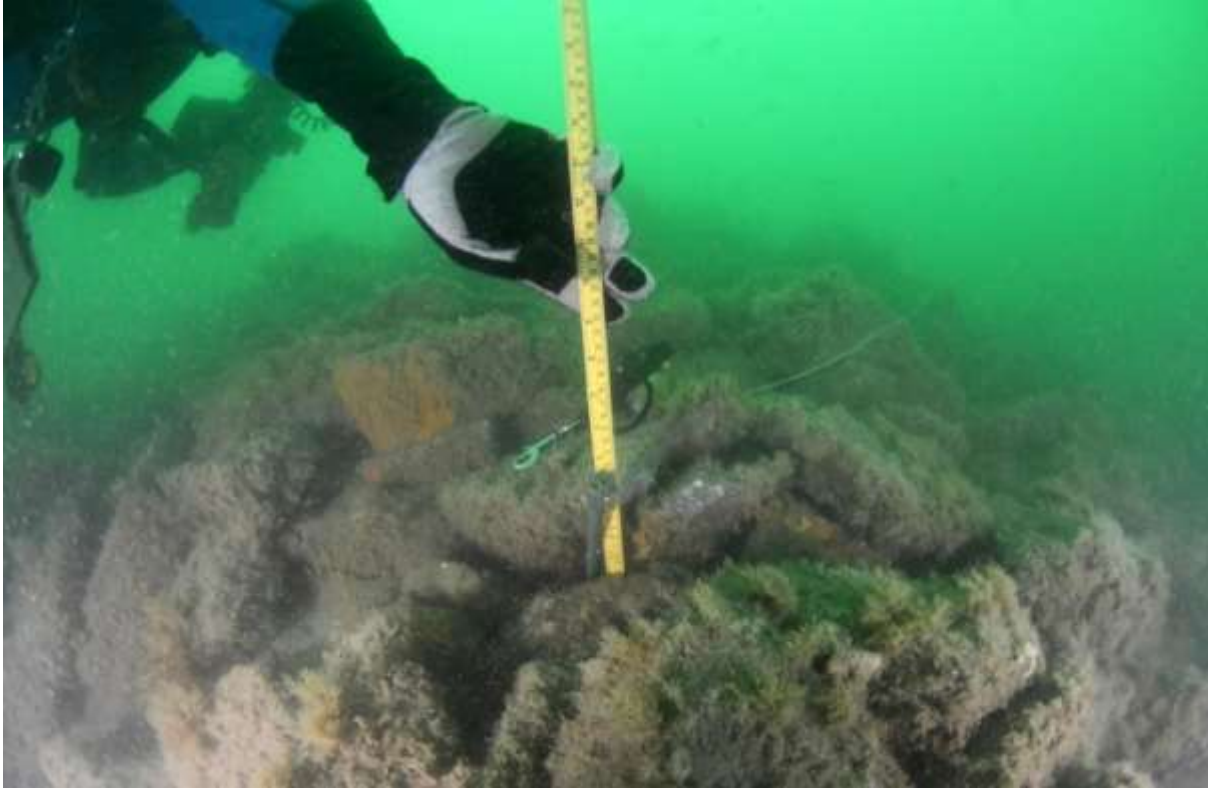
The copper nail has a round head and round shaft. Due to it being firmly embedded in-between rocks in the ballast mound it is not possible to determine its length without removing it. However the broken nail, again with a round shaft but without the head was 22cm.

Figure 9 A diver measures the copper nail. (© Martin Davies)
